# Catastrophic failure of 4 cobalt-alloy Omnifit hip arthroplasty femoral components

Li-On Lam<sup>1</sup>, Karl Stoffel<sup>1</sup>, Alan Kop<sup>2</sup>, and Eric Swarts<sup>2</sup>

<sup>1</sup>Fremantle Orthopaedic Unit, University of Western Australia, Fremantle Hospital, <sup>2</sup>Department of Medical Engineering and Physics, Royal Perth Hospital, Western Australia  
Correspondence KS: nkstoffel@hotmail.com  
Submitted 07-03-12. Accepted 07-04-19

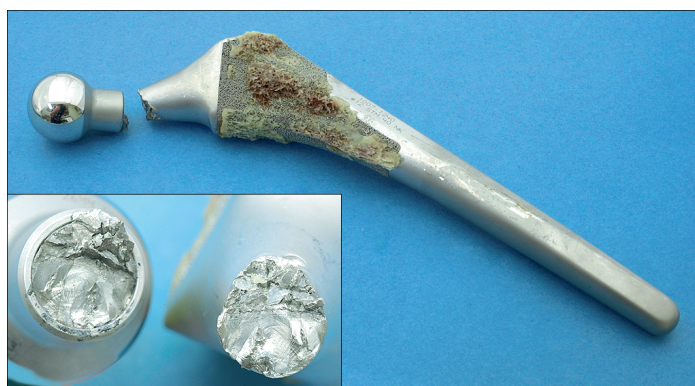
Figure 1. Macro photograph of fractured stem. Insert shows surface of fracture.

lar heads. In all cases, the fractures had occurred immediately adjacent to the base of the modular head (Figure 1). Both surfaces of the taper of head and neck showed evidence of crevices and intergranular corrosion.

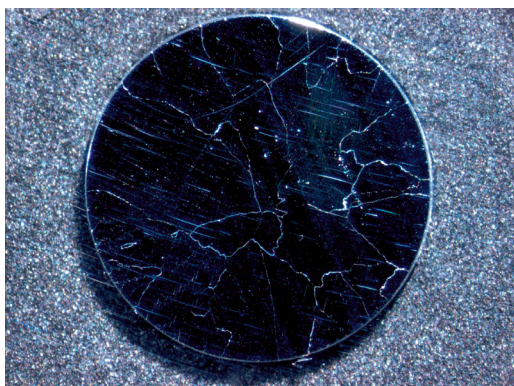
Figure 4. Macrostructure of a cross section taken through the neck of a fractured stem. Note the large grains and the presence of precipitates at the grain boundaries.

Suboptimal macro- and microstructure of the implants also predisposed them to failure. Macroscopically, we found that the grain size was large.

Grain size is a factor that has a direct effect on the fatigue life of an orthopedic device. In general terms, the larger the grain size, the lower the materials yield and fatigue strength. Microscopically, the extensive carbide precipitates along the grain boundaries also predispose the device to failure.

This report is the largest series of fractures in the neck region of uncemented cobalt-alloy femoral components that we are aware of. In light of our findings, attention should be paid to the manufacturing process—as we believe that the structure of the device could be improved by introducing a solution-annealing step that would help to prevent intergranular carbide precipitation. We also advise caution when using a skirted head in combination with a device of suboptimal microstructure.
