## Fracture of fully hydroxyapatite-coated titanium femoral stem of a total hip replacement—a report of 3 cases

Dinesh K Sharma<sup>1</sup>, Stuart Brooks<sup>1</sup>, Stuart Creasey<sup>2</sup> and Brian Lewis<sup>2</sup>

<sup>1</sup>Birmingham Heartlands & Solihull (Teaching) Hospitals, Birmingham, <sup>2</sup>Materials Research Institute, Sheffield Hallam University, Sheffield, UK

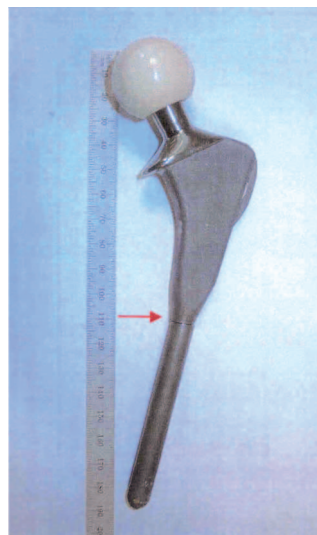
All 3 components were retrieved using a hole in the intermedullary canal made distal to the tip of the femoral stem. In each case, the proximal component was loose with osteolysis and had lost all evidence of the hydroxyapatite coating. The distal part of each prosthesis was bonded firmly to the bone. This, in turn, was the cause of difficult revision as it was first separated from the medullary canal by bone gouge and was then removed by punching the component proximally. There was no evidence of infection in any of the cases, based on cultures or clinical assessment.

Metallurgical analysis of one of the failed stems (Figure 2) was done using a Philips XL40 scanning electron microscope equipped with an Oxford

Figure 2. The failed stem as it was received, with the location of the fracture indicated by the arrow at the top of the distal tip. The hydroxyapatite (HA) coating was shown to be lost, which was thought to be due to an infection that generates environmental conditions conducive to dissolution of the coating.
