# Faulty design increases the risk of neck fracture in a hip prosthesis

**ABSTRACT** – From October 1993 to May 1994, we performed 35 total hip arthroplasties (20 women) using a Charnley type modular 28 head manufactured by Medical Tec Brazil. 9 fractures through the neck of the stem prostheses occurred, all but 1 in men, after mean 4 (0.3–6) years. All fractures were due to an inadequate confluent radius causing abnormal transmission forces through the neck. The higher the load (men, heavy body weight), the greater the risk of fracture. The metallographic, chemical and microhardness analyses showed no abnormalities. We ascribe these fractures to faulty design of the stem prosthesis.

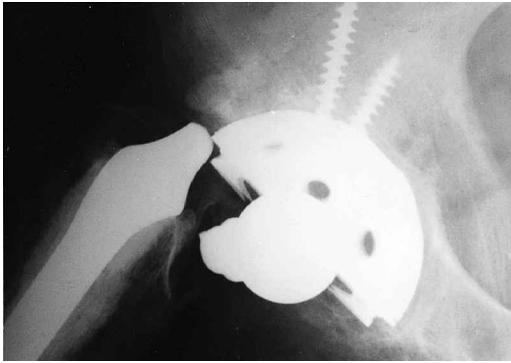
Figure 1. Fractured neck of femoral component.

In all cases, a rupture took place in the area of the confluent radius and then a fatigue crack spread toward the interior of the axis first slowly, then faster until the final rupture.

The technical analysis demonstrated that all fractures occurred at a point where the diameter of the prosthetic neck is smallest (10 mm) and then increases to 11.7 mm diameter by a sharp confluent radius. The neck at this level, on its inferior border, has a circular indentation to facilitate extraction.

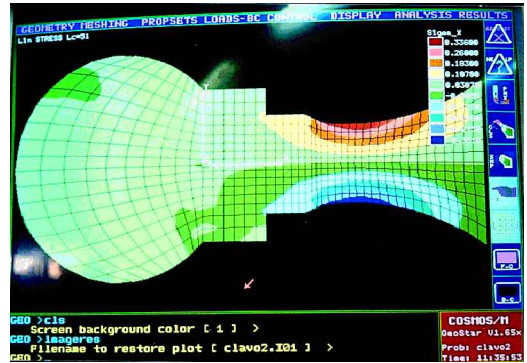
Figure 2. The distribution of tension in the head and neck of a femoral component.

The overall tension was calculated with a finite model (Figure 2).

Finally, we studied the overall tension, calculated by means of a finite model, by observing the flexion and tension forces in the areas subjected to this prosthesis design. We found that the confluence radius between the femoral head and neck is inadequate with fracture risk.

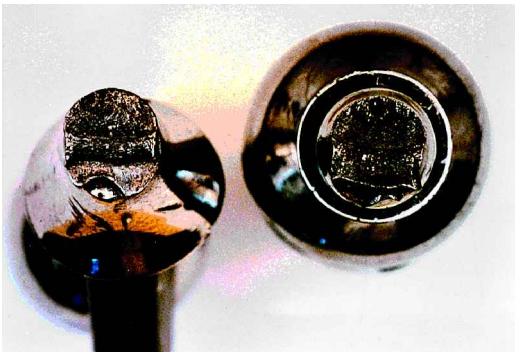
In all the samples the fracture surface had three very different areas from lateral to medial: a smooth surface with beach or clam, shell marks, another with more accentuated beach marks, and a third area with a rough granular appearance.

Figure 5. Fracture surface neck of femoral component showing different areas.
