Massive exposition to titanium, but without sensitization

A case report of an overlooked disassembly of a modular acetabular component

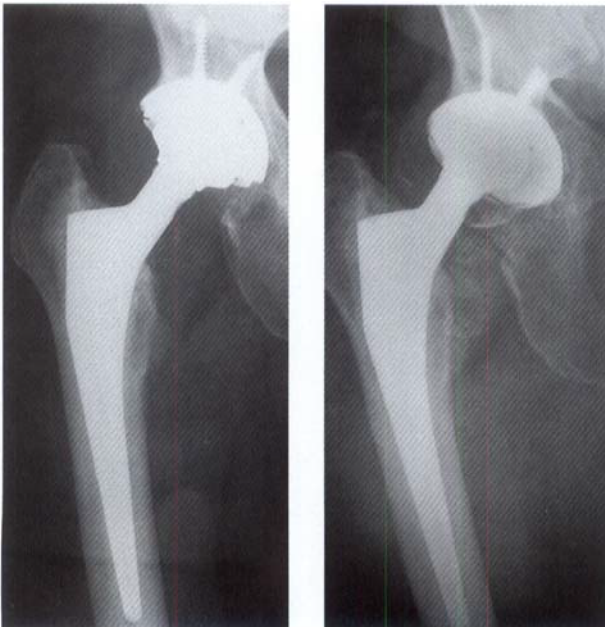
December 1988 (left), 5 years prior to revision, showing a satisfactory position of the prosthesis.

November 1991 (right), 19 months prior to revision, showing an eccentric position of the prosthetic head in the acetabular shell.

Reevaluation of the radiographs from November 1991 showed an eccentric position of the prosthetic

head in the cup and a curved shadow distal to the head indicating, as pointed out by Retpen and Solgaard (1993), displacement of the polyethylene liner. Thus, for a period of at least 19 months prior to revision, metal-on-metal contact caused excessive deposition of CPTi and TiAlV debris. This metallosis explains the cloudy mass also seen on the radiographs from November. Our case emphasizes the importance of detecting radiographic signs of disassembly.

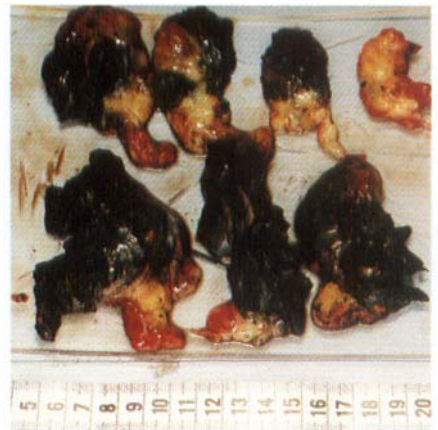
Sectioned soft tissue block, excised at revision, with excessive metallosis and necrotic cysts.

At revision, we found a 6 × 8 × 10 cm block of black, fibrous soft tissue adherent to the joint pseudocapsule and embedding the sciatic nerve. In the joint cavity, excessive amounts of black liquefied debris were found. The polyethylene liner was subluxated 90 degrees out of the metal shell. 11 g, i.e., 28 percent, of the metal shell, and approximately half the screw material had eroded away. The remaining metal shell, screw parts and femoral stem were found to be well fixed. The femoral head had 2 superficial scratches and the polyethylene liner was worn down by the femoral head. The soft tissue block was sectioned, several necrotic cysts with an approximate diameter of 1 cm and multiple metal deposits were found. The tissue was microscopically composed of hyperplastic synovial and fibroblastic tissue with calcifications and excessive deposition of black pigment lying extracellularly or within macrophages.
