# Late disassembly of modular acetabular components

## A report of two cases

Jens B Retpen and Søren Solgaard

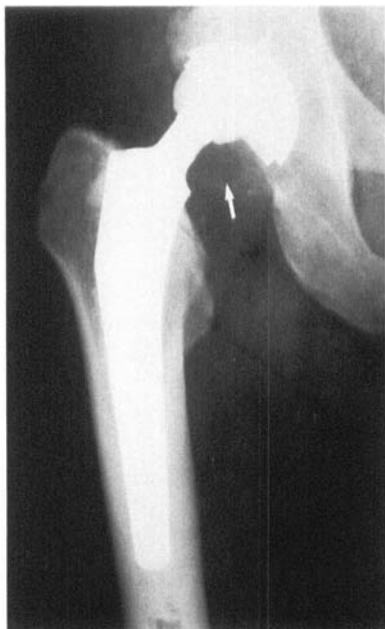
## Case 1.

There was a fracture of the proximal part of the rim of the insert, which was tilted out of the metal socket and rotated 90 degrees. The femoral head was located in the metal socket, and the titanium was burnished in a 10 × 10 mm area in the proximal part, but there were no signs of metal debris or metallosis. Both the femoral component and the acetabular socket were stable. It was not possible to fit a new insert in the metal socket as the flanges were distorted; it was removed without any loss of bone and a new one implanted. The femoral head was exchanged. The postoperative period was uneventful and the patient went back to work after 6 weeks. Reevaluation of the prerevision radiographs revealed that the displaced polyethylene insert could be identified as a dark curved shadow distal to the metal backing (Figure 1).

Retrieved acetabular components. Burnished area on the metal backing is marked with arrow.

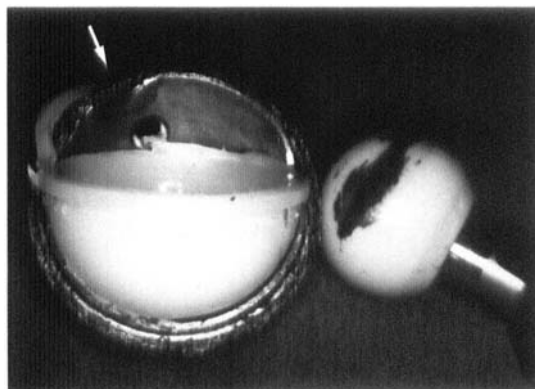
August, 1991, he felt what he described as a distortion of the hip followed by pain. He suddenly had a limp, and the hip produced a loud squeaking sound. Radiographs the same day showed an eccentric displacement of the femoral head in the cup (Figure 1). Fracture of the ceramic head or of the polyethylene insert was suspected and revision was performed the next day.

Prerevision. The curved shadow represents the displaced polyethylene insert (arrow).

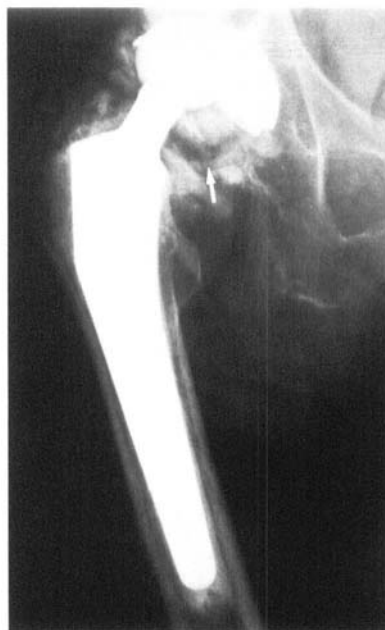
## Case 2.

Retrieved acetabular components.

At revision we found excessive metallosis of the soft tissues. The rim of the insert was fractured and the insert tilted out of the metal socket and rotated 90 degrees. The femoral head was located in the socket, of which 20 percent at the proximal part was totally eroded away. The underlying bone was necrotic and stained black by titanium debris. The displaced polyethylene insert was worn by the neck of the femoral component.

The remainder of the socket was fixed to bone, but it was removed without difficulty together with necrotic bone; debridement of affected soft tissues was performed. A new socket was implanted in cement, and the femoral head was exchanged.
