# Polyethylene failure of metal-backed patellar components

## 111 AGC total knees followed for 7-22 months

Henrik N. Andersen, Carsten Ernst and Peter A. Frandsen

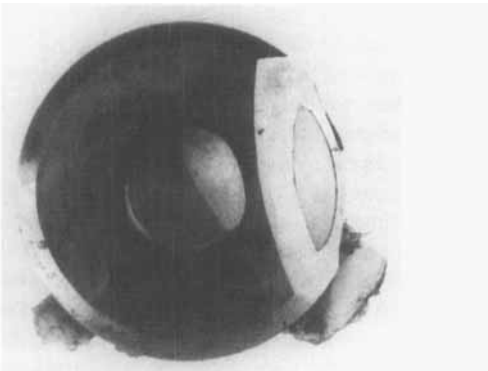
In all 8 cases, the polyethylene was broken and separated from the metal backing, which was still firmly attached to the undamaged patella. All the metal backings of the patellar components showed signs of gross wear (Figure 3), whereas in only 2 cases the femoral component showed slight abrasive wear of the lateral condyle.

Figure 3. Case 2. A removed metal backing with abrasive wear of the lateral edge.

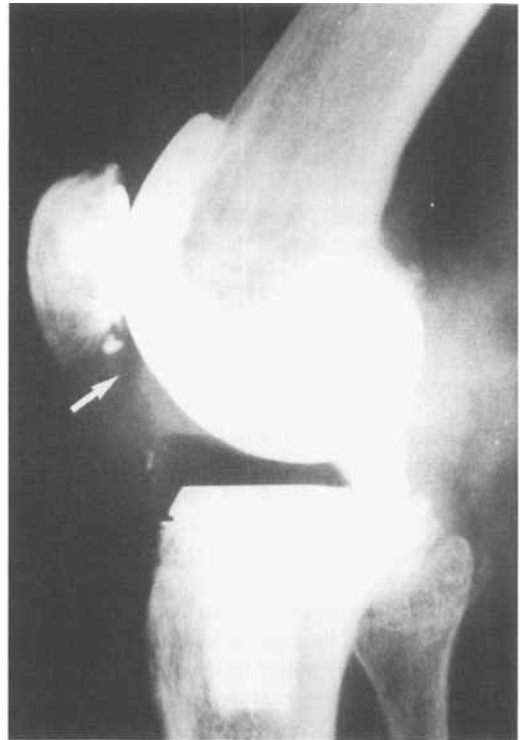
Figure 2. Case 6. Lateral radiograph demonstrating a discrete shadow (arrow) of displaced polyethylene cover.
