Separation of plastic and metal in an acetabular cup

Rolf Önnerfält and Herbert Franzén

Lund University Department of Orthopedics, S-22185 Lund, Sweden
Tel +46-46-171000. Fax +46-46-130732
Submitted 91-05-01. Accepted 91-05-27

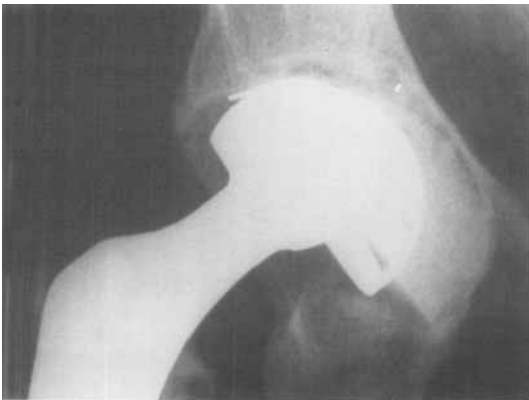
Postoperatively, the hip was painful and continued to be so for 2 years. Radiographs then showed complete wear of the polyethylene (Figure 1), and the patient was referred to us for further treatment. During the revision, we found that the polyethylene insert had rotated 180°. There was excessive wear, the rim was

Figure 1. Two years postoperatively. The polyethylene insert has rotated 180° and has broken.

of the polyethylene in a cup with a small diameter. The result is that the center of rotation becomes eccentric within the acetabular component. This produces increased torque forces, which explains the rotation of the insert. The same rotation has been reported for eccentric polyethylene cups without metal backing by Ramadier et al. (1980), who concluded that this type of cup should be avoided.

broken, and so was the metallic shell (Figure 2). The joint was outlined against black synovium (Felmet et al. 1989), and there was black tissue in the pores of the bone. After synovectomy, the floor was covered with an autogenous bone graft and a polyethylene cup was cemented into place.

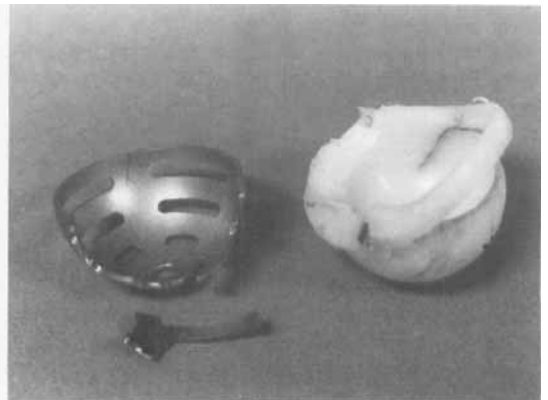
Figure 2. "Corpora delicti."
