Fracture of the tibial tray of the PCA knee

A case report of early failure caused by improper design

Gunnar Flivik, Peter Ljung and Urban Rydholm

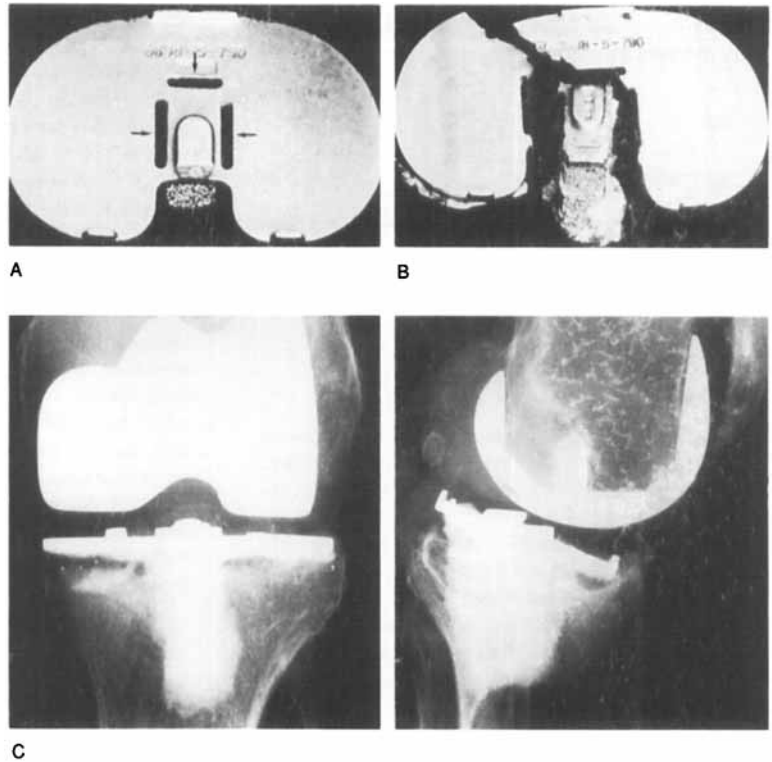
Figure 1. A 57-year-old man with rheumatoid arthritis operated on with a PCA prosthesis.

A. The stemmed tibial PCA component with slots (arrows) to aid in removal. Note the small connecting bridges between the stem and tray.

B. The removed tibial component. Note fracture of all the connecting bridges between the stem and tray.

C. After 4 years. The tibial component is fractured. The stem seems well fixed.

The stemmed PCA tibial component with slots surrounding the stem was analyzed by Skinner et al. (1987) with a three-dimensional finite element method. They concluded that this type of prosthesis runs a great risk of fracturing at the weak points caused by the slots if the support beneath the metal tray becomes inadequate. Our observations, as well as those by Gradisar et al. (1989), support the prediction of Skinner et al. (1987).

The fractures of the metal tray in our case were in part due to the stem being firmly cemented to the tibia at the same time as the tray did not have adequate bone support, due to preexisting deficient bone stock and later bone resorption. However, the most important factor was the use of an improperly designed tibial component. We now consider the use of a tibial metal tray with slots between tray and stem inappropriate. The PCA stemmed tibial component is no longer manufactured with slots, but the old slotted model is still in clinical use and is kept in

stock. We advise against using tibial components with this specific design.
