# Polyethylene failure in a PCA unicompartmental knee prosthesis

Ole Maagaard Christensen, Thorbjörn Gantzel Christiansen and Torben Johansen

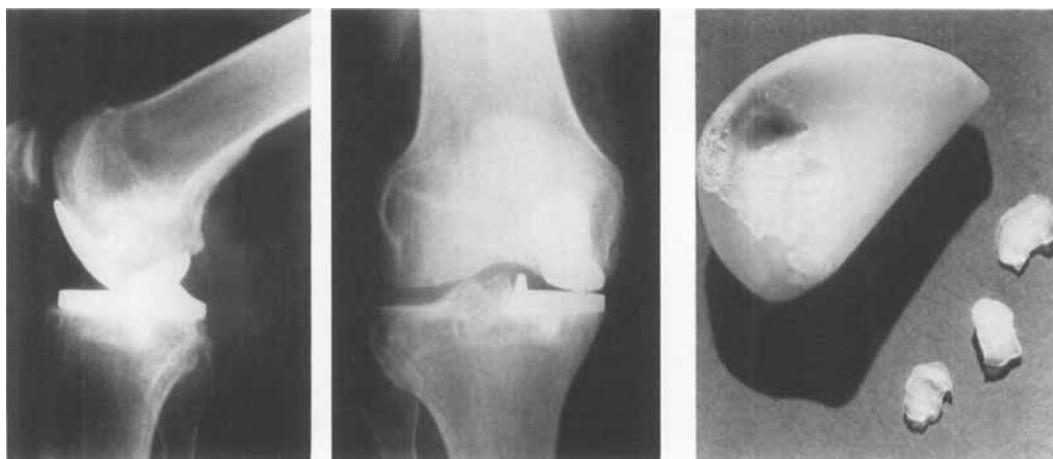
Radiographs showed still no change in position of the components, but moderate patellar arthrosis had developed, and it was decided to revise the knee. The polyethylene insert was found to be deformed by cold flow, with a large defect centrally (Figure 1) from which three fragments had torn off and become embedded in the infrapatellar fat. Both components were firmly fixed to the bone, and there was reactive synovitis. A total knee arthroplasty (PCA New Modular-R) was performed.

Figure 1. A 54-year-old man with knee arthroplasty. After 31 months, the prosthesis was correctly aligned without signs of loosening. Moderate patellar arthrosis had developed. The knee was explored because of pain.

The polyethylene insert of the tibial component was deformed by cold flow and fractured; the three fragments were found in the infrapatellar fat.

The cause of the fracture in the polyethylene insert in our patient was probably restoration of the physiologic strain on the femorotibial joint and the patient's return to work (Lotke 1981, Gschwend and Wyss 1981). We found a severe synovitis around the three polyethylene fragments. The polyethylene has also been found to have worn thin medially in 3 cases after total PCA arthroplasty (Graham 1988), although this type of prosthesis is designed to withstand uniform strain on the femorotibial components. Graham (1988) ascribes the wear in his patients, who were physically very active, to asymmetric loading while walking, particularly on the medial side.

Our prosthesis was placed correctly. Thus, with the design of the tibial component, which provides a broad contact surface, there should be no high contact pressure in a localized area. The deformity of the polyethylene insert could therefore be due to cold flow. This phenomenon is well known in inserts without metal backing, but has not been seen
