Failure of metal-backed uncemented patellar components

Report on 3 cases

We report 3 cases of metal-backed patellar component failure of the Microloc[®] total condylar knee, which was implanted in 51 cases. The main reason for failure was the design of the patellar and femoral components in combination with flexion of more than 100°.

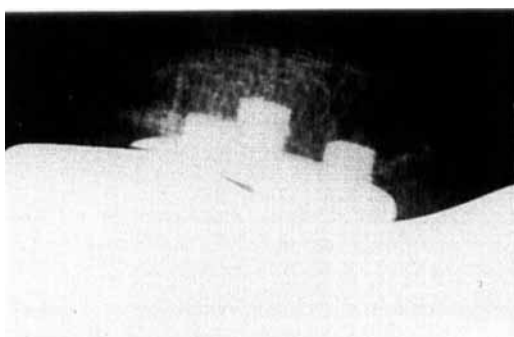
A skyline radiograph of the 59-year-old female showed a lateralized patella with a damaged metal back. The lateral radiograph revealed metal beads in the tibial polyethylene from the porous coating. At revision, black synovium, fractured polyethylene, a loosened metal back, and grooves in the trochlea of the femoral component were found in all the cases. In 2 cases the tibial components also had to be

A. The skyline view shows a lateralized patella with a damaged metal back.

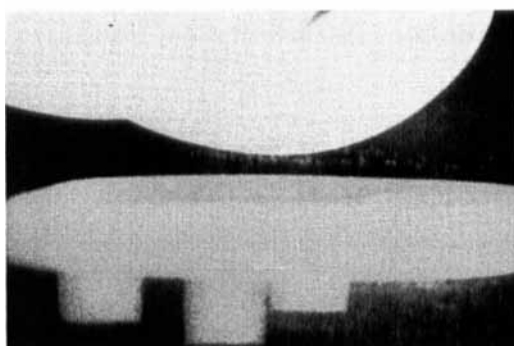
B

B. The lateral radiograph reveals metal beads from the porous coating of the loosened metal back in the tibial polyethylene.

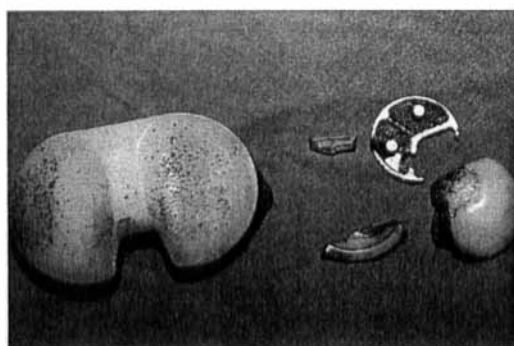
D

D. Polyethylene and metal back were totally damaged. Balls of the microporous surface of the loosened metal back were impressed in the tibial polyethylene.

changed because of wear of the plastic by the metal beads. The new polyethylene patellar implants were cemented, and the postoperative course was uneventful. At the histologic examination, synovitis was found; and in deeper layers, polyethylene debris was surrounded by a macrophagic reaction (Figure 1).

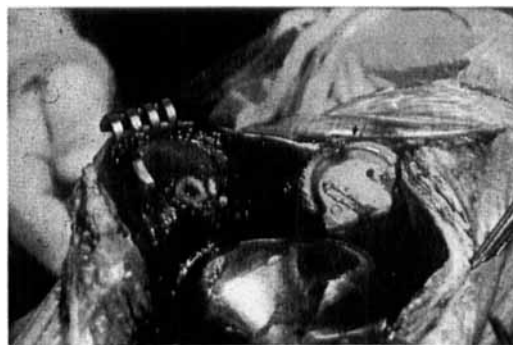
C

C. At arthroscopy a black synovium, a fractured polyethylene, a loosened metal back, and grooves in the trochlea of the femoral component were found in all 3 cases.

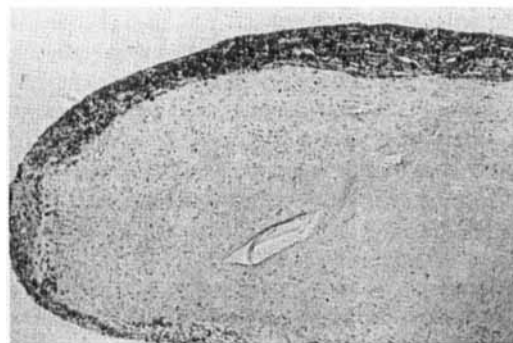
E

E. Histologic section shows synovitis with signs of metallosis. Small polyethylene pieces were surrounded by a macrophagic reaction in deeper layers.
