Fracture of hip prostheses due to inadequate welding

Per Aspenberg, Lars Kolmert, Lars Persson¹, Rolf Önnarfält

Twenty-five patients underwent total hip arthroplasty using a copy of a well-known prosthesis during the period 1974-1976. Five of the prostheses fractured through the neck after 5-12 years. There were no prodromal symptoms and no trauma preceded the fractures. Technical analysis revealed that inadequate welds were responsible.

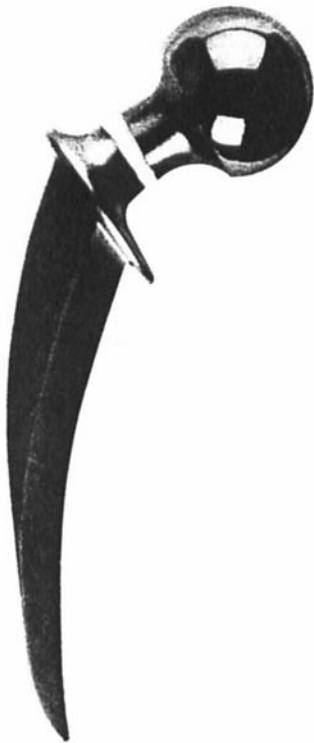
Figure 1

similar, perpendicular to the axis of the neck (Figure 1). The time interval from primary operation to fracture ranged from 5 to 12 years (Table 1).

Figure 1. Fractured prosthesis.

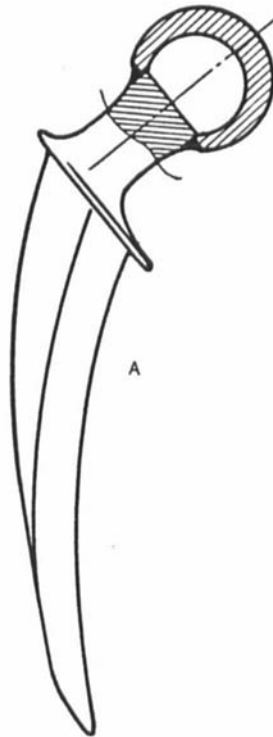
Figure 2

Figure 2. A. Original Brunswik prosthesis, the head welded to the neck.

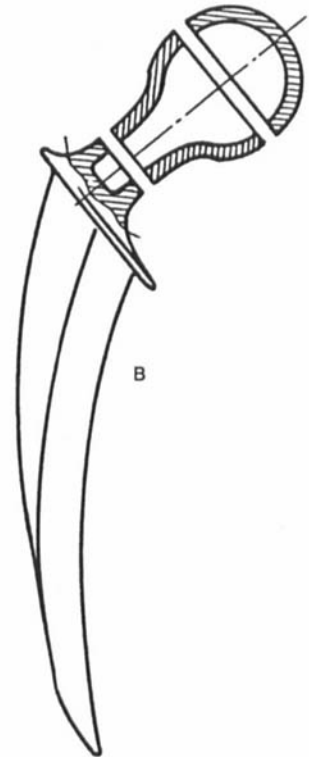
B. "Type Brunswik" prosthesis, cast parts to be welded together.

On visual observation the cut surface along the neck revealed that the prosthesis consisted of three pieces that had been cast separately and welded together (Figure 2). Thus, there was a weld around the equator of the head and a second weld encircling the middle of the neck (the original Brunswick prosthesis has no weld in this

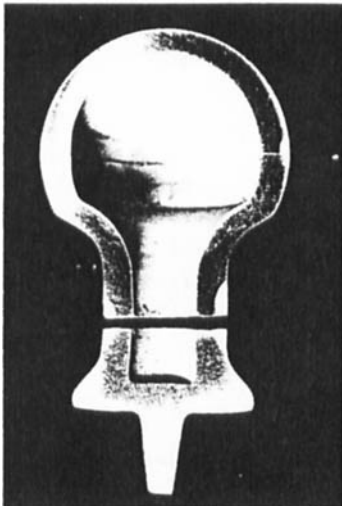
Figure 3

Figure 3. Fractured prosthesis cut along the neck. Welds appear bright at the sides of the fracture.

Three of the fractured prostheses were examined technically (Cases 3–5). One of them (Case 4) was cut along the axis of the neck. The surface was ground, polished, and etched (ASTM E 340–68) with Kelling’s reagent (ASTM E 407–70 no. 95) in order to visualize the welds (Figure 3). The fracture surfaces of the other two prostheses were studied in a scanning electron microscope.

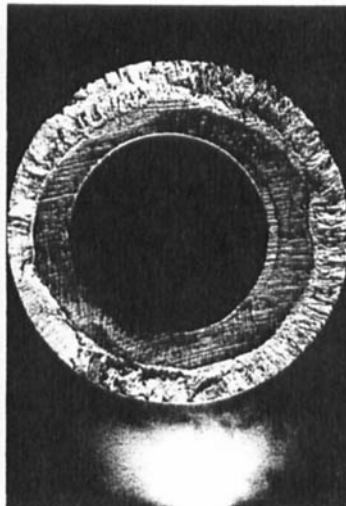
Figure 4

Figure 4. Fracture surface. The inner half of the surface has not been welded.

latter, highly stressed area). Both components of the neck had hollow centers with a wall thickness of 4.2–4.4 mm. In all three examined prostheses, the fracture had occurred through this weld, and it was apparent from radiographs that the same had happened in the other two cases. This weld did only penetrate half of the wall thickness, leaving an open slit on the inside (Figures 3, 4). The cut prosthesis also showed a 4-mm crack in the fillet between the neck and the flange and a number of pores in the cast material that were not immediately adjacent to the fracture (Figure 5).

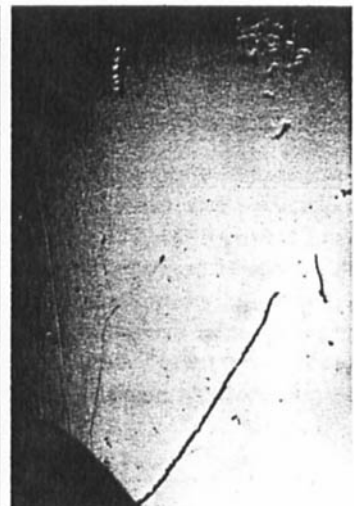
Figure 5

Figure 5. Crack and pores in the cast material, not adjacent to the fracture.

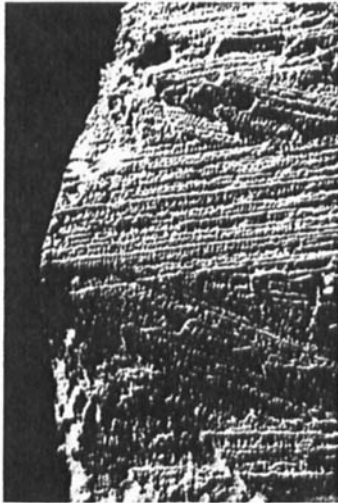
Figure 6

The scanning electron microscope (SEM) fractograms showed that the fracture surface of the weld had a dendritic structure in large areas (Figure 6). This dendritic structure extended to the surface of the prosthesis, whereas at the other end – in the transition zone between root gap and filler material – the fracture had developed in an intercrystalline mode. In this area, fatigue striations were seen (Figure 7). Only a small area in this transition zone displayed dimples, indicating ductile material and final rupture. Schematically, the different SEM findings were located, as in Figure 8.

Figure 6. Dendritic structure of the fracture surface. Most of the fracture had this appearance. Light microscope $\times 100$.

The dendritic structure of the fracture surface indicated that the solidification zone of the weld had propagated as two fronts starting near the cast material on each side of the weld and meeting in the middle. The two fronts had pushed gas and impurities in front of them preventing metallic bonding between the meeting solidifying zones, and resulting in low mechanical strength.

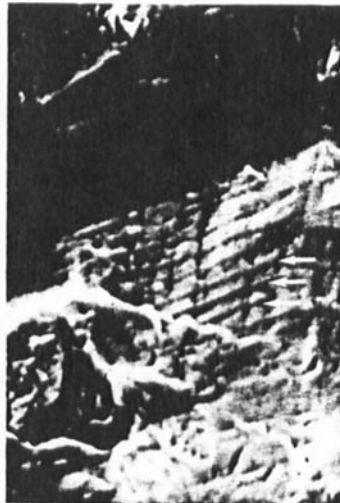
Figure 7

Figure 7. Fatigue striations, found where full fusion of the weld was achieved. Width of each striation: 2.5 microns. (SEM.)

The fatigue striations had developed in the small part where stress was concentrated due to the imperfection of the rest of the weld. For each cyclic load, the crack had propagated the distance between two striations until final rupture.
