## A NEW DESIGN OF THE CHRISTIANSEN ENDOPROSTHESIS

### *Report of Two Cases in which Separation of the Two Components of the Prosthetic Head Occurred*

J. H. SOLHAUG, A. MØLSTER & O. SØREIDE

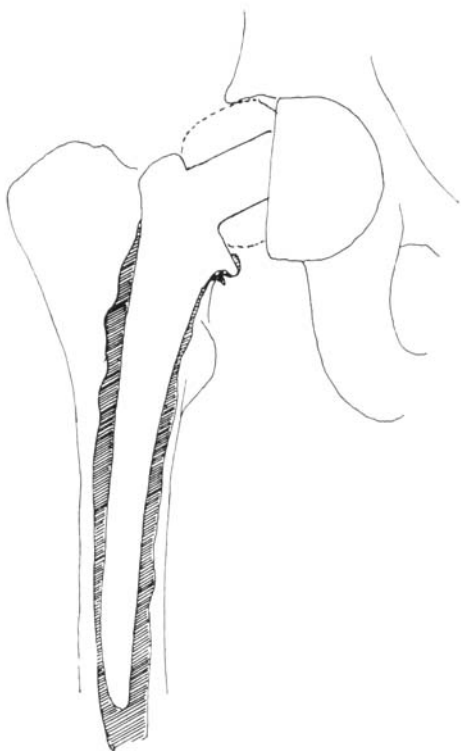
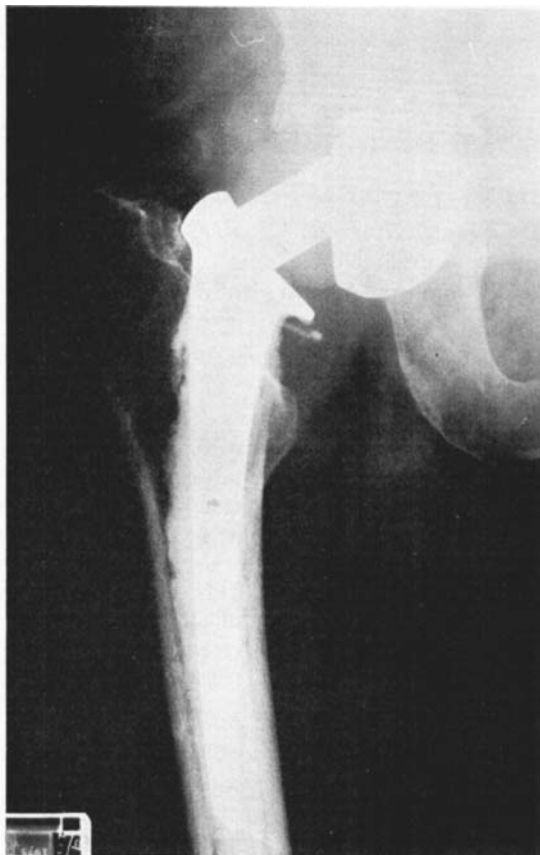
We would like to present a previously unpublished complication. In two patients operated on and fitted with Christiansen's endoprosthesis a dislocation of the plastic head from the metallic cap necessitated reoperation and replacement of the dislocated head.

*Figure 1. X-ray and diagram showing dislocation between the two head pieces, the metallic cap separated from the plastic head.*

attachment between the cap and the plastic head prevents this complication and consequently it seems reasonable revert to this original modification.

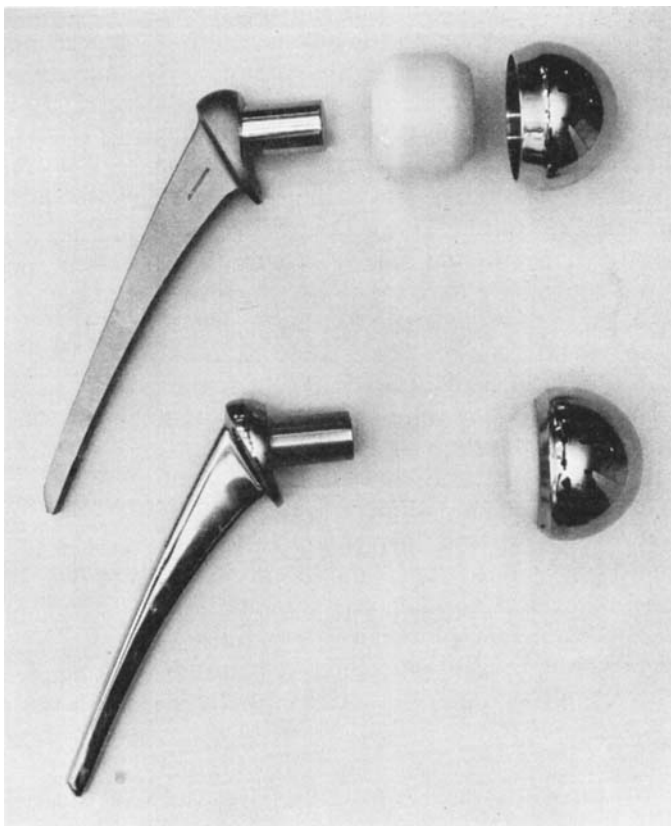
*Figure 2. Christiansen's endoprosthesis. Above, the latest modification with trunnion-bearing, Delerin head and metallic cap separated. Below, the original modification of the prosthesis with the cap attached to the plastic head.*

which now prevails the plastic head is separated from the steel cap (Figure 2). This modification has the advantage that the prosthesis pieces may be sterilized in an autoclave. Furthermore this modification is supposed to permit some degree of movement between the head and the cap (Christiansen 1974).

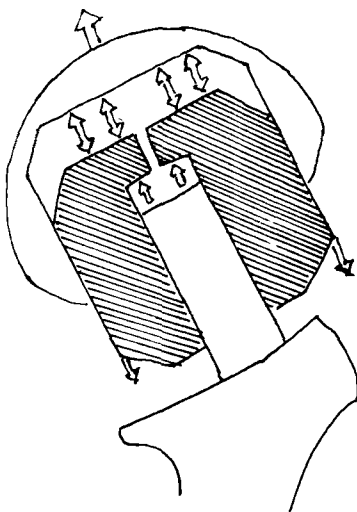
*Figure 3. Possible hydraulic mechanism in the system between the trunnion-bearing joint and the covering metallic cap. Increased pressure occurring in the space between the head and the cap leading to dislocation between the metallic cap and the plastic head.*

The mechanism of dislocation in the above-mentioned cases is uncertain. In both patients, however, a clot of fibrin and blood (approx. 15 cm<sup>3</sup>) was found in the bottom of the steel cap. It is possible that this clot under certain circumstances has closed the hole in the bottom of the plastic head causing a sort of valve mechanism, letting blood or tissue fluid into the steel cap but not out. Furthermore a hydraulic mechanism is possible in the system between the trun-

nion-bearing junction and the cap (see Figure 3) pumping the head out of the cap. The difference in the length of the tap and the height of the head (26 and 16 mm, respectively) possibly explains the fact that the dislocation occurs between the head piece and the cap and not in the tap joint. Theoretically even a wrongly positioned shaft component could contribute to the dislocation. However, in our two patients the shaft pieces were adequately inserted. Another possibility would be a tight fit between the metallic cap and the acetabulum resulting in a binding of the metallic cap and increased rotational stress at the plastic-metallic junction.

It is evident that this complication is found only in the latest modification of the prosthesis. Though uncommon, this is a serious complication necessitating reoperation in this advanced age group with increased operative risks. A firm
