## FACTORS IN THE MECHANICAL FAILURE OF THE FEMORAL COMPONENT IN TOTAL HIP PROSTHESIS

*Report of Six Fatigue Fractures of the Femoral Stem and Results  
of Experimental Loading Tests*

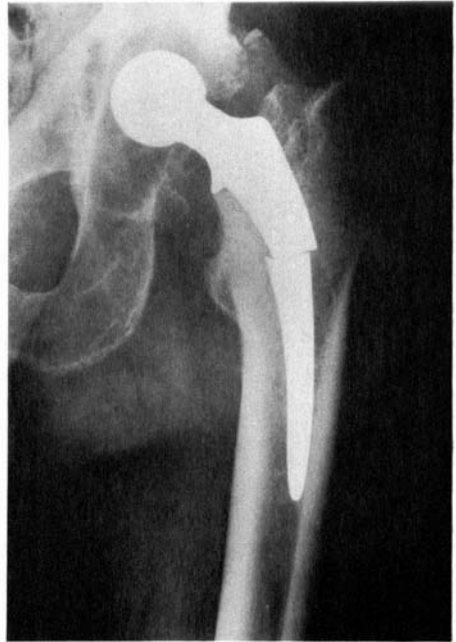
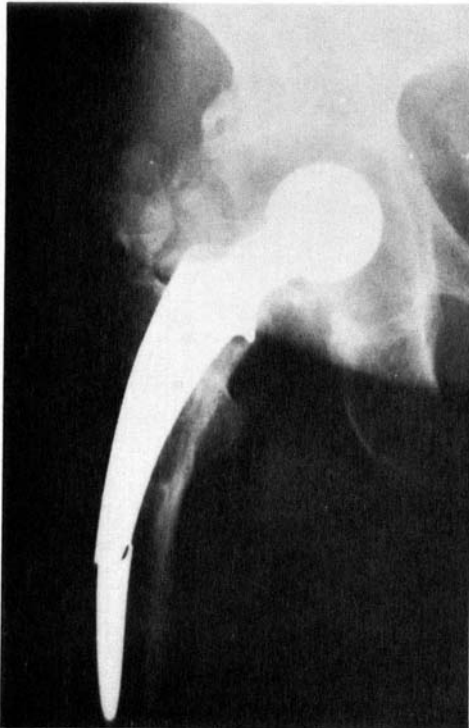
*Figure 1. X-ray check 20 months postoperatively. Failure of the stem at the limit of the upper and middle third.*

Radiographs taken after the onset of pain revealed fractures of the stem of the femoral component with some displacement of the fracture ends, indicating that the metal was not immobilized by the surrounding acrylic (Figures 1, 2 and 3). The sites of failure, in terms of percentage of stem length measured from distal to proximal, are shown in Figure 4. The failure site ranged in level from 36 per cent to 71 per cent of the stem length with three of the six failing at  $45 \pm 3$  per cent of the stem length. The radiographs revealed no abnormal relationship between the femoral stem and acetabular cup nor any malposition of the femoral component.

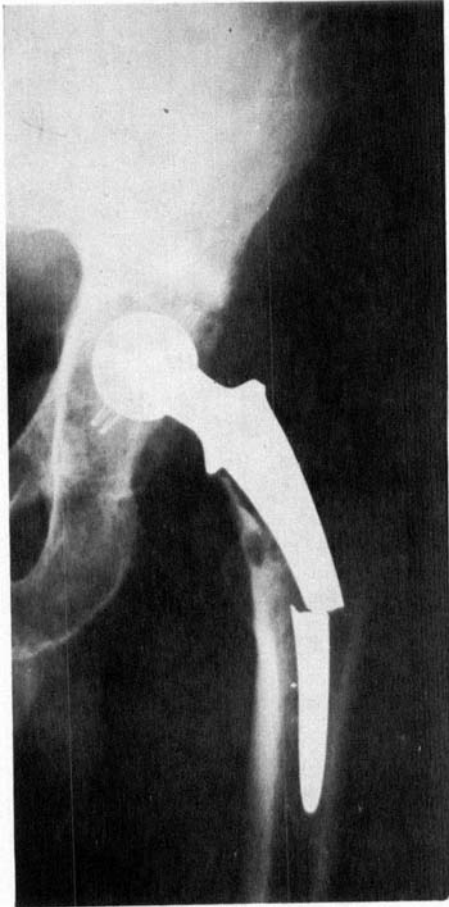
*Figure 2. Case 2. X-ray check 27 months postoperatively reveals the fracture at the limit of the distal and middle third.*

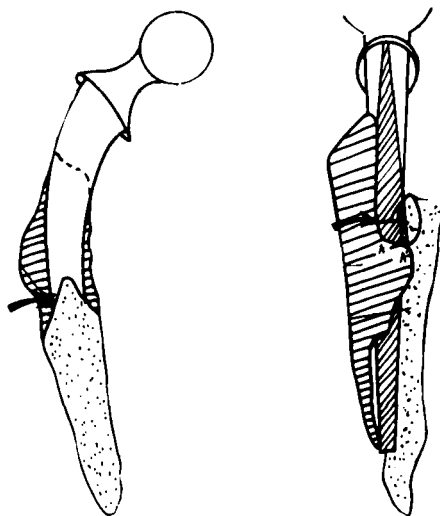
*Figure 5 A. The acrylic mantle, removed at the time of revision through a large window in the lateral cortex, did not circumscribe the entire stem.*

*Figure 5 B. Reconstruction of the relationship of the stem and the acrylic mantle shows the incomplete covering. Particularly the fact that the upper medial edge of the stem is not in contact with cement can cause an unfavourable loading configuration. The arrow indicates the level of the fracture at the femoral stem.*

Two cases demonstrated cracking of the acrylic. Incomplete covering of the femoral stem by the acrylic mantle was seen in the third case and failure occurred at the edge of the defect in the acrylic mantle (Figure 5 A and B).

It would seem to be technically important to insert the stem in the varus position with respect to the femoral shaft axis and to insure that it is well covered by acrylic. The cracking of the acrylic is a potential danger leading to an unfavourable loading condition of the femoral stem. Stainless steel is a more resistant material with regard to fatigue phenomena in comparison with the protasul alloy because of the significantly higher yielding point and its better metallographic structure.

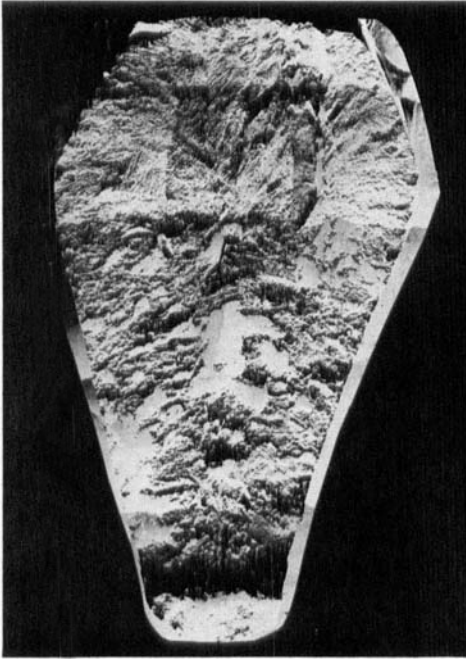
*Figure 6. S.E.M. picture by a Cambridge Stereoscan showing the different pattern of failure of the outer third representing the initiating fatigue zone. The remaining two thirds of the cross section shows a brittle fracture pattern.*

Examples of the scanning EM findings are shown in Figures 6 and 7. These demonstrate a fatigue failure of the lateral side of the cross section followed by a brittle fracture of the remainder.

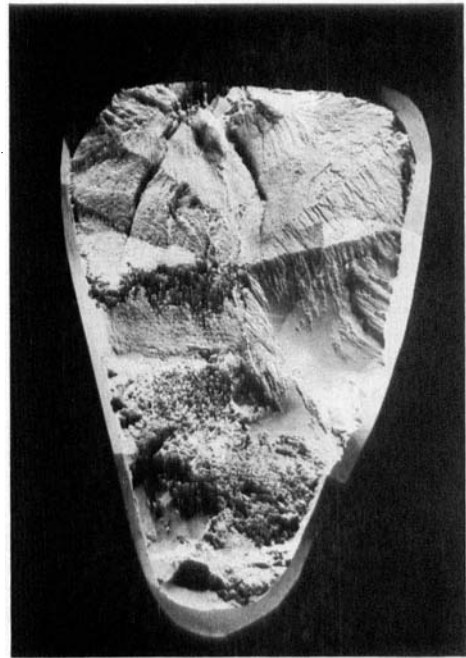
*Figure 7. S.E.M. picture of the fracture site of the stem (case 3). The outer two thirds of the cross section failed in fatigue and the remaining part followed with a brittle fracture at the time the cross section was weakened enough to allow a sudden brittle fracture of the inner third of the area.*

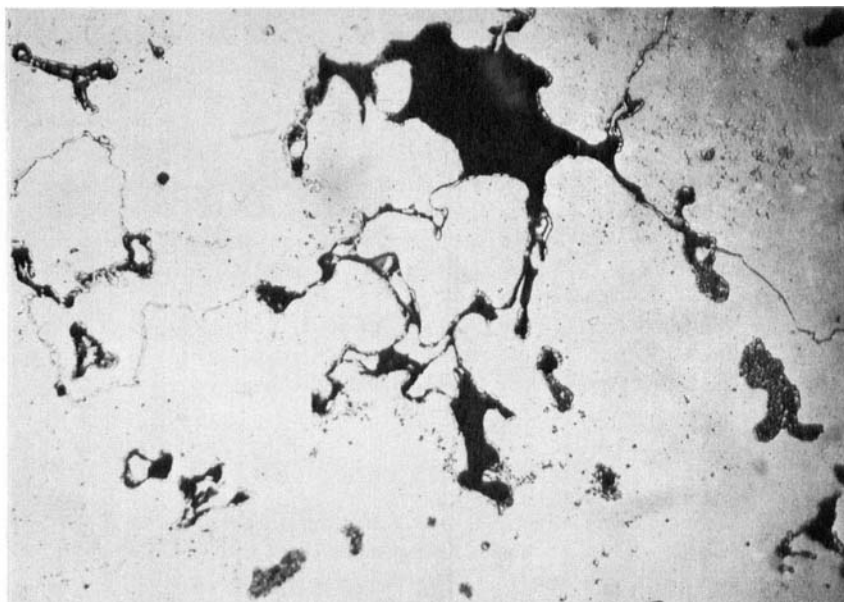
*Figure 8. Metallurgical examination shows microvoids of different sizes in the material near the fracture site. Magnification 460  $\times$ .*

The metallographic examination revealed a coarse grained cast structure with typical basaltic crystals, of a mean diameter of 1 mm, which met in the middle. These crystals formed a mosaic pattern with scattered rather than longitudinal orientation. Several microvoids were seen (Figure 8). As shown in Figure 9 A and B precipitations of eutecticum and impurities at the grain boundaries were also

In summary it can be stated that grain size, grain structure and phases appearing in these specimens are unfavourable for a material that is exposed to impact load, while the microvoids observed represent an incidental danger.

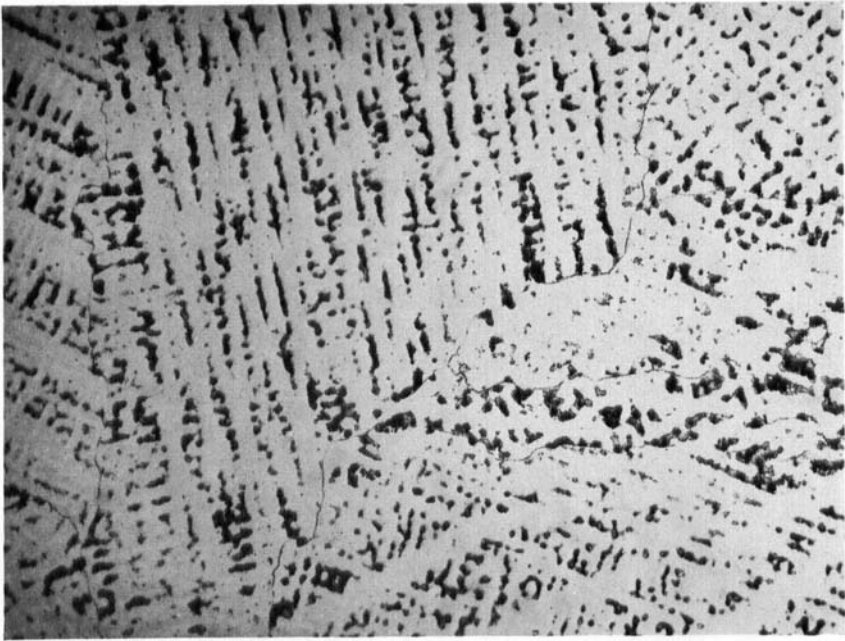
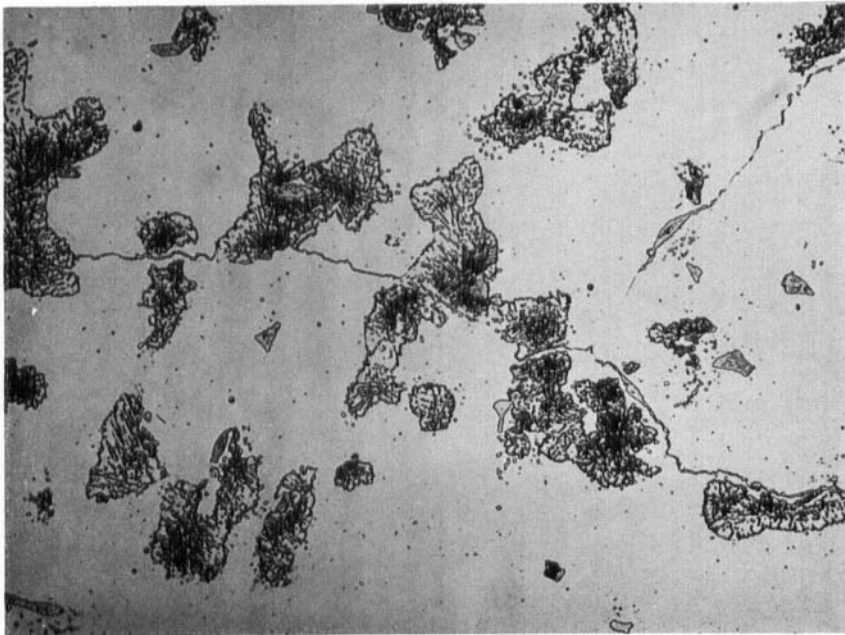
seen. These probably represent a brittle  $\sigma$ -phase which is especially prone to occur in cast cobalt alloys. The precipitation of this  $\sigma$ -phase can be caused by the presence of impurities or by inappropriate previous thermal or mechanical treatment.

*Figure 9 A and B. Metallography shows the coarse size. Eutecticum and precipitations are observed at the grain boundaries.*

*Figure 9 A. Magnification 60 ×.*

*Figure 9 B. Magnification 450 ×.*

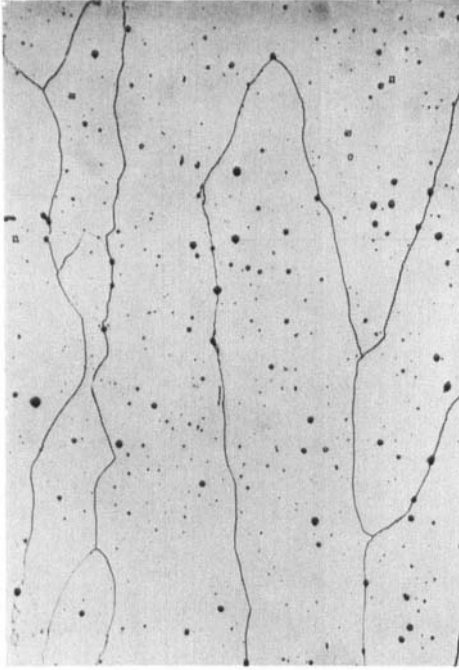
A heat treatment was carried out on a specimen at 1300° C for one hour. This treatment caused the complete dissolution of the eutecticum and partial disappearance of the precipitations at the grain boundaries (Figure 10). After this thermal treatment only electrolytic etching could make the grain boundaries visible. A compression test showed that thermal treatment (1300° C—1 hour) increased the yield stress ( $\sigma_{0.2}$ ) of the material in spite of grain growth which normally decreases the yield stress.

*Figure 10. Metallography after thermal treatment (1300°C-1 hour) shows that the eutecticum is completely dissolved and the precipitations at the grain boundaries have almost completely disappeared.*
