# The STRYDE limb lengthening nail is susceptible to mechanically assisted crevice corrosion: an analysis of 23 retrieved implants

Morten Stendahl JELLESEN<sup>1</sup>, Trine Nybo LOMHOLT<sup>2</sup>, Rikke Quist HANSEN<sup>1,2</sup>, Troels MATHIESEN<sup>2</sup>, Carsten GUNDLACH<sup>3</sup>, Søren KOLD<sup>4</sup>, Tobias NYGAARD<sup>5</sup>, Mindaugas MIKUZIS<sup>4</sup>, Ulrik Kähler OLESEN<sup>5</sup>, and Jan Duedal RÖLFING<sup>6</sup>

**Background and purpose** — We noted several adverse events in patients in whom the first version of the STRYDE limb-lengthening nail (NuVasive Specialized Orthopaedics, San Diego, CA) had been implanted. Pain, osteolysis, periosteal reactions, and cortical hypertrophy at the nail junction were noted. Here, we present the analysis of 23 retrieved STRYDE implants.

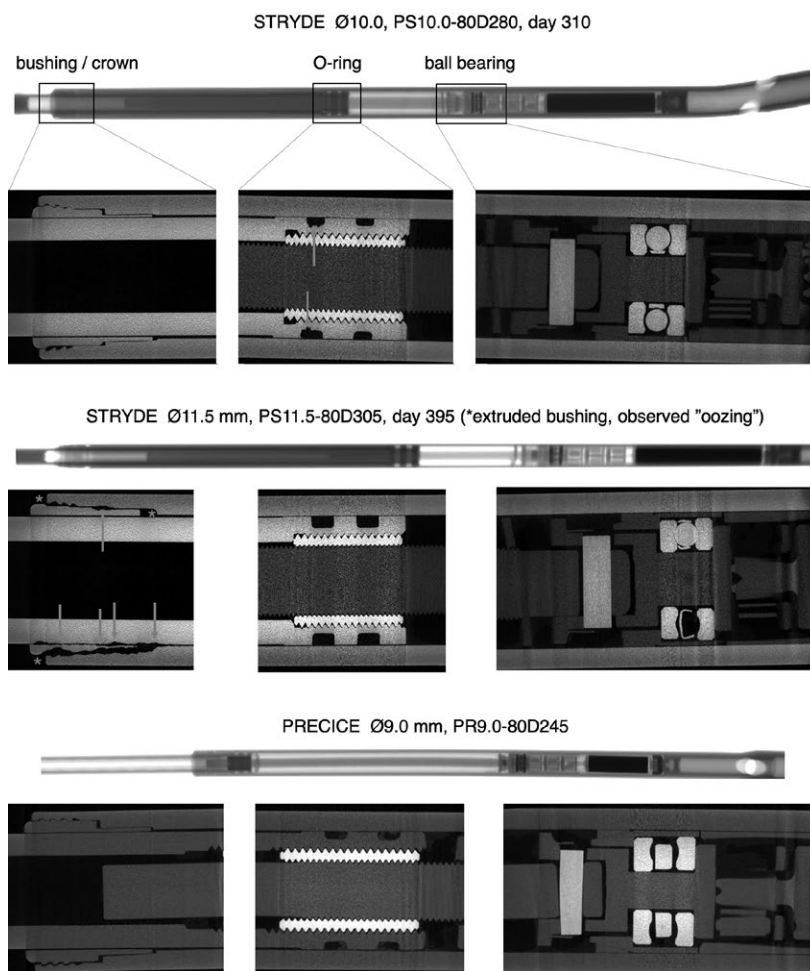
Micro-CT of 12 STRYDE nails documented corrosion attacks at the telescopic junction, primarily at the bushing, but also at the distraction rod and internal components of the nail surrounding the bushing (Figure 6).

Figure 6. Micro-CT of 2 STRYDE and 1 PRECICE P2. Overview and detailed imaging of the bushing/crown, O-rings and ball bearing. Corrosion is seen around the bushing/crown in 12/12 nails scanned at this location (middle panel), corrosion at the O-ring was observed in 1/5 nails scanned at this location (top panel). Notably, no signs of corrosion were seen around the ball bearing in 4/4 scanned nails at this location. No corrosion was seen in the reference PRECICE P2 nail at any location. The mechanical components inside the housing appeared to be similar between STRYDE and PRECICE P2.

mechanical construction; only the bushing seemed to be constructed differently (Figure 6). Close 360° contact between the housing and bushing were observed in PRECICE P2, while none of the 12 STRYDE nails had that feature (Figure 6, lower vs. top panel).
