Supplementary data

Table 2. Chemical composition (wt.%) of STRYDE based on PMI analysis

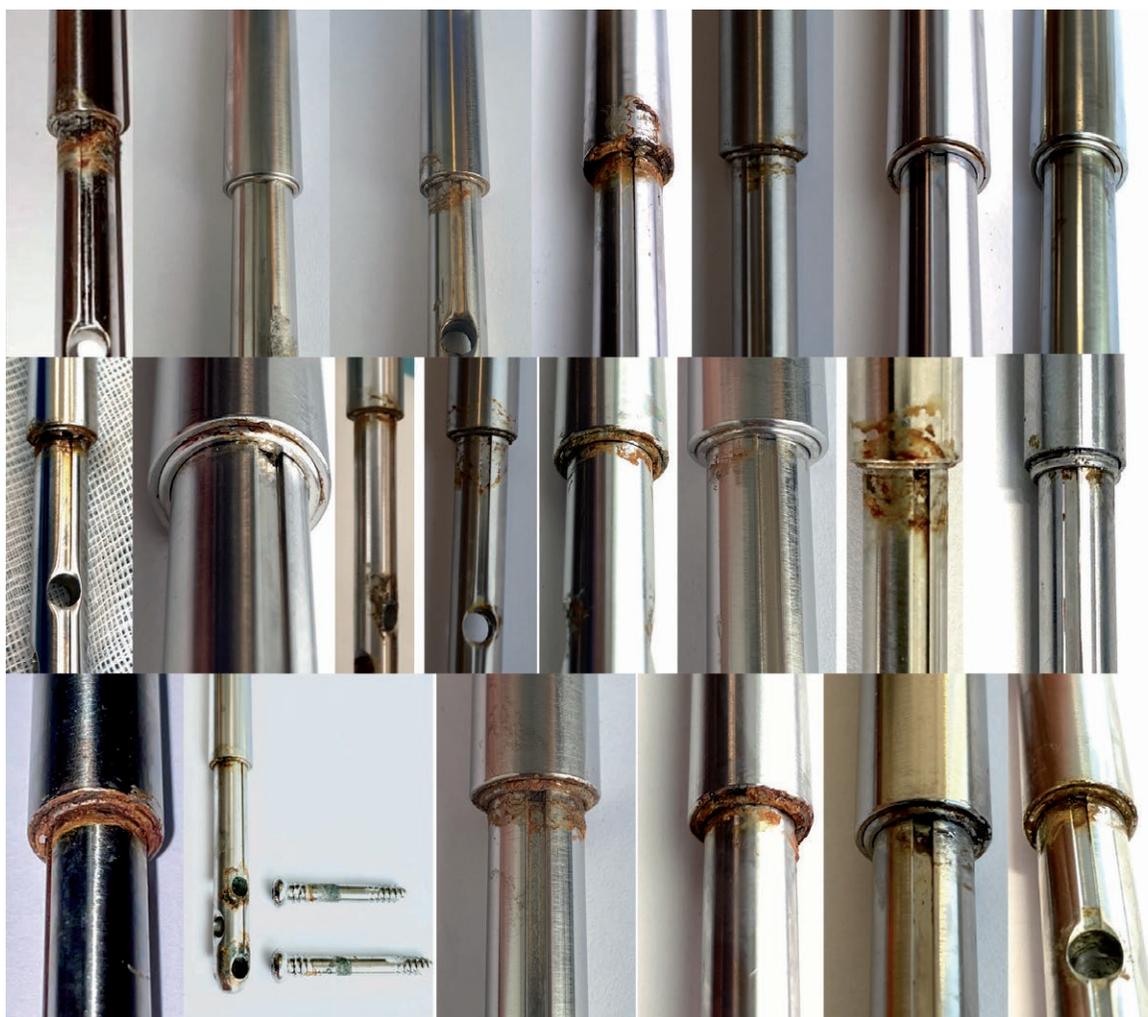
Figure 1. Photos of nail junctions taken by surgeons. Order: time of implantation from 107 days (top left) to 609 days (bottom right).

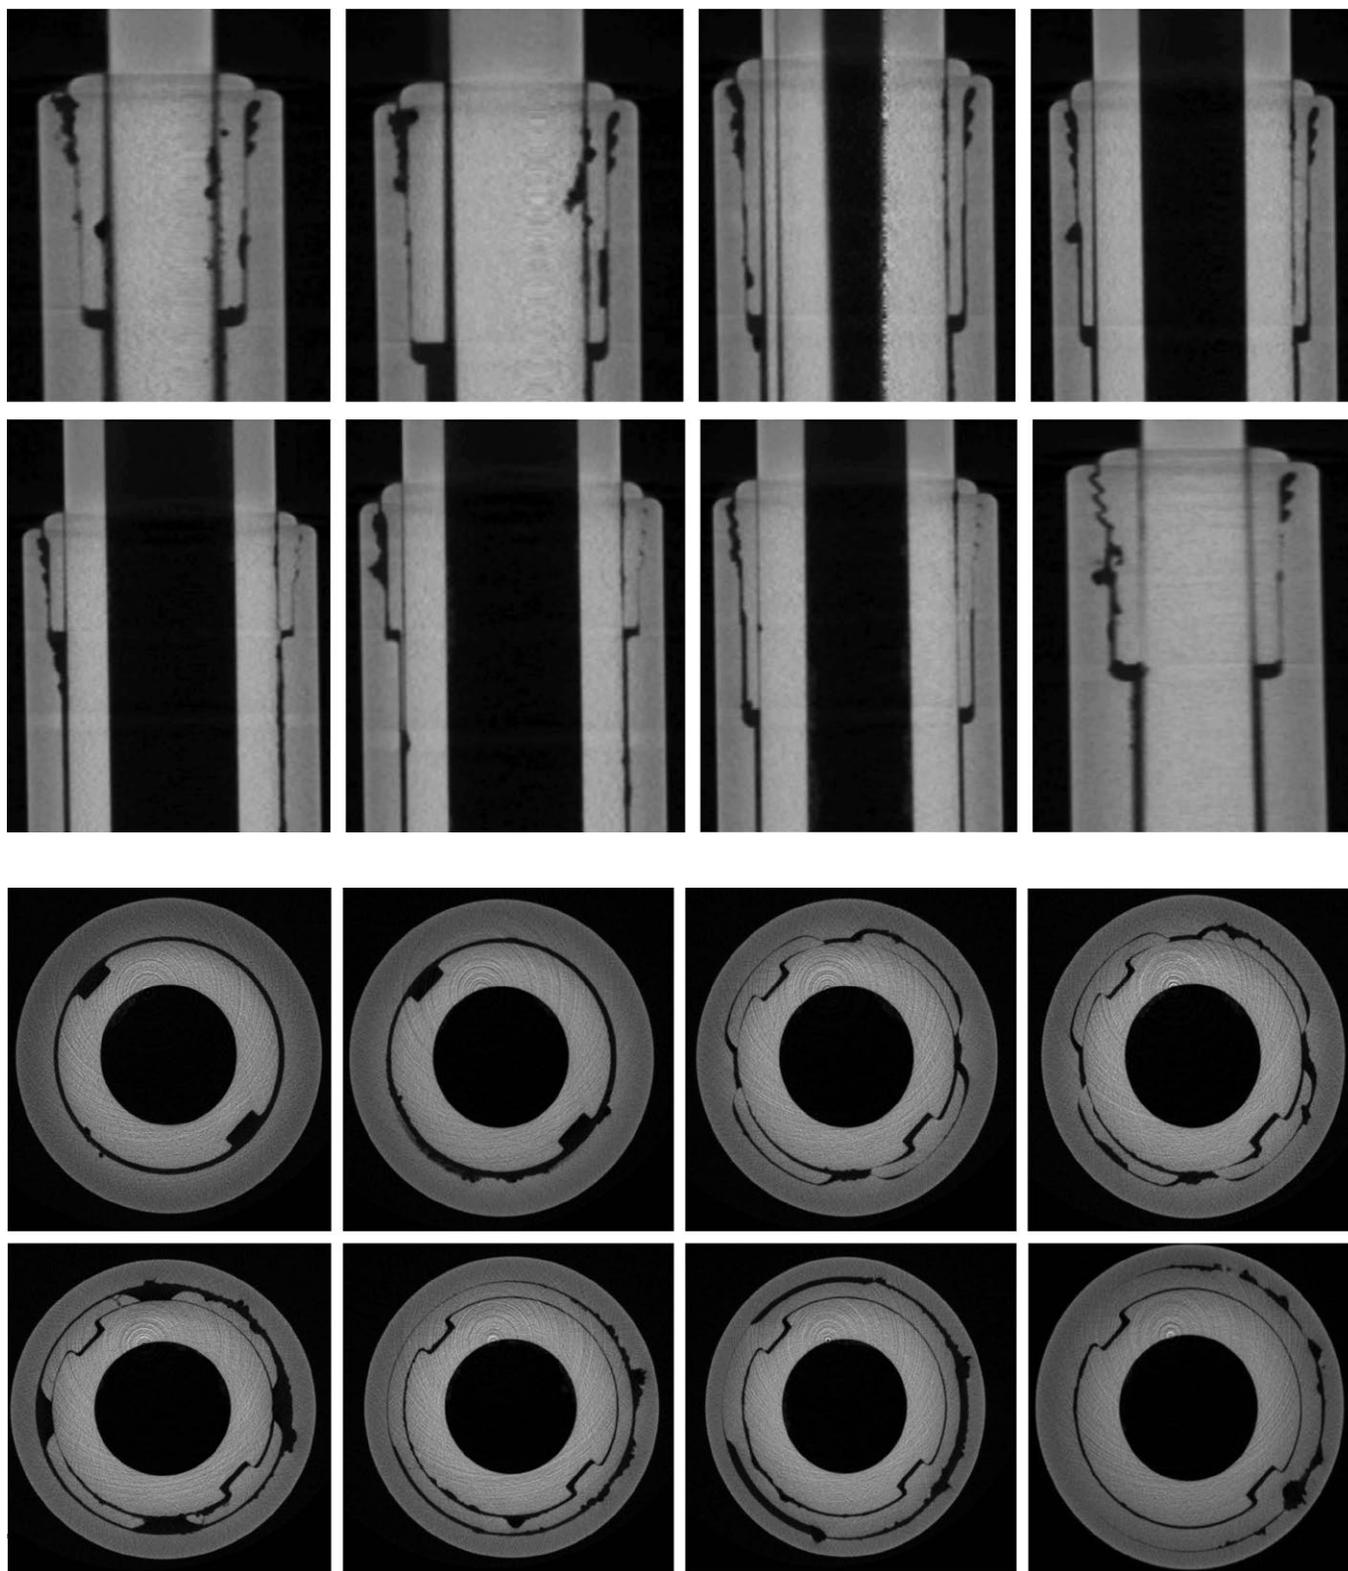
Figure 2. Micro-CT: Example of 1 corrosion-attacked bushing, vertical and axial slices.

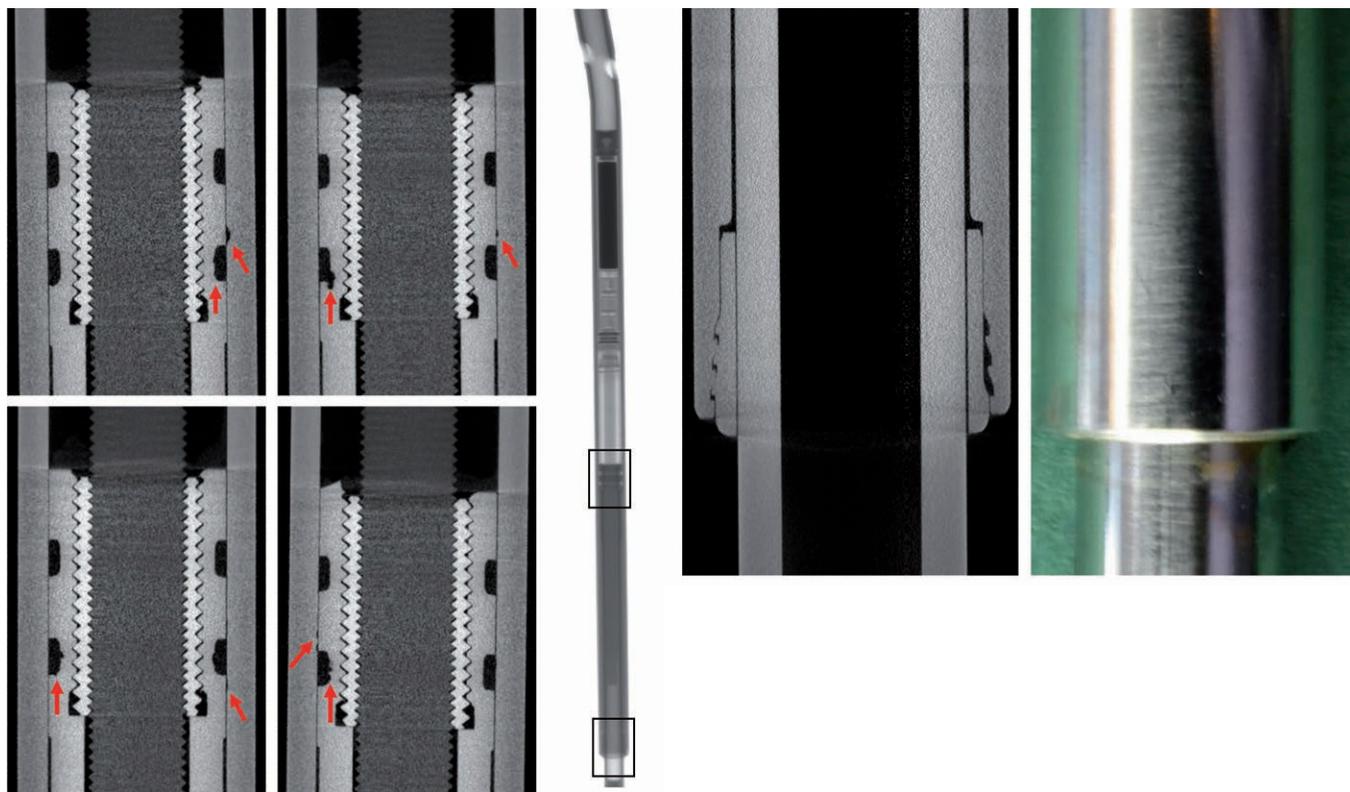
Figure 3. Micro-CT: Corrosion at the level of the O-ring (red arrows) without severe corrosion at the bushing. Sectioning revealed an intact O-ring but crevice corrosion attack.

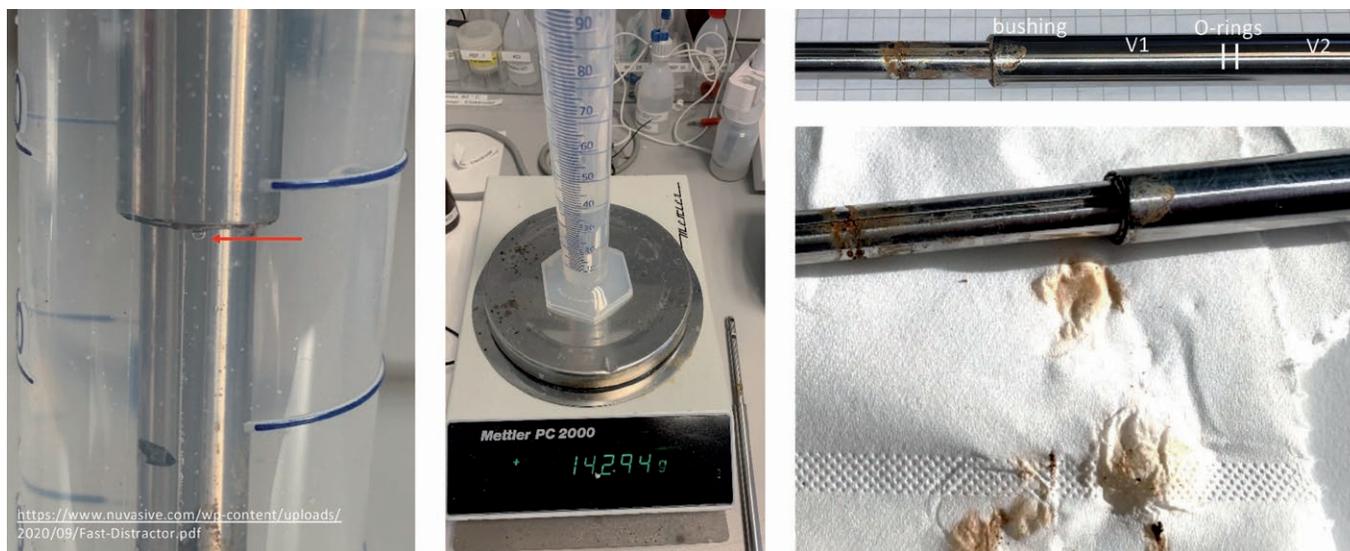
17 mm distraction of a STRYDE nail with the "fast distractor" submerged in saline water. Air bubbles emerge (red arrow).

17 mm retraction with the "fast distractor" submerged in saline water. No air bubbles are seen and the weight is measured.

Subsequently, the nail was dried and distracted again. Brown fluid leaked from the nail.

Figure 5. Distraction–retraction–distraction experiment: brown fluid leaking from the junction.

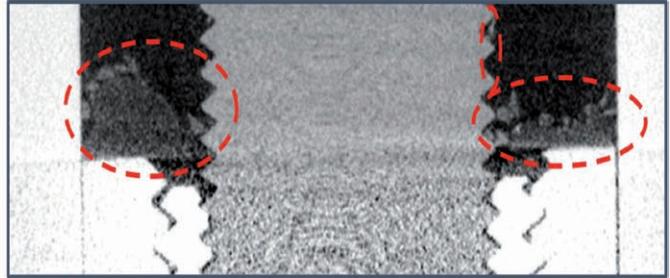
Figure 7. Dry lubricant (brown crystalline structure) on internal titanium rod (left panels). Micro-CT (right panel) showing debris of dry lubricant (red marks).

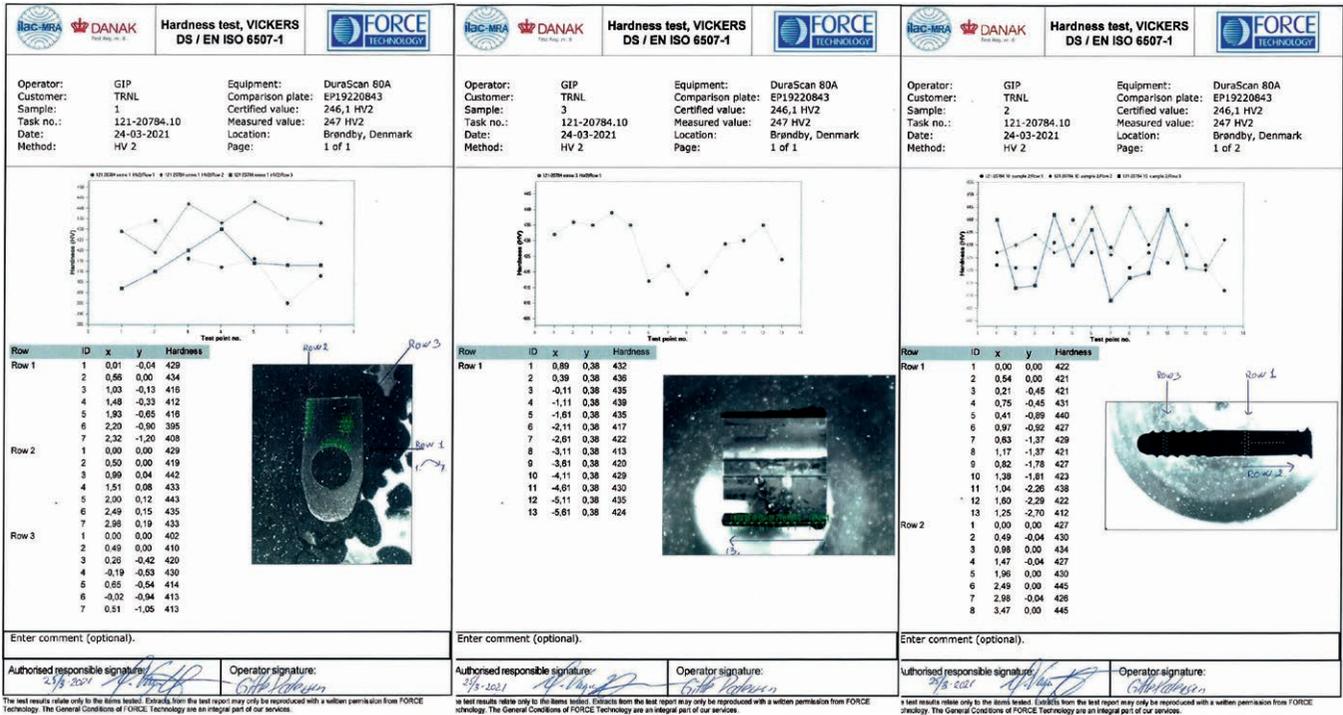
Figure 11. Hardness analysis of the nail and locking screws.

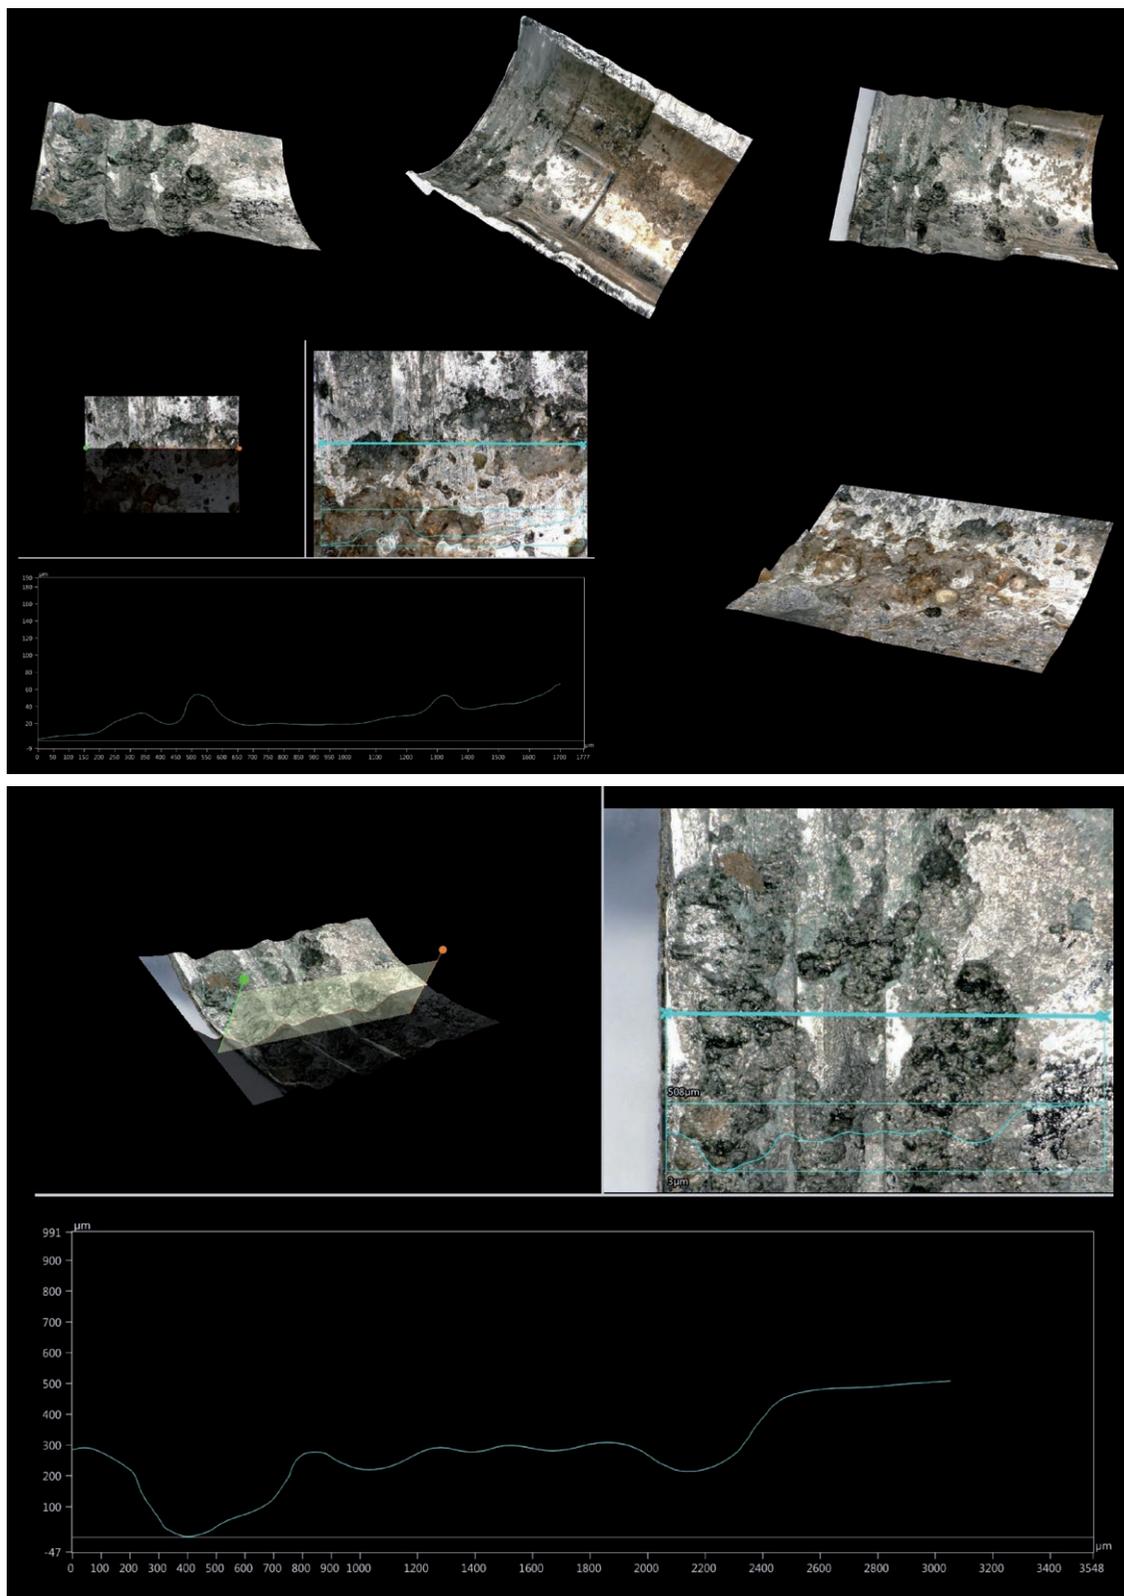
Figure 12. Digital microscopy—example of 1 sectioned bushing.

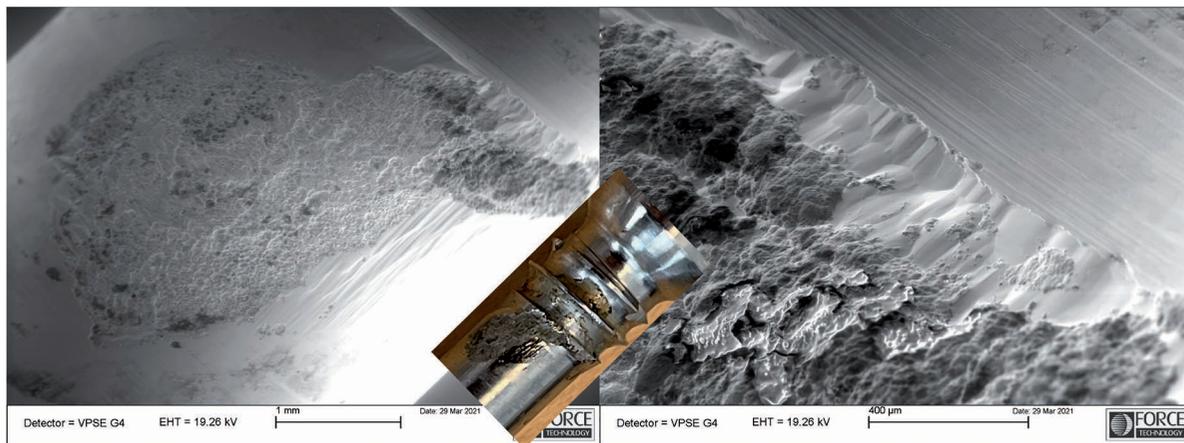
Figure 13. SEM: mechanically assisted crevice corrosion of a screw.
