Palacos-angiography?

Unusual radiographic findings after cemented hip prostheses

Erling Gjengedal and Gisle Uppheim

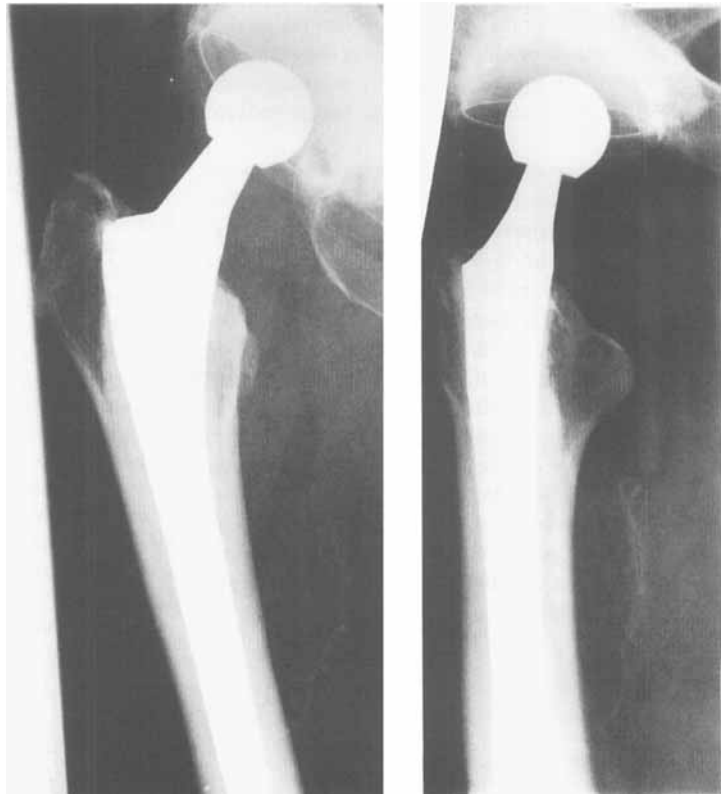
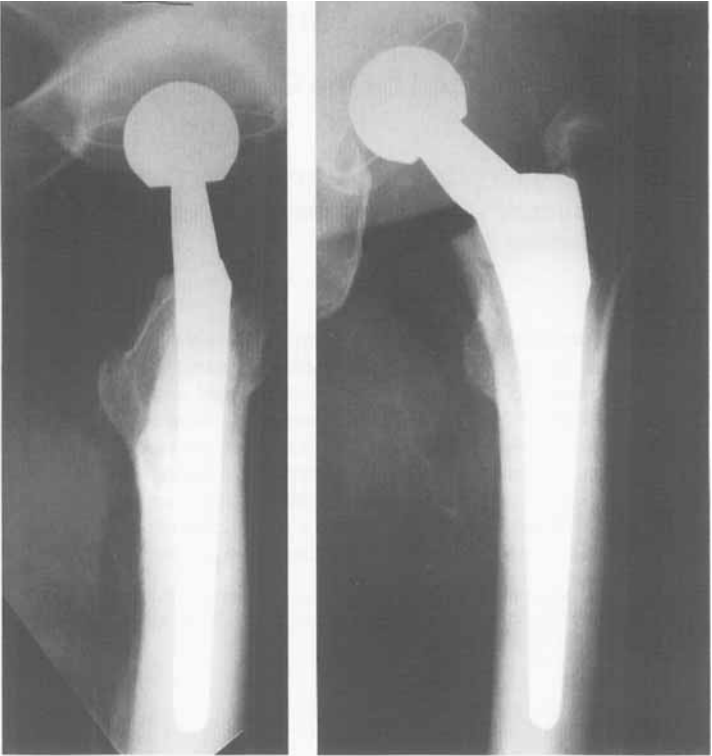
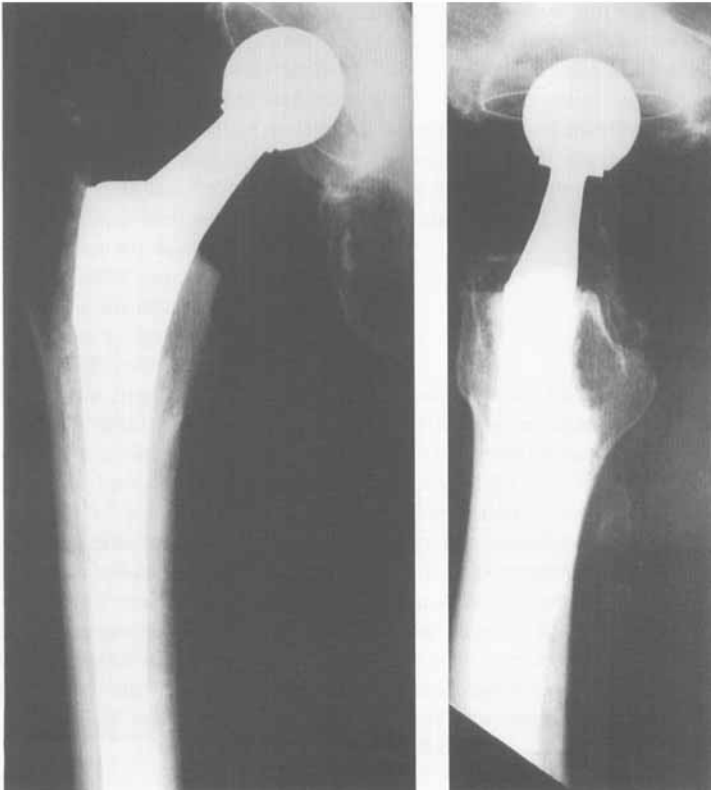
A 66-year-old woman had a total hip replacement because of arthrosis. The postoperative radiographs showed a thin 12-cm long thread-like shadow emerging from the medial femoral cortex and leading to the deep femoral vein. It was misinterpreted as being a radiopaque thread in a surgical sponge. The patient was reoperated, but no surgical sponge was found.

We believe that the surprising radiographic finding represents a "jetbeam" of acrylic-cement in the deep femoral vein system (v. nutriciae). Since then, we have had 4 more patients with similar postoperative radiographic findings.

The thread-like shadows in the 66-year-old woman and in 2 of the other 4 cases.
