# Failure of metal-backed patellar arthroplasty

## 47 AGC total knees followed for at least 1 year

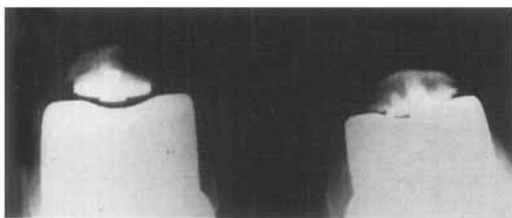
Figure 1. Disintegration of the patellar button. Skyline radiograph showing femoropatellar metal-against-metal contact.

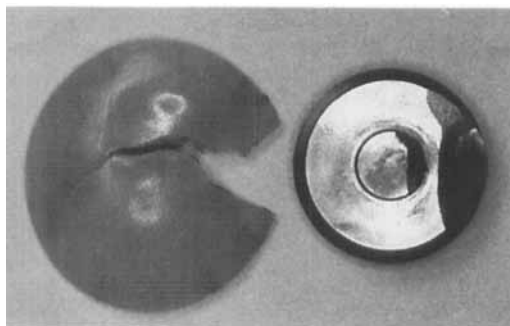
The sex and the patellar complications of the series are shown in Table 1. The clinicoradiographic results at the latest follow-up of the series are shown in Table 2. Seven patients were admitted between the normal clinicoradiographic control visits during the entire period of the study because of sudden pain in the operated on knee. One patient had a nontraumatic patellar fracture that was treated conservatively. Another patient had traumatic cement cracking and loosening of the entire patellar component, and underwent revision. Five other patients experienced sudden pain in the knee and loud squeaking during knee motion. Radiographically, metal-against-metal contact was demonstrated between the patella and femoral components (Figure 1). These knees were all revised within the shortest possible period of time by removal of the patellar button, synovectomy, and insertion of a polyethylene component. The symptoms disappeared following this treatment. The findings during revision were black synovial lining and dissociation of the polyethylene from the metal (Figure 2), with the latter remaining firmly seated in the cement and bone.

The polyethylene had either fractured or showed excessive wear. Upon histologic examination, metallic synovitis, with giant-cell granulomas, was

Figure 2. An example of the harvested metal-backed patellar button demonstrating total dissociation of the polyethylene and the metal. The polyethylene component is fractured and grooved, and the metal component shows severe wear.

The main reason for failure is probably that the metal is square with sharp edges over which the polyethylene becomes very thin (Stulberg et al. 1988). In our 5 cases of patellar component disruption, we have not found any other explanations for the failure, for our patients were not overweight, and none of them had valgus knees, which carry a risk of patellar impingement (Merkow et al. 1985). In these 5 cases, the resurfacings were until failure judged to be optimal from the surgical, radiographic, and patients' points of view. Radiographic analysis yielded neither a difference between the HKA angles in noncomplicated cases versus cases with complications, nor was there any difference between the placement of the patellar components. We therefore concluded that the reason for failure must be an inherent error in the design of the patellar component. The problem is not specifically related to the product that we have used, but may be a universal problem of metal-backed patellar components (Bayley and Scott 1988). The frequency of failure of patellar components in the short-term follow-up

after surgery (maximally 2 years) in our present consecutive series may only be the top of an iceberg. Thus, withdrawal from the market of the current standard for metal-backed patellar prostheses seems warranted.
