FAILURE OF AN ELBOW ENDOPROSTHESIS

KATSUMI SUZUKI & SADA O TAKAHASHI

Section of Orthopaedic Surgery, Kanto-Rosai Hospital, Nakaharaku,
Kawasaki City, Japan

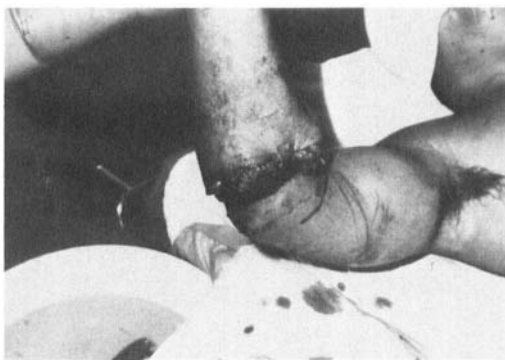
A 23-year-old male machinist, whose right elbow had been broken, was admitted to our clinic on August 19, 1965. A fetid secretion which resembled meat juice was dripping from the roughly sutured wound (Figure 1). An X-ray showed a comminuted sideswipe fracture (Watson-Jones 1960) and small gas bubbles (Figure 2). As the complication of gas gangrene was suspected, strict brushing and debridement were performed immediately with administration of antisera and antibiotics. *Clostridium welchii* was cultivated from the secretion.

Figure 1. Severely injured right elbow (August 19, 1965).

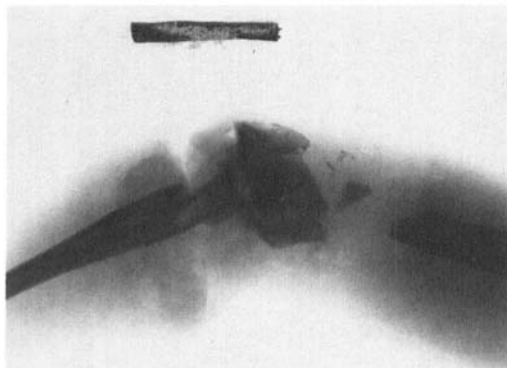
Figure 2. X-ray of right elbow (August 19, 1965).

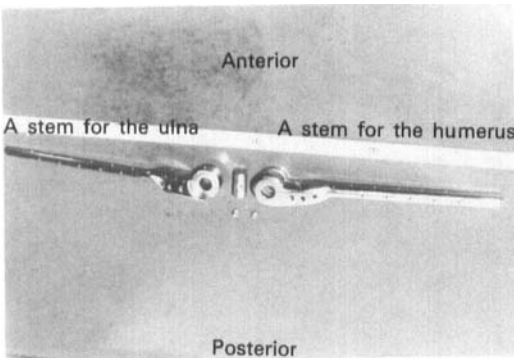
On November 18, 1966, a specially designed hinge joint, made of chrome nickel alloy was inserted into the elbow joint (Figure 3). 22-A is an excellent stainless steel (Cr. 19–21, Ni. 21–23, Mo.1.5–2.5, C<0.1, Cu. 1.5–2.5) which was introduced by Prof. Saburo Iino and Prof. Yunoshin Imai in 1951 (Iino & Imai 1951), and has since been used clinically in Japan.

Postoperatively, the range of passive motion was from 0 to 80°. However, a hematoma and a fistula subsequently appeared and staphylococcus aureus was detected. On December 19, 1966, the metal joint appeared through the ruptured skin and had to be removed. Thus, the first attempt to reproduce a movable elbow joint had failed.

Figure 3. A specially designed hinge joint made of chrome nickel alloy (22-A).

elbow joint, Roger Dee began a design program in London in 1968 (Dee 1976). In the case reported here, a metal hinge joint for the elbow made of chrome nickel alloy (22-A) was inserted. However, this metal joint suffered from three deficiencies: firstly, it was not designed for use with acrylic cements; secondly, its straight rod stem was torsionally unstable in the reamed bone marrow cavity; and thirdly, it was not designed to reproduce the triceps mechanism. Unfortunately, therefore, our first attempt at an elbow endoprosthesis failed.

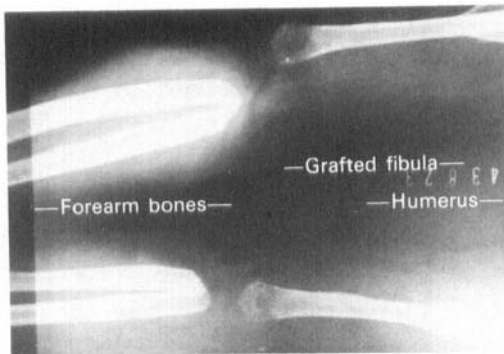
Figure 4. X-ray of the right elbow after a fibular bone graft.

On January 27, 1967, the second attempt, involving a functional arthrodesis, was made beginning with curettage and a pedicle skin graft. During the following 3 years, three autogenous bone grafts were performed, with bone from the right fibula (Figure 4) and ilium, and from the left tibia and ilium. On February 29, 1969, when he

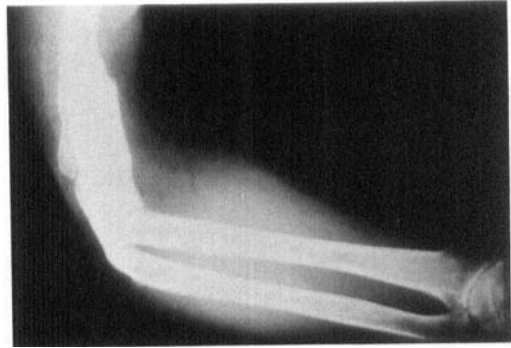
Figure 5. X-ray on August 9, 1977. The elbow had united in a functional position.

threw a snowball, his left tibia fractured and was placed in a plaster cast, which was removed after 2 months. In the meantime, the elbow had united in a functional position (Figure 5).

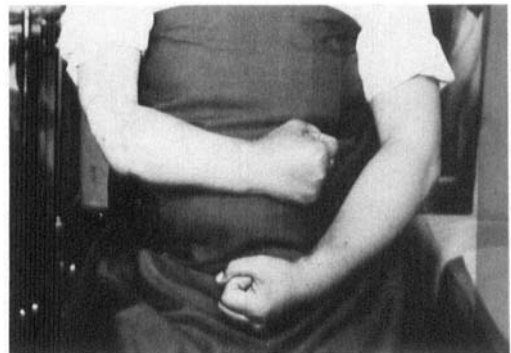
Figure 6. Making a powerful grip on August 9, 1977.

The patient is currently working comfortably, as before the injury (Figure 6).
