Periprosthetic fractures of the greater trochanter through osteolytic cysts with uncemented MicroStructured Omnifit prosthesis

Retrospective analyses of 23 fractures in 887 hips after 5–14 years

Pang-Hsin Hsieh¹, Yu-Han Chang¹, Po-Cheng Lee¹ and Chun-Hsiung Shih²

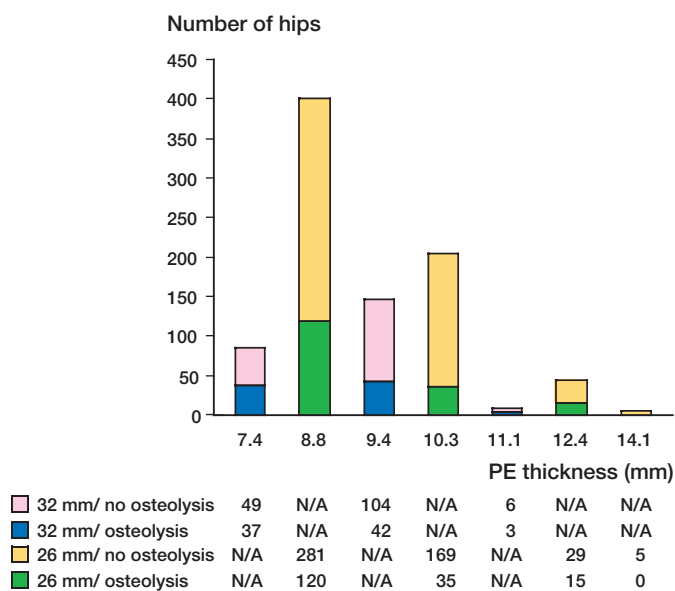
Figure 1. The thickness of polyethylene, and femoral head size used in hips with or without osteolysis.

and those who did not. On multiple logistic regression analysis that included all variables, only the use of a thin (< 8 mm) polyethylene liner remained a significant independent predictor of osteolysis, with a relative risk of 2.2 times (95% CI: 1.3–3.9, $p = 0.005$). The thicknesses of polyethylene and the sizes of the femoral heads used in hips with or without osteolysis are presented in Figure 1. The annual linear wear rate of the liner was 0.15 (SD 0.6) mm/year in the whole series. Hips with a fractured trochanter had a larger osteolytic lesion and a higher annual wear rate (Table 2).

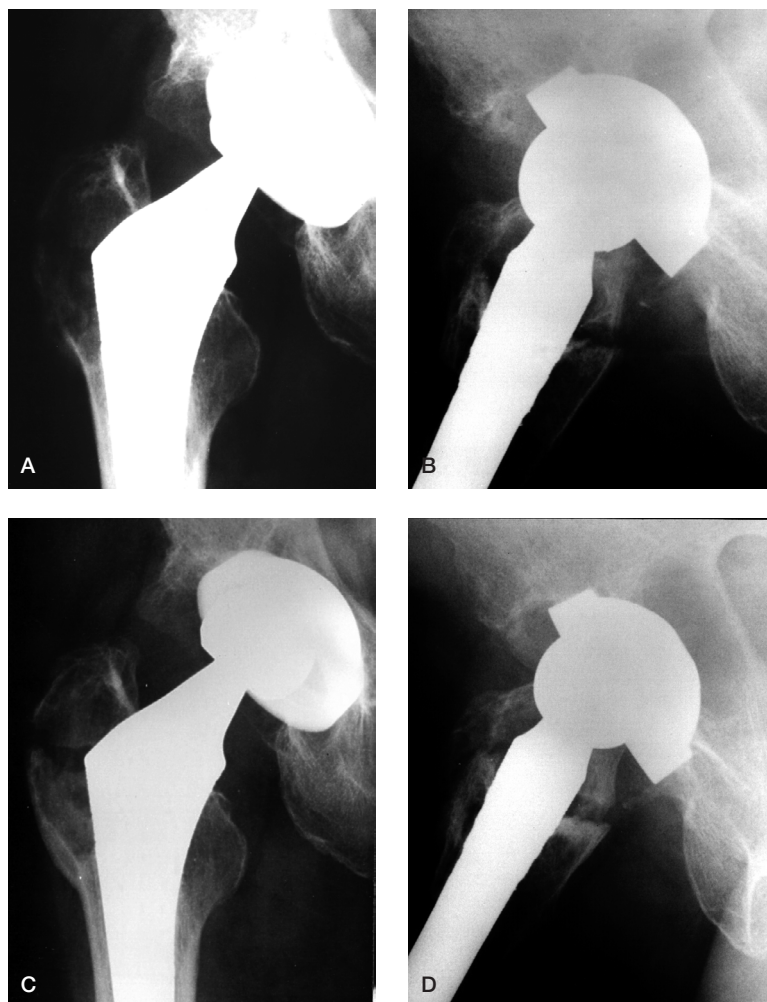
Figure 2. A 56-year-old man who had THA on the left side 6 years previously presented with gradual onset of lateral hip pain lasting for 2 months without any trauma. The anterior/posterior (A) and the lateral (B) radiographs showed a non-displaced fracture through an osteolytic cyst of the greater trochanter. The prosthesis was well-fixed. 2 years later, the anterior/posterior (C) and the lateral (D) radiographs showed that the fracture had healed. The femoral head was more eccentric, demonstrating polyethylene wear.

Nonoperative treatment was suggested in 17 patients who had minimal fracture displacement. They were managed with crutch walking, activity restriction and pain-relief medication until the symptoms were resolved. The fracture healed clinically and radiographically in 15 patients

at 6–8 weeks (Figure 2A–C). In 2 hips, however, the fracture did not unite and displaced about 2 cm superiorly.

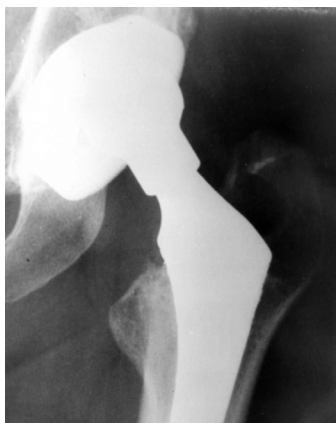
Figure 3A. Anterior/posterior radiograph of a 51-year-old woman taken 7 years after THA, and before the fracture, shows an osteolytic cyst on the greater trochanter and severe polyethylene wear.

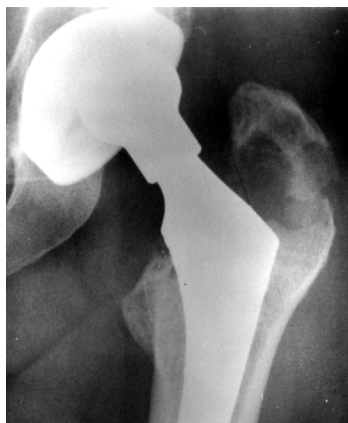
Figure 3B. 3 months later, the same patient experienced sudden lateral hip pain after a minor strain. The radiograph showed a displaced fracture through the cyst. She underwent surgery to fix the fracture, bone graft the cyst, and revise the metal shell and the liner.

4 fractures were initially treated with internal fixation, bone grafting of the cyst, and revision of the components (1 metal cup and liner revision, 3 liner and femoral head exchange) because of obvious fracture displacement (Figure 3). They all healed, one with minimal displacement.

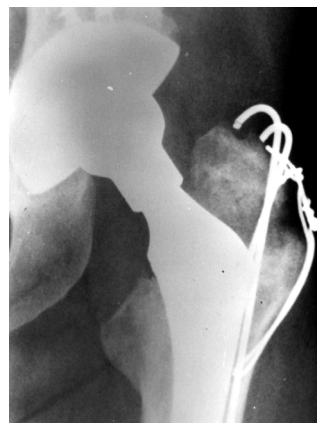
Figure 3C. A 2-year postoperative radiograph showing that the bone graft had incorporated and the fracture had healed.
