### Fracture of a ceramic acetabular insert after ceramic-on-ceramic THA—a case report

Koji Suzuki, Masaaki Matsubara, Sadao Morita, Takeshi Muneta and Ken-ichi Shinomiya

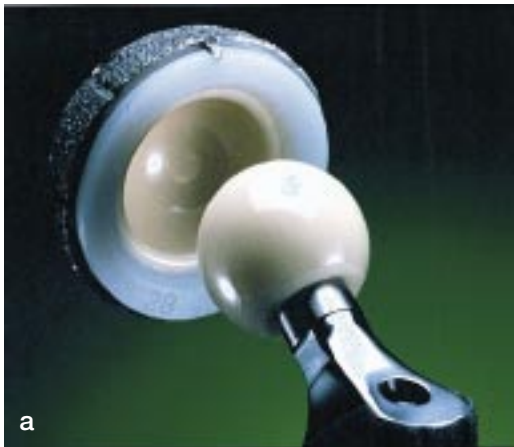
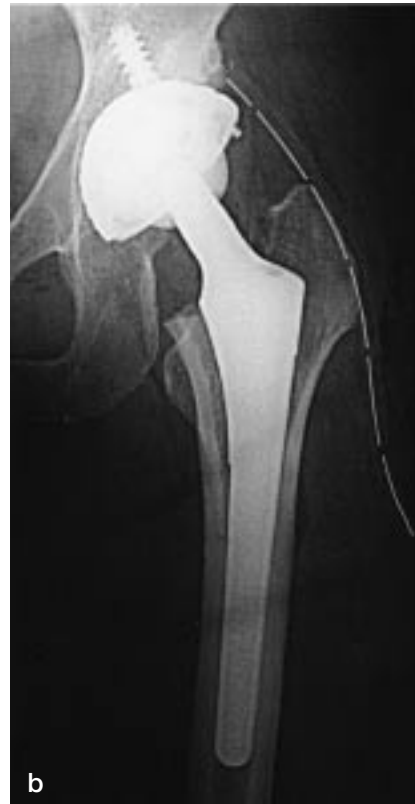
Figure 1.  
a. Photograph of implant. The ceramic liner had a polyethylene backing to prevent direct contact between the femoral stem neck and the liner.  
b. The inclination of the acetabulum was not steep immediately after the arthroplasty.

Our patient reported no trauma, and her activities had been housekeeping and gardening. The cup abduction angle was 40 degrees, which obviated the stress concentration observed at higher inclinations of the cup.

The ABS cup has a polyethylene backing between the metal cup and the ceramic insert, which averts contact between the ceramic and metal neck. This layer may also have a shock-absorbing effect. The ceramic layer in the ABS cup, however, is only 4 mm thick, a design which increases the likelihood of a fracture.

As regards the locking mechanism of the socket, the metal shell has 4 hooks that hold the polyethylene backing in place. As for the ceramic liner and the polyethylene backing, mechanical taper locking at 80 °C degrees is used and the components are cooled down to obtain congruity.

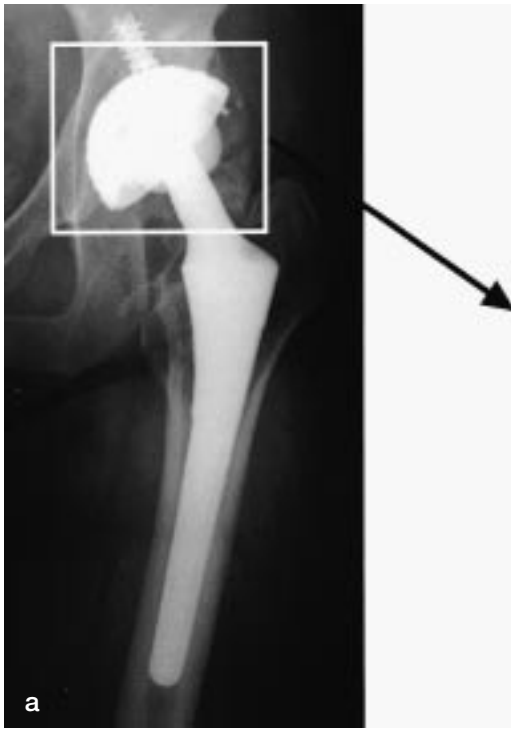
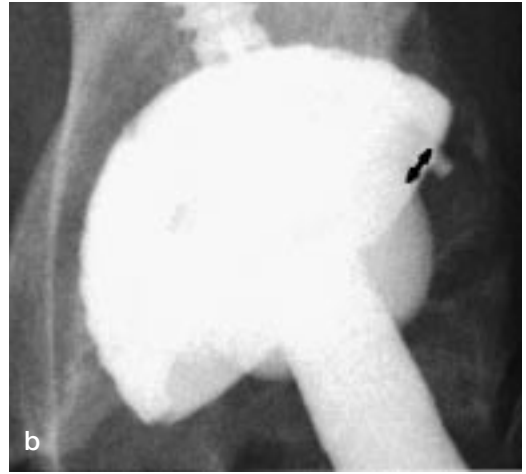
Figure 2.  
a. Anteroposterior radiograph immediately after surgery.  
b. Note a slight deviation of the femoral head 1.5 years later.

1.5 years after surgery, she had no complaints. The femoral head had moved slightly, as compared with the postoperative radiograph. (Figure 2). 3 months later she felt a click and squeak in the groin, but had not injured herself. Radiographs showed a fracture of the ceramic acetabular insert (Figure 3).

The only abnormality we found at follow-up was a slight deviation of the femoral head on the radiograph. It is possible that fracture of a ceramic insert should be suspected if the femoral head is deviated on the radiograph, even if the patient has no complaints.

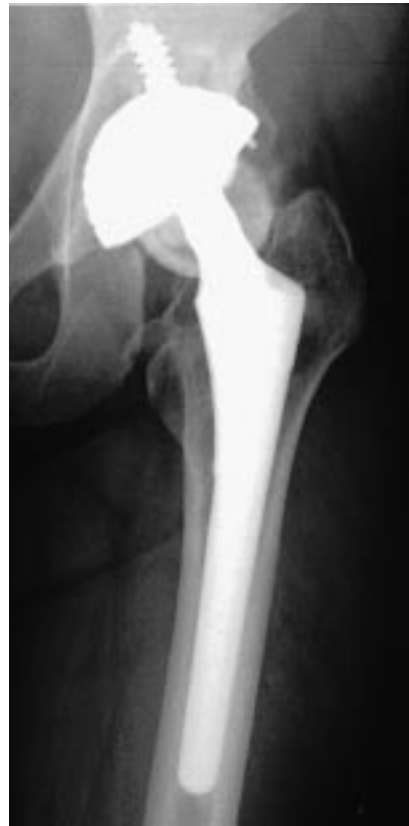
Figure 3. A fracture of the ceramic acetabular insert was found 2 years after surgery.

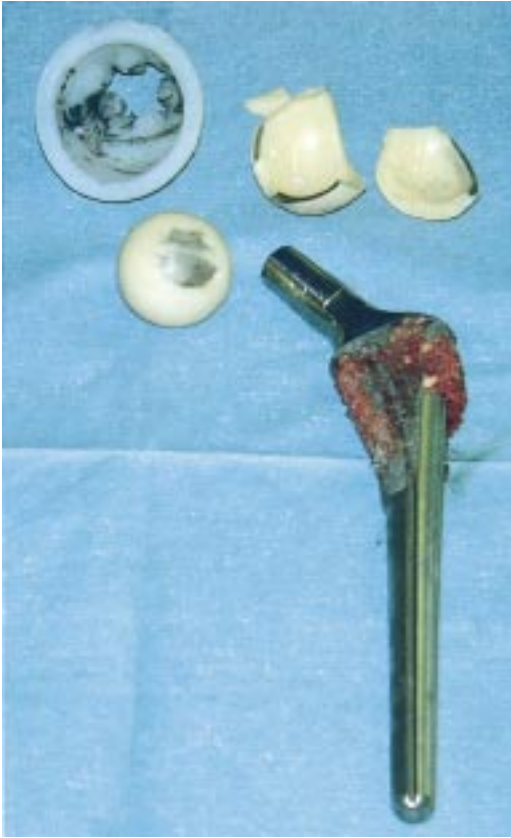
Figure 4. Retrieved implant showing fractured insert, but intact femoral head.

At surgery, the edge of the broken ceramic liner was discolored, which showed that it had been in direct contact with the metal (Figure 4). This could have been secondary to fracture of the liner and dislocation, although it seems more likely that the ceramic inlay first became dislocated and then showed impingement and fracture of the liner.

The stem was revised and the liner changed. The well-fixed metal shell was not removed. At surgery, we found the fracture of the insert, which had become detached from the polyethylene backing, the greatly worn polyethylene backing and the ceramic head that was discolored from contact with the metal shell (Figure 4). The postoperative course was uncomplicated. After 6 months, she had no pain, walked without aids, and had resumed normal daily activities.
