# Dislocation of the polyethylene liner in hip arthroplasty

## 6 patients with dislocation within 3 years

Oliver Niggemeyer, Bernd Fink and Wolfgang R  ther

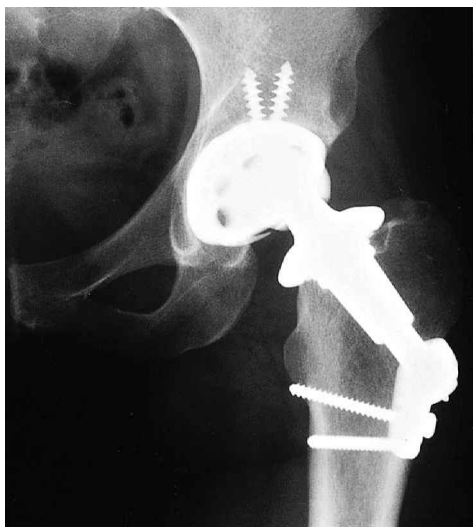
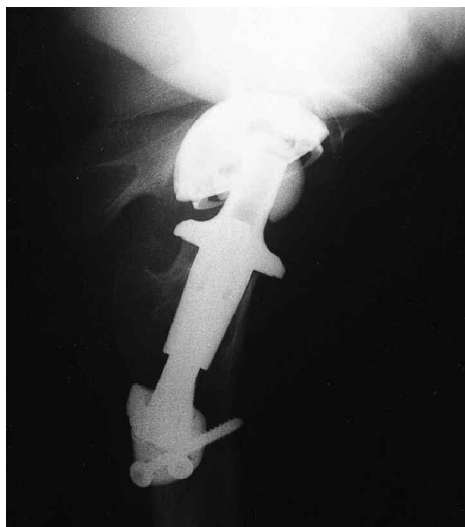
Figure 1. The eccentric position of the head of the thrust plate prosthesis in the cup is due to luxation of the liner.

A technetium bone scan was normal. 2 months afterwards, she had an acute onset of severe pain in her hip with reduced motion. Radiographs showed that the head of the thrust plate prosthesis had an eccentric position in the cup (Figures 1 and 2). The hip was revised 31 months after surgery because of suspected damage to the liner. At operation, the polyethylene had dislodged from the metal shell and the edge of the liner was almost completely cut off. The metal shell was well fixed, but was removed because the surgeon thought that insertion of a new liner or cementation of a smaller liner or cup with cement was hazardous. A cementless Plasma-cup (Aesculap, Freiburg, Germany) was inserted without a bone graft. Histological

In our reported cases, the complication is probably due to the following mechanism. After an initial rotation of the liner in the shell, any asymmetrical position or slight subluxation of the liner will damage the periphery of the liner by the sharp metallic edge of the shell. When the edge is cut off, complete luxation and fracture of the liner will occur more easily. Mechanical testing of the Harris-Galante II acetabular cup and polyethylene liner has shown that minimum rotary torque is transmitted from the joint to the liner/shell interface, if the acetabular cup and liner are placed and fixed correctly without impingement (Schmalzried and Harris 1992, Tanzer et al. 1992, Padgett et al. 1993, Schmalzried et al. 1994).

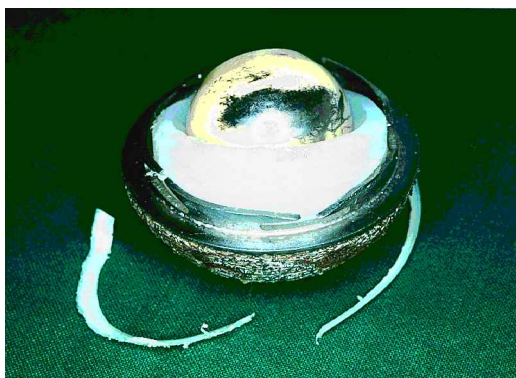
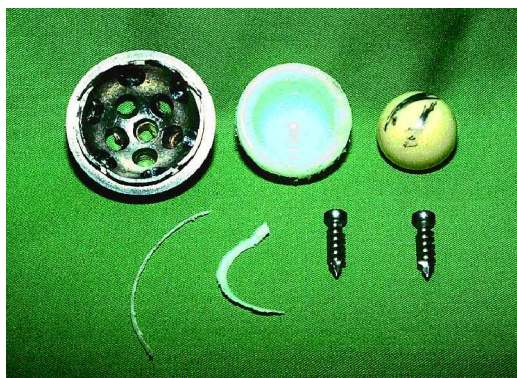
Figure 2. The acetabular cup with metallosis of the ceramic head has been removed. The liner is intact, but the edge is cut off.

We found an excessive wear on the outside of all the polyethylene liners, but only slight wear on the inside. Thus, rotation of the liner in the metal shell would probably cause this particular pattern of wear, as reported by others (Jasty and Harris 1990, Louwerse and Heyligers 1999, Della Valle et al. 2001).
