## Removal of the well-bonded distal part of a non-cylindrical broken femoral stem (Autophor 900S) with hollow trephine reamers—report of two cases

George C Babis, John Tsarouchas, Petros J Boscainos, George P Tzagarakis and Theodore Pantazopoulos

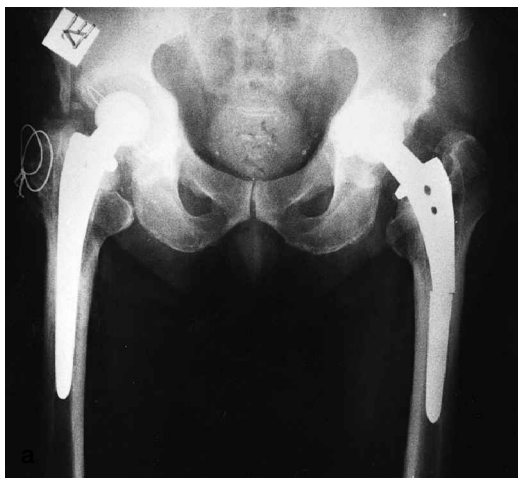
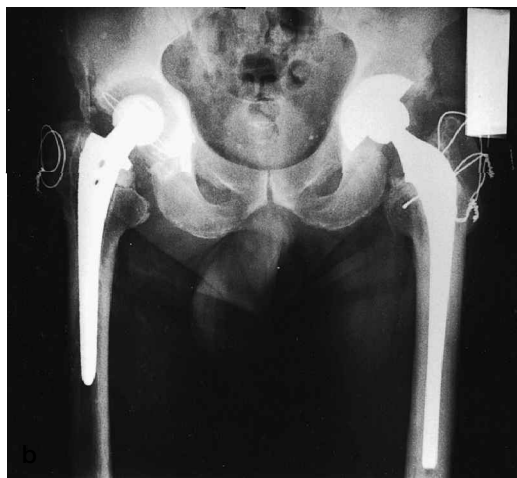
Figure 1. A 61-year-old man with bilateral total hip arthroplasties and a fracture in the middle of the left Autophor 900S femoral stem (a). The distal part is centralized in the femoral canal and radiographically well-fixed while the proximal part is grossly loose. After revision (b) of the left ceramic total hip with a hybrid total hip arthroplasty. No femoral bone deficiency can be detected.

A 61-year-old man, who had had bilateral total hip arthroplasties 9 years ago, was referred with a fatigue fracture of the left femoral stem. Using a transtrochanteric approach, we easily removed the loose proximal part. We used a motorized 14 mm hollow trephine reamer (DePuy, Warsaw, Indiana) to extract the distal part of the stem. Reaming lasted for 30 minutes and we had to use 2 trephines

because of wear of the cutting heads. We cooled the area with saline irrigation to avoid heat damage to bone. The distal part was finally extracted, impacted within the trephine. Radiographs after implantation of a new stem showed no substantial bone loss (Figure 1).

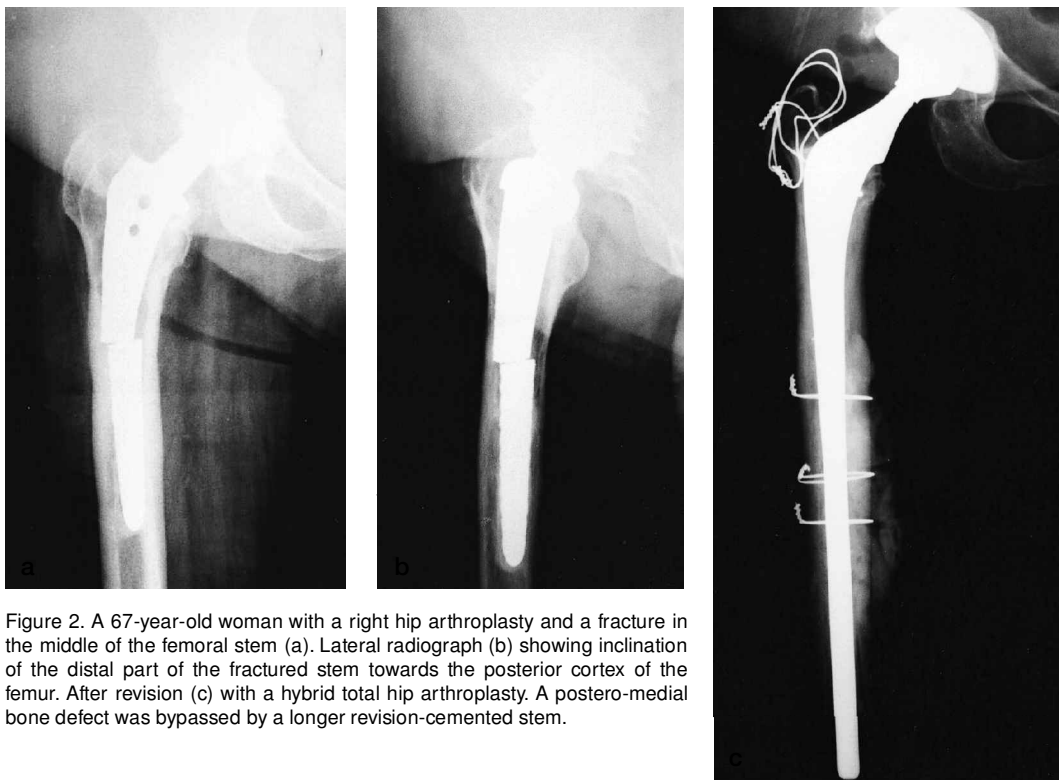
Figure 2. A 67-year-old woman with a right hip arthroplasty and a fracture in the middle of the femoral stem (a). Lateral radiograph (b) showing inclination of the distal part of the fractured stem towards the posterior cortex of the femur. After revision (c) with a hybrid total hip arthroplasty. A postero-medial bone defect was bypassed by a longer revision-cemented stem.

A 67-year-old woman sustained a stem fracture after 11 years. We used the same procedure as in case 1 to remove the distal stem. Extraction reaming was arduous and lasted for 40 minutes. After removing the distal part of the stem, we detected a  $1.5 \times 4$  cm defect at the posterior femoral cortex. We ascribed the defect to posterior inclination of the stem, which guided the trephine posteriorly. We did not use an image intensifier during the pro-

cedure. The defect was covered with cortical bone from the posterior femoral cortex using cerclage wires and morselized fresh frozen bone allografts. A longer femoral stem was inserted with cement to bypass the defect (Figure 2).

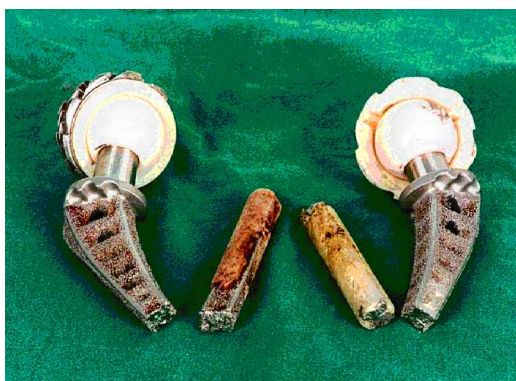
In both cases, marble-like bone or dense mineralized fibrous tissue was firmly attached to the distal portion of the fractured stem (Figure 3).

Figure 3. The marble-like appearance of the bone firmly attached to the distal part of both broken stems.
