# Interface gap after implantation of a cemented femoral stem in pigs

Jian-Sheng Wang, Herbert Franzén and Lars Lidgren

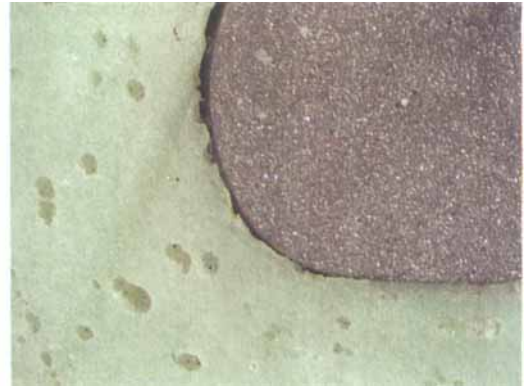
b. The close-up shows a gap with "saw tooth" edge at the cement-stem interface.

The analysis of serial sections showed that there was 85% contact between the cement and stem and 90% contact between bone and cement with gaps found both in the cement-stem and the bone-cement interfaces. Most of the gaps at the cement-stem interface occurred at the same position in the different sections and were not affected by the cutting direction (Figures 2 and 3). A complete circumferential gap was not found in any of the specimens. Some gaps were associated with pores at the cement-stem interfaces. These gaps were irregular, with a saw-tooth appearance, and were often seen in the sections with cement mixed at atmospheric pressure (Figure 2). Other gaps showed a clear edge without pores, they were often seen in the vacuum-mixed sections (Figure 3). The appearance of the gaps at the bone-cement interface looked the same regardless of mixing procedure (Figure 4). The total percentage of the circumference occupied by the gaps in both bone-cement and cement-stem interfaces did not differ significantly, regardless of the mixing technique (Table). The majority of the gaps were less than 100 µ (gap grade I) (73 % at bone-cement interface and 83 % at the cement-stem interface). Grade III gaps (> 500 µ) were found in only a few sections in all specimens.

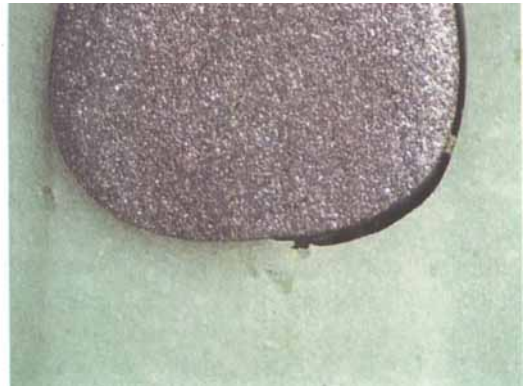
b. The close-up shows a gap with a sharp edge at the cement-stem interface.

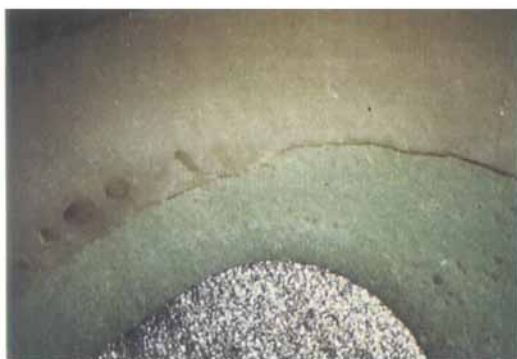
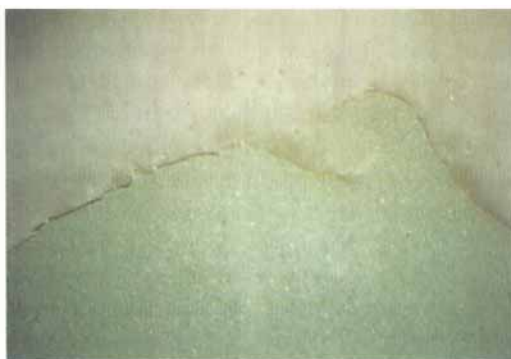
Figure 4. The gap between the bone and the cement ( $\times 12$ ).

a. The cement was mixed at atmospheric pressure.

b. The cement was mixed under vacuum.
