# Venous outflow obstruction 8 years following Ring total hip arthroplasty

## A rare complication of acetabular loosening and polyethylene wear

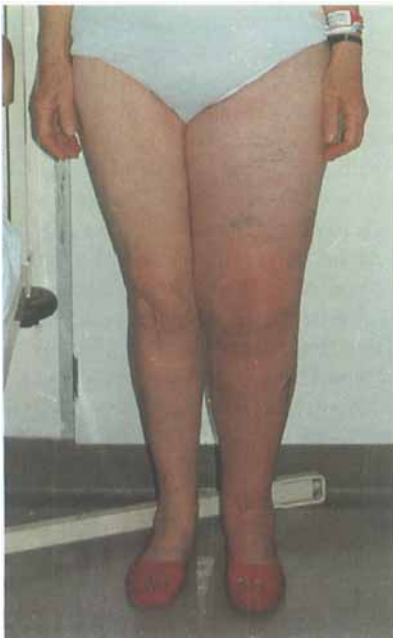
She had a massive swelling of the lower limb with pitting edema and a firm tender swelling in the left iliac fossa and inguinal region (Figure 1). A presumptive diagnosis of venous outflow obstruction was made and the patient was referred to the vascular surgery department.

Preoperative swollen left lower limb.

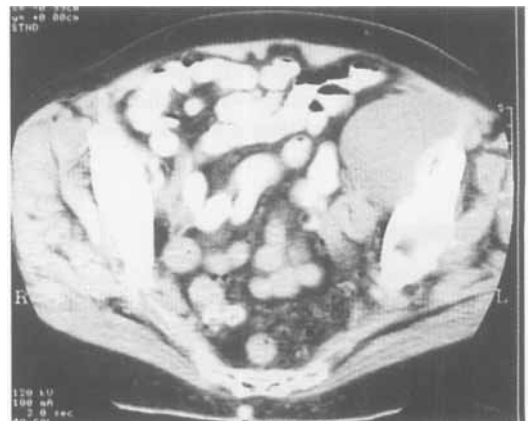
A pelvic radiograph showed no signs of loosening of the prosthesis. A venogram showed no evidence of venous thrombosis and radioisotope lymphangiogram excluded lymphedema. An inguinal lymph node biopsy was unhelpful. CT scan of the pelvis and hip revealed a large cystic lesion adjacent to the hip and extending anteriorly to the left ilium (Figure 2). Aspiration of the cyst revealed straw-colored fluid and cytology demonstrated unremarkable lymphoid cells.

Computed tomography scan showing a large cystic mass medial to the ilium and anterior to the hip.

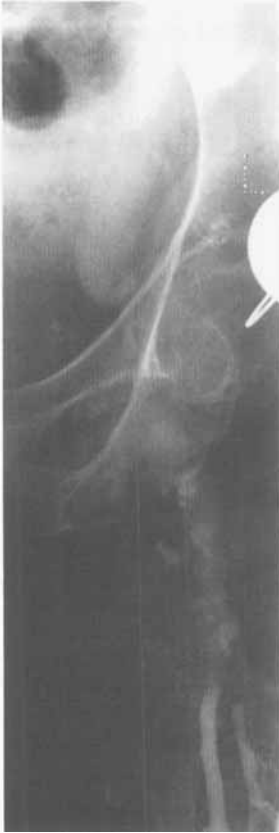
6 months after the onset of symptoms, she was referred to the orthopedic department with a massive swelling of the entire limb which was approximately double the circumference of the normal side. A soft, tender inguinal swelling and a firm iliac fossa mass were noted. Straight leg raising and rotation of the hip were painful. A repeat venogram showed compression of the femoral vein in the groin (Figure 3), causing venous outflow obstruction, but no thrombosis.

Venogram showing compression of the femoral vein at the level of the hip joint.

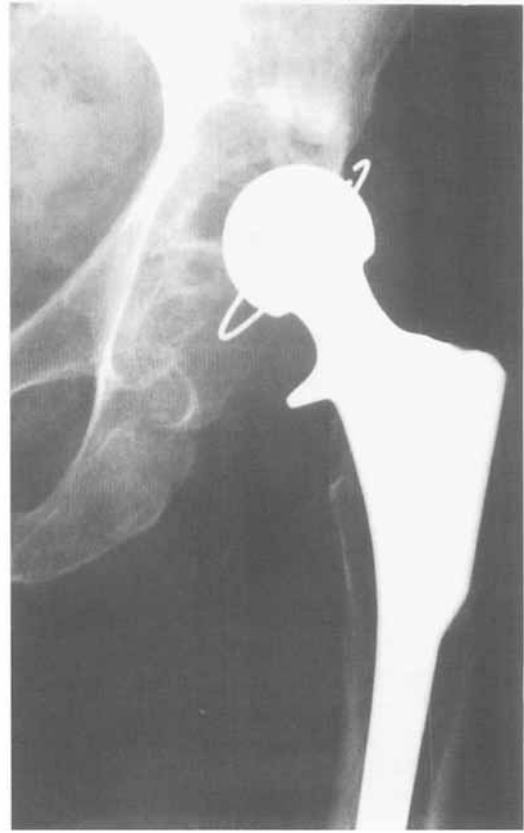
A repeat hip radiograph demonstrated loosening of the polyethylene socket associated with osteolysis

Loosening of polyethylene socket and osteolysis of acetabulum.

(Figure 4). At revision surgery, there was extensive granulomatous tissue formation which was excised and approximately 300 mL of straw-colored fluid drained spontaneously. Histological examination of the granulomatous tissue showed fibrosis and numerous foreign body giant cells related to bi-refringent polyethylene particles under polarized light microscopy.

Postoperatively, the swelling started to decrease within 2 weeks. The patient was painfree and the leg edema had entirely resolved at 8 weeks' follow-up.
