High failure rate of cementless threaded acetabular cups

A radiographic and histologic study in the goat

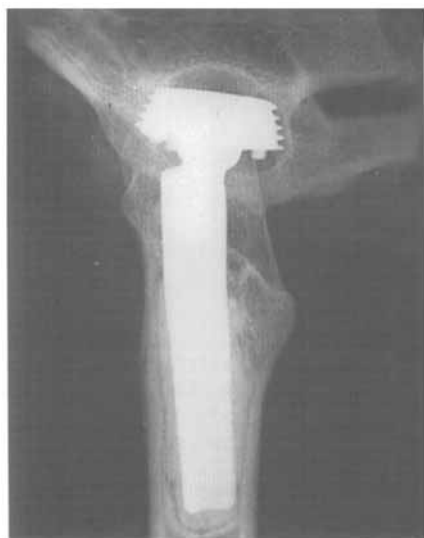
Figure 1. Limited demarcation, not covering the entire ring. On the left, there is no radiographic demarcation.

No demarcation: no lucent zone with a sclerotic margin (Figure 1).

Limited demarcation: a thin line of demarcation, that does not cover the entire ring (Figure 1).

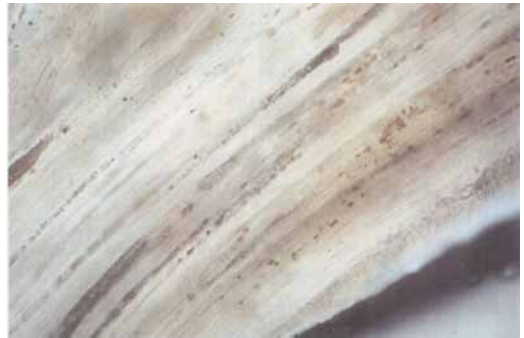
Figure 4. Dense fibrous membrane with collagen bundles organized parallel to the surface of the Mekring. Only a few fibrocytes and hardly any vessels are visible. The thickness of this membrane varied between 0.3-0.8 mm (hematoxylin-eosin, $\times 250$).

The first type of fibrous membrane (Figure 4), seen in 4 goats, consisted of collagen bundles organized parallel to the surface of the Mekring, with few fibrocytes and hardly any vessels. The thickness of this layer varied between 0.3-0.8 mm. Spots of limited bone absorption were present, close to the polyethylene liner as well as the titanium Mekring.

Migration was not seen in goats with a thin dense collagen membrane interface on histological examination (Table 1). Apparently this provides a more stable anchorage of the implant with less loss of bone, which is consistent with the findings of Søballe et al. (1992).

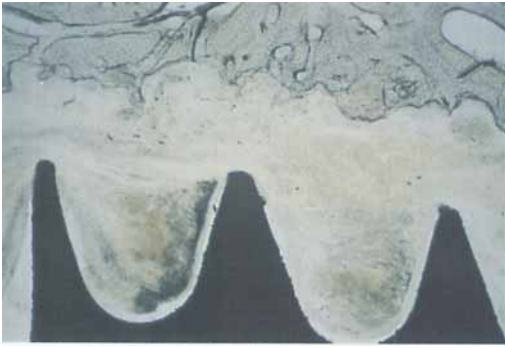
Figure 5. Fibrous membrane with many fibrocytes and vessels, but without massive collagen production. The thickness of this membrane varied between 1.2–2.2 mm (hematoxylin-eosin, $\times 60$).

The second type of fibrous membrane (Figure 5), seen in 10 goats, consisted of connective tissue, with many fibrocytes and vessels, but without collagen bundles.

Foci of histiocytes containing iron pigment were present as remnants of bleedings. The thickness of this fibrous membrane was generally 1.2–2.2 mm. Bone absorption was seen on a larger scale and was more pronounced adjacent to the polyethylene liner than the titanium Mecring. Another 3 goats, all in the 6-week group, showed a mixture of type 1 and type 2 interface.
