## Case reports

### Acetabular cup loosening—peeling off of the plasma-sprayed porous coating in 2 cases

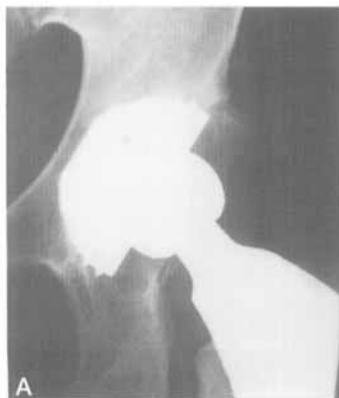
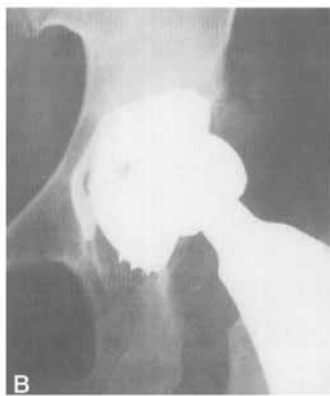
#### Case 1.

- A. At first complaints of pain.
- B. A few weeks later the component showed a change in orientation and a separate radiopaque layer around the dome.
- C. Removed RCC, from which nearly all of the porous coating had peeled off.

Before the revision, 3.5 years after the primary THR, new radiographs revealed a definite change in the position of the RCC to a more vertical inclination and a radiopaque “halo” was seen above the dome of the cup. At the reoperation, the joint fluid and tissues were black because of titanium metallosis and the RCC was completely loose. Nearly all of the plasma-sprayed porous coating had peeled off from the dome of the shell, but remained tightly fixed to the wall of the bony acetabulum. The metallosis was caused by abrasion at the shell against the porous coating. Bone ingrowth into the porous coating was so good that it had to be removed piecemeal with a chisel.

In both of my cases, the primary cup fixation was achieved using threads of the RCC without supplementary screws. The primary fixation was apparently sufficient for bone ingrowth into the plasma-sprayed porous coating. Obviously, in spite of the secondary fixation of the porous dome, bone resorption occurred between the threads and finally the cup stability was based only on the bony fixation of the remaining porous dome. Load transfer was thus concentrated to the dome, giving rise to shear forces at the interfaces between bone and coating as well as between coating and shell. Interestingly, the interface between the titanium shell and porous coating failed first.

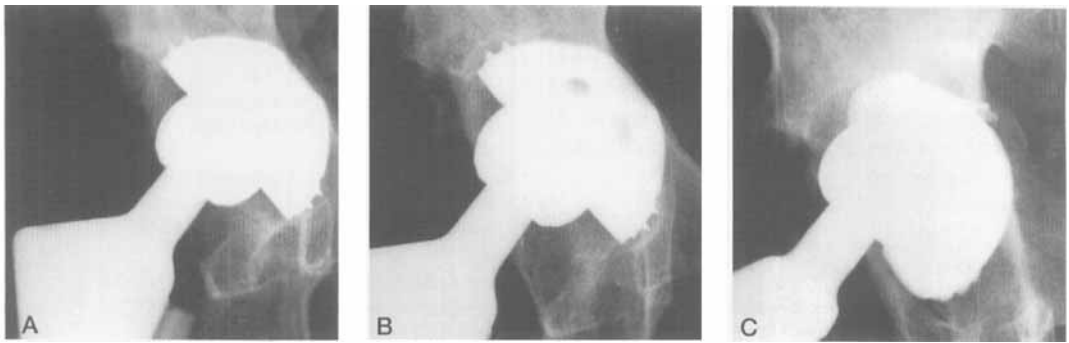
### Case 2.

- A. Shortly after THR.
- B. 2 years after surgery, bone resorption around the threads.
- C. 5 years after primary THR, a definite change in cup orientation and an asymmetric position of the head in the RCC are seen. Note separate radiopacity in the central dome area.
- D. Loosened acetabular cup in which about half of the porous coating had peeled off.

A 52-year-old man had a cementless primary THR in 1990 with a Biomet Bi-Metric stem and RCC for developmental dysplasia in his right hip. The cup was 48 mm in diameter and no screws were used for fixation. 2 years after the THR the radiographs showed osteolysis around the threads, but the position of the cup was unchanged. 5 years after THR, the patient began to complain of pain on starting and exertion. The radiographs showed that the position of the cup had become more vertical and the position of the prosthetic head within the cup was asymmetric. Furthermore, a separate radiopacity adjacent to the dome was seen. At revision, gross metallosis in the periarticular tissues was found and the RCC was obviously loose. Most of the acetabular bony surface was covered by the separated coating of the RCC. About half of the porous coating had peeled off from the dome of the cup. Polyethylene wear was marked and the insert was also infiltrated by titanium particles. Again, the separated porous titanium layer was tightly fixed in the acetabular bone and could only be removed piecemeal with a chisel. The stem was well fixed, though there was a small periprosthetic granulomatous cyst in the trochanteric region.
