# Intrapelvic penetration of Olmed cervical hip fracture screws

## A report of 7 cases

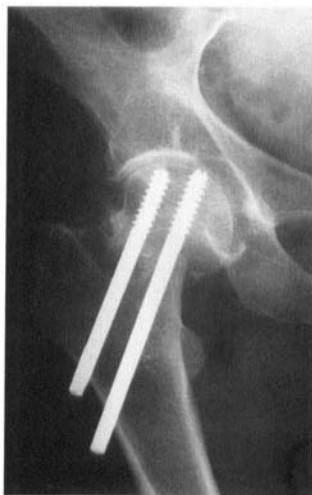
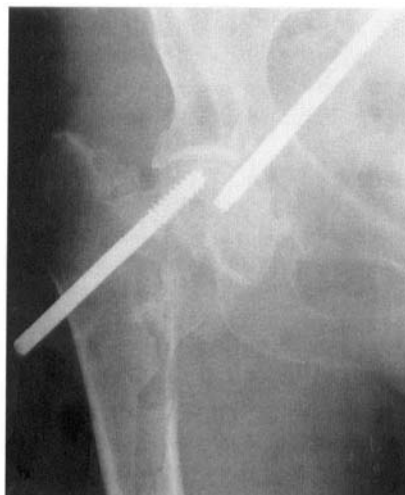
Figure 1. Case 2.

Immediately postoperatively.

2 months after the osteosynthesis.

An 82-year-old woman sustained a cervical hip fracture with severe displacement after a fall. She underwent osteosynthesis with Olmed screws the day after the injury, and the postoperative radiographs showed an acceptable position of the screws (Figure 1). The tip of the distal screw was at the bone-cartilage border, but the surgeon had not penetrated the hip joint. She was able to bear full weight after 1 week. Because of increasing hip pain, new radiographs were taken 2 months later; they revealed that the distal calcar screw had penetrated into the pelvis (Figure 1). She underwent a THA without complications.

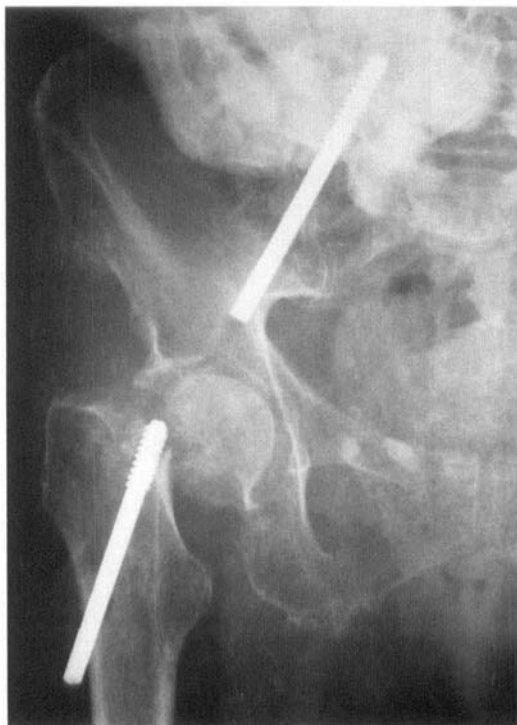
Figure 2. Case 3. 6 months after the osteosynthesis.

sis, obtaining an acceptable position of the screws. She returned to the nursing home after 2 weeks, but due to increasing hip pain, a new radiographic examination was carried out 6 months later. It showed the distal screw migrating far into the pelvis (Figure 2). The patient underwent reoperation. She was tiny, and by gentle pushing against the lower part of the abdomen it was possible to press the severely dislocated screw backward into the acetabulum and extract it through the posterior incision. Because of her contractures, only a Girdlestone procedure was performed.
