# Stem fracture with the Exeter prosthesis

## 3 of 27 hips followed for 10 years

Magne Røkkum, Kjell Bye, Karl R Hetland and Astor Reigstad

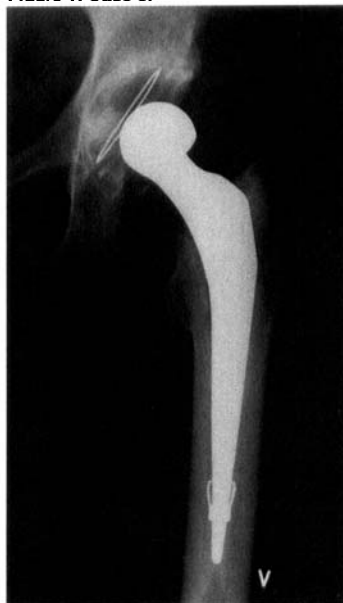
Figure 1. Case 5.

At 1 year small lucencies have developed between cement and bone proximally. 0.1 cm subsidence of the stem within the cement.

3 cases of femoral stem fracture occurred after 1.3, 8.6, and 9.0 years and were reoperated. The hip pain had started suddenly during plain walking. In 2 cases, pronounced lucencies between cement and bone in zones 1 and 7 developed during the first postoperative year (Figure 1). 1 stem lost proximal support due to pseudarthrosis of a femoral osteotomy (Figure 2). The fracture levels measured from the tip of the stem were at 7.7, 7.7, and 7.6 cm. Fracture waves consistent with fatigue failure were clearly visible on the cut surfaces, starting anterolaterally and propagating to the medial side, ending in a lip of metal. No bending of the fragments was seen. Stem defects, which could have contributed to the fractures, were not observed.

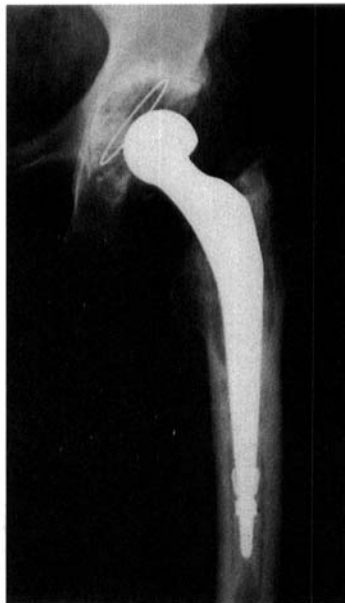
At 5 years there are endosteal erosions in zones 2 and 6. Fracture of the cement and centralizing jig is seen, of which the distal part is sinking together with the stem. 0.5 cm of stem subsidence has taken place.

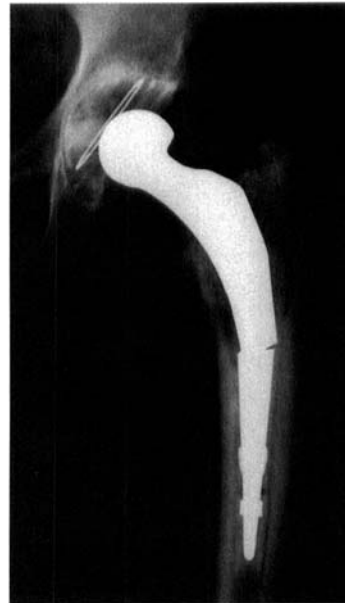
Stem fracture after 8.6 years. Endosteal bone lysis surrounds the proximal half of the stem. The stem has subsided 1.6 cm, partly within the cement, partly together with the distal cement mantle.

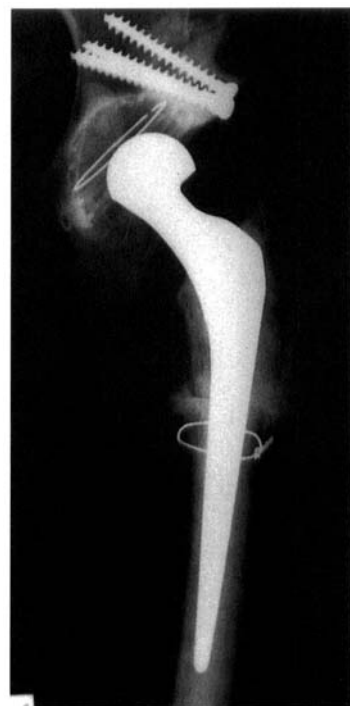
Figure 2. Case 25.

Shortening osteotomy of the femur was achieved simultaneously with the primary total hip replacement.

The same fracture level in our cases indicates that the stem design is an important factor. Due to the pronounced taper design, the slender and weak distal end of the stem is fixed in a comparatively thick cement mantle. Bending of the stem during loading may cause disruption of the proximal bone-cement interface. Proximal debonding increases both the fatigue stress of the distal part of the stem and the distal bone-cement interface shear stress. Hence, we believe that the same process underlies both the loosening and the stem fractures. The non-union of the femoral osteotomy (Figure 2) results in a similar stress distribution to the stem as proximal bone-cement debonding.

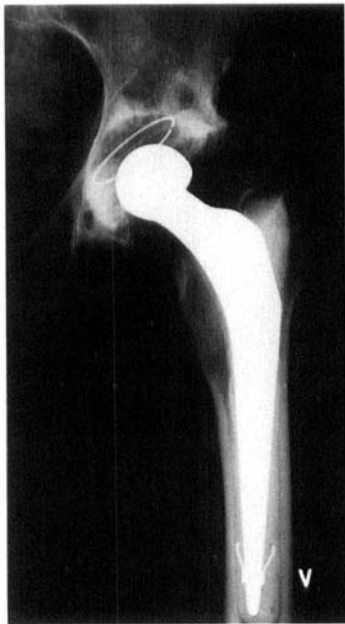
Figure 3. Case 22.

Postoperatively.

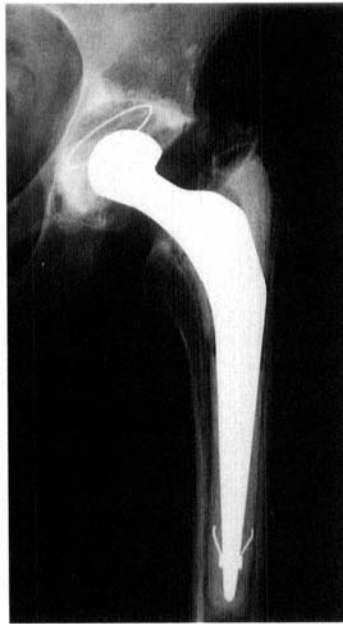
At 10 years a lucency is enveloping the cement. Cement fracture 11 cm proximal to the tip of the stem. A total of 1.2 cm of stem-sinking occurred, 0.1 cm within the distal cement mantle, as indicated by the dissociation of the centralizing jig.

cular risk factors. The radiolucencies started proximally, enveloping the cement mantle within 1 year and coinciding with stem subsidence. In cases 22 and 24, there were cement fractures about 11 cm from the tip of the stem. Stem-sinking together with the intact distal part of the cement mantle followed, while the proximal cement remained in place (Figure 3). In case 10, no cement fracture occurred, but the whole cement mantle accompanied the stem intimately during subsidence.
