# Two-year outcome of hydroxyapatite-coated prostheses

## Two femoral prostheses retrieved at autopsy

We performed a histological study of the bone-implant interface on 2 human femurs implanted with a hydroxyapatite-coated self-locking stem for 2 years. Extensive bone formation with no intervening fibrous tissue was noted around the entire circumference of the 2 prostheses. The newly-formed bone had 2 morphotypes: an alveolar disposition

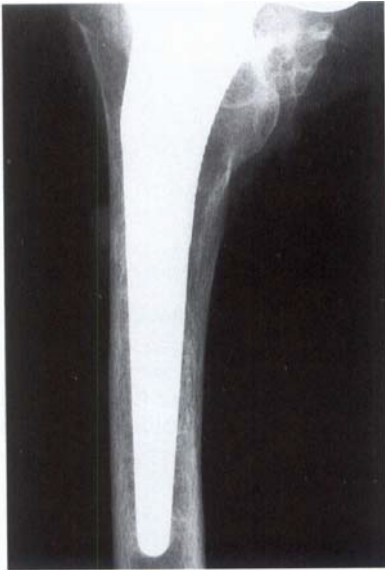
Figure 1. Case 1. 83-year-old woman.

The stem is slightly undersized and tilted in a varus position.

The radiograph shows a rather tiny network of bone

trabeculae at the tip of the stem between the implant and the endosteum.

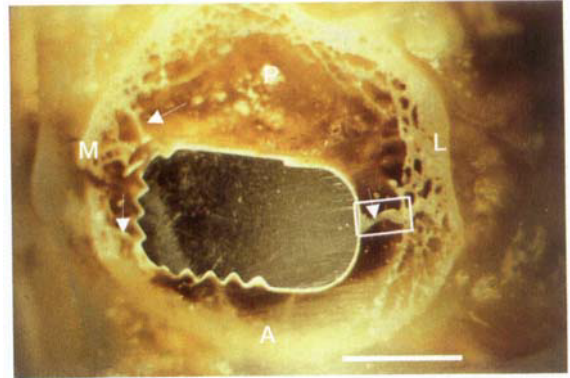
Metaphyseal section of the femur. New bone made of isolated bony trabeculae (arrows) is seen on the medial and the lateral aspects of the implant. (A) anterior, (P) posterior, (M) medial and (L) lateral sides; square = microscopic field of lower left close up, bar = 1 cm.

A macroscopic view of the metaphyseal area (Gruen Zones I and VII) showed scattered trochanteric cancellous bone with very thin cortical shells. On the lateral and the medial aspects of the implant, isolated and often sigmoid-shaped trabeculae could be identified, up to 1 mm thick. Microscopic examination showed that they were made of lamellar bone. Haversian remodeling was visible close to the HA coating. Direct contact between bone and ceramic

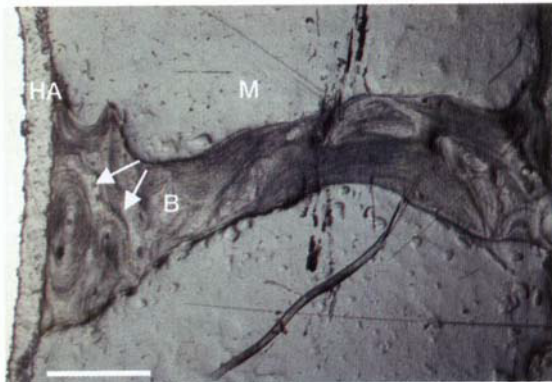
Sigmoid-shaped bone trabecula. Bone is of lamellar structure, but Haversian remodeling is noted close to the HA coating (arrows). Around the bone, the bone marrow is in direct contact with the HA layer. I implant, B bone trabecula, M bone marrow. Reflected light microscopy, bar = 1 mm.

The interfacial bone found in Zones II, III, V, and VI were of a digitiform morphotype. Superficial irregularities were noted in the segment of the coating in contact with bone marrow, while its original thickness was preserved in the bone-HA interface. In these areas of degradation, several osteoclasts were found, forming resorptive lacunae. In no place was complete degradation of the coating down to the metallic substrate observed.

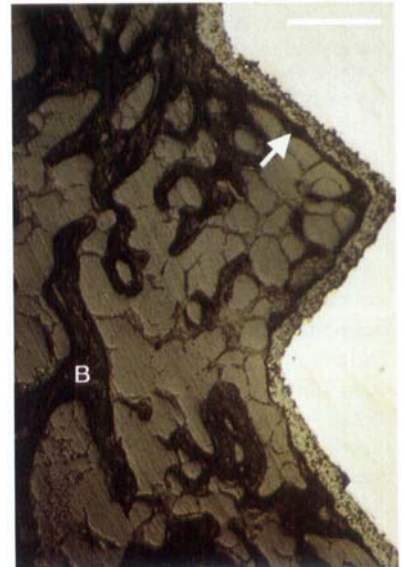
Alveolar morphotype on the lateral aspect of the tip of the stem. A continuous sleeve of bone (arrows) runs along the HA coating. I implant, B bone. Reflected light microscopy, bar = 1 mm.

The tip of the stem, which constitutes Zone IV, was completely surrounded by newly-formed bone tissue. A bony sleeve was running continuously around the tip of the stem (an alveolar morphotype). No degradation of the coating was visible. The marrow tissue in the meshes of this cancellous bone contained rather fatty involuted tissue with very few cells.

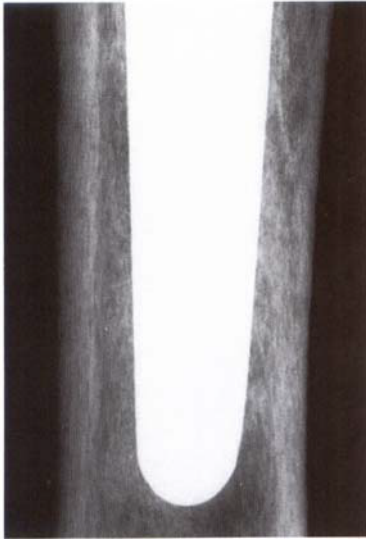
Figure 2. Case 2. 88-year-old woman.

The tip of the stem. Extensive new bone formation is visible all around the implant. Note the high degree of osteoporosis of the cortices.

Radiographically, this stem seemed tightly fitted into the medullary canal. A detail of the tip of the stem showed bone formation. From a histological standpoint, two major differences from Case 1 could be

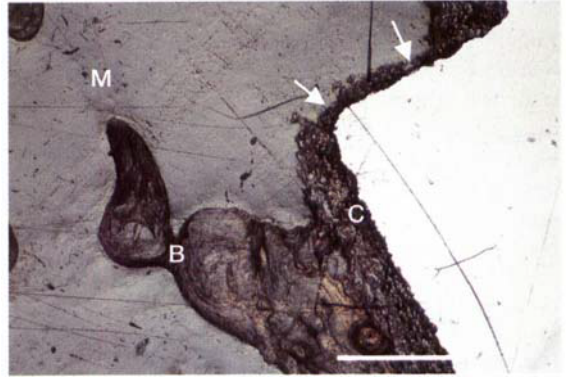
Resorption of the coating (arrows) in the bone marrow–ceramic interface areas. I implant, C ceramic layer, B bone tissue, M bone marrow cavity. Reflected light microscopy, bar = 200  $\mu$ , diaphyseal section.

In most places where the coating faced bone tissue, the original thickness of the ceramic was preserved. Extensive resorption of the coating was observed in areas without bone covering, where marrow cells had access to the apatite coating. Macrophages with a cytoplasm that was charged with ceramic debris were seen in the areas of resorption as well as free particles of ceramics in the extracellular fluid. This degradation process may or may not leave a thin remnant of ceramic, the metal being in contact with bone marrow. In several places, secondary formation of immature bone tissue was found to occur on the ceramic remnant. Secondary mineralization took place, leaving a mature bone tissue interfacing with the prosthesis.
