Polyethylene wear in unicondylar knee prostheses

106 retrieved Marmor, PCA, and St Georg tibial components compared

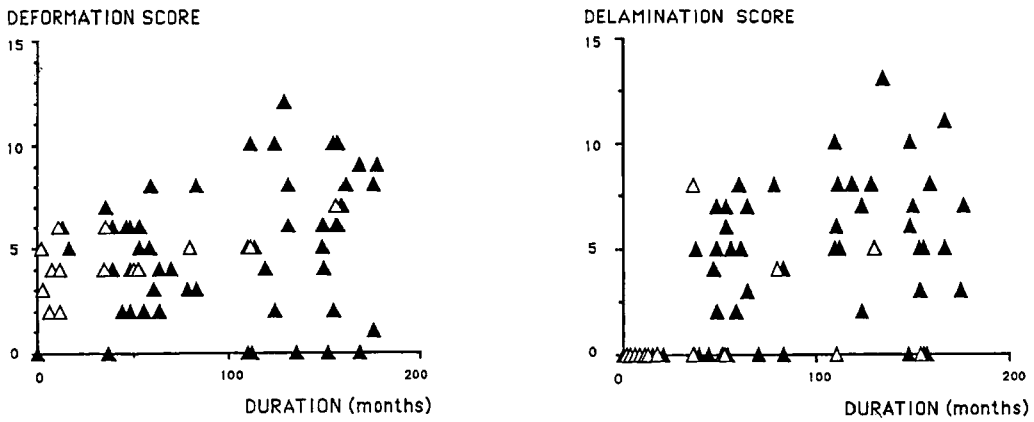
Figure 1. Deformation and delamination scores against duration of implantation of St Georg design; (▲) nonbacked and (△) metal backed.

Deformation and delamination were the predominant wear types on the St Georg prostheses. Although highly variable, there was a trend towards higher deformation with increasing time of implantation. Delamination of this design occurred in retrieved prostheses approximately 4 years after insertion. Metal backing did not affect wear or delamination (Figure 1). Sub-surface failure was first evident as white areas in the polyethylene (Figure 2).

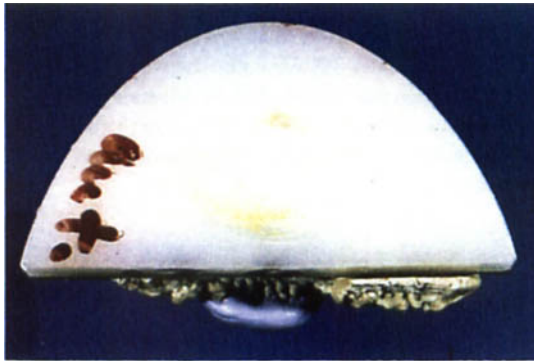
Figure 2. Photograph of retrieved St Georg tibial component (duration 7 years) showing break-up of the polyethylene surface due to delamination.

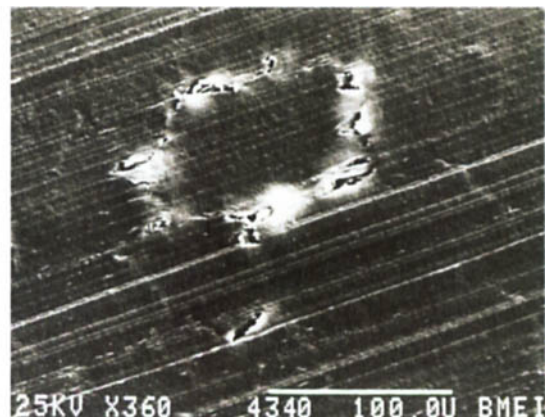
Figure 5. Scanning electron micrograph of fusion defect under non-worn region of polyethylene. The defect is partially bonded to the surrounding polyethylene, x400.

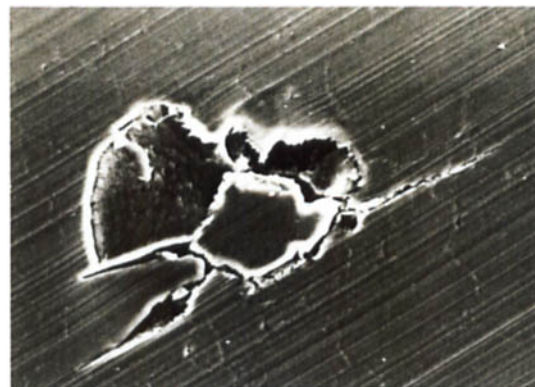
Figure 8. Scanning electron micrograph of fusion defect under the wear track showing initiation of cracks from the edges of the defect, x140. Duration 7 years.

polyethylene (Figure 6). In these regions, high stresses around the defects were apparent (Figure 7). In addition, defects in this region formed initiation sites for cracks (Figure 8).

Our results suggest that sub-surface cracks are initiated by the fusion defects which were seen in the St Georg polyethylene. They are due to the manufacture of polyethylene which is processed by extrusion or compression-moulding into bar form. Components are then machined into their final shape. Total consolidation is not possible because of the high melt viscosity. The number of fusion defects remaining in processed polyethylene will depend upon the degree of consolidation. Rose and Radin (1990) speculated about the role that fusion defects played in "severe wear" regimes, suggesting they played a crucial role in propagating cracks. Our study demonstrates that Marmor polyethylene which did not contain fusion defects never delaminated. It also shows that the defects in highly stressed regions of the polyethylene produce locally increased stressed concentrations. This leads to debonding of the defect and initiation of cracks which gradually extend and coalesce to liberate flakes and particles of polyethylene from the surface. Once the surface layer becomes discontinuous, the cracking will steadily progress. Even in the plastic without defects, the cyclic sub-surface shear stress will eventually lead to potential crack development but the process will require a higher number of cycles than material with defects. Meanwhile, as deformation and wear at the surface proceed due to adhesive and abrasive mechanisms, the maximum shear stresses will occur at a lower level. Furthermore, the magnitude of the stresses will decrease with time due to an increased contact area. Hence a given area of plastic will receive an insufficient number of cycles at high enough stresses to produce fatigue cracking (Figure 16).

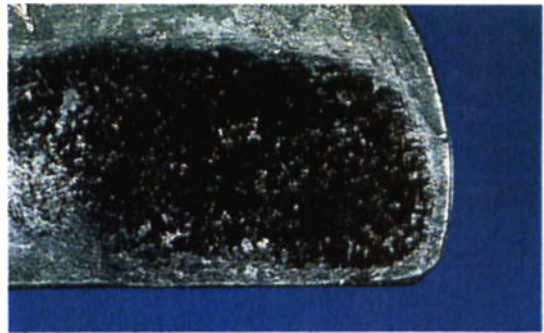
Figure 9. Photograph of retrieved Marmor tibial component. The component has been sputter-coated with a layer of gold to show clearly deformation of the wear track and the numerous pits, x5. Duration 7 years.

Wear of the polyethylene component of the Marmor prostheses was very different from wear seen on the St Georg prostheses. A shiny wear track formed on all components with no evidence of delamination (Figure 9). Pitting of the polyethylene also occurred with pits which measured from 250-1000 μm . The pits were shallow, measuring less than 0.5 mm deep (Figure 10), and were formed in regions where there appeared to be high local stresses directly at the surface (Figure 11). Deformation of the polyethylene around the pits appeared to be higher than in nonpitted polyethylene (Figure 11).

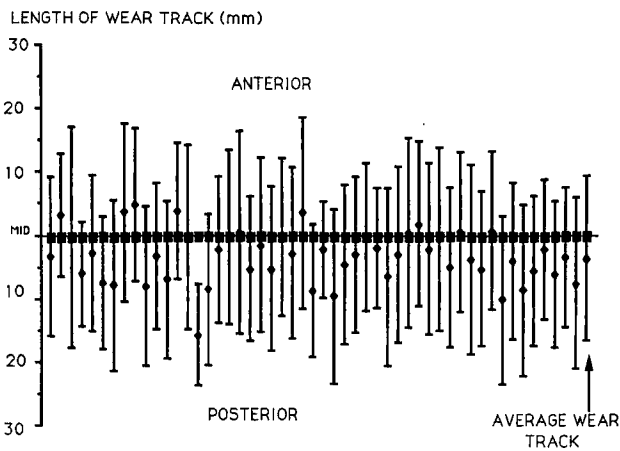
Figure 13. Position and length of wear tracks on St Georg Sledge prostheses.

Both in the St Georg and Marmor prostheses the average length of track was 24 (15-35) mm and was positioned posteriorly (Figure 13).

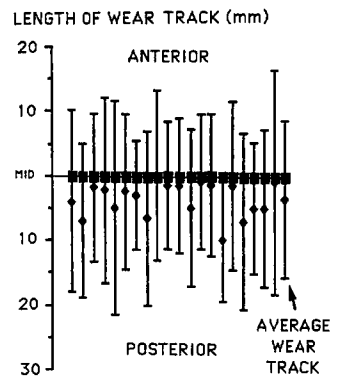
Figure 14. Position and length of wear tracks on Marmor prostheses.

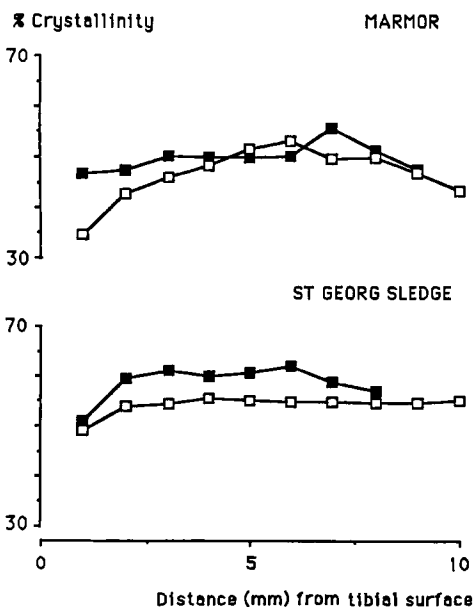
Figure 15. Profiles for percentage of crystallinity under the wear track and non-worn regions for St Georg Sledge and Marmor tibial components; (■) unworn and (□) worn.

The average crystallinity at the surface of unworn polyethylene was 52 percent for the St Georg design and 46 percent for Marmor designs. There was a decrease in crystallinity of the polyethylene under the wear track in all the Marmor components investigated, with crystallinity as low as 34 percent at the surface of the polyethylene for one component (Figure 16).

Changes in crystallinity under worn and nonworn areas of St Georg prostheses were not as large, and although there was a trend to lower crystallinity under worn areas, it was not so apparent as that observed for Marmor designs (Figure 16).
