PROSTHETIC REPLACEMENT OF TUMOUR-DESTROYED DIAPHYSEAL BONE IN THE LOWER EXTREMITY

A description is given of a prosthesis for replacement of tumour-destroyed diaphyseal bone in the lower extremity. It can be used in a salvage procedure and as an alternative to intramedullary nailing or plating procedures. The method is not complicated provided that mechanically sound devices are used and technical errors are avoided. The operation time is short and the patients can be mobilized early.

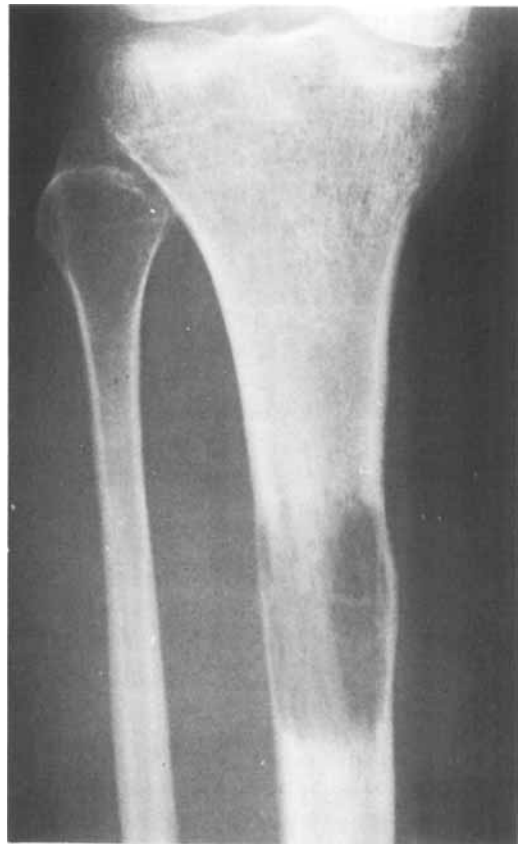
Figure 2. This destruction in the proximal tibia was due to a metastasis of a hypernephroma. The upper border of the defect is situated about 2–3 cm distal to the tuberositas tibiae.

The first case was a 55-year-old woman with a metastasis in the right tibia from a hypernephroma (Figure 2). The size of the osteolytic lesion on the X-ray was 4×5 cm. The primary tumour had been discovered and removed about 2 years earlier. It was suspected that another metastasis was located in the distal metaphysis of the right femur. No other metastases were detectable by whole body scintigraphy.

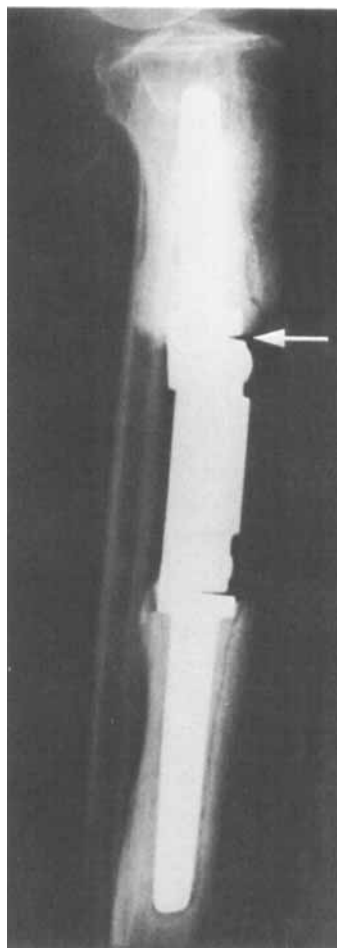
Figure 3. The destruction shown in Figure 2 has been replaced by the three-part prosthesis shown here. The situation illustrated is that 8 months after reinsertion of the prosthesis (for details see text). Observe the slight sinking of the prosthesis – cement block both proximally and distally. Note the sclerosis of the bone around the tip of the distal stem which should be interpreted as a sign of functional stress.

At the proximal arrow the prosthesis shows bending at the screw level and the screw was found to be loose at operation. There was also a crack in the material of the prosthesis at the site of the screw hole. There was no loosening of the cement either proximally or distally in relation to the bone.

After a further 8 months the patient suddenly experienced instability. From the X-rays it appeared that the prosthesis was broken in its proximal part (Figure 3). This time a prosthesis of stainless steel was manufactured in the hospital workshop within 4 days. At reoperation the prosthesis was found to be broken at the level of the proximal screw hole. The nut had loosened most probably because the teflon-coated nut had been re-used at the previous operation. The patient survived another 8 months without problems with the prosthesis. Thus, this patient was able to walk freely for 2½ years following the first operation in spite of complications which in retrospect were at least to some extent avoidable.

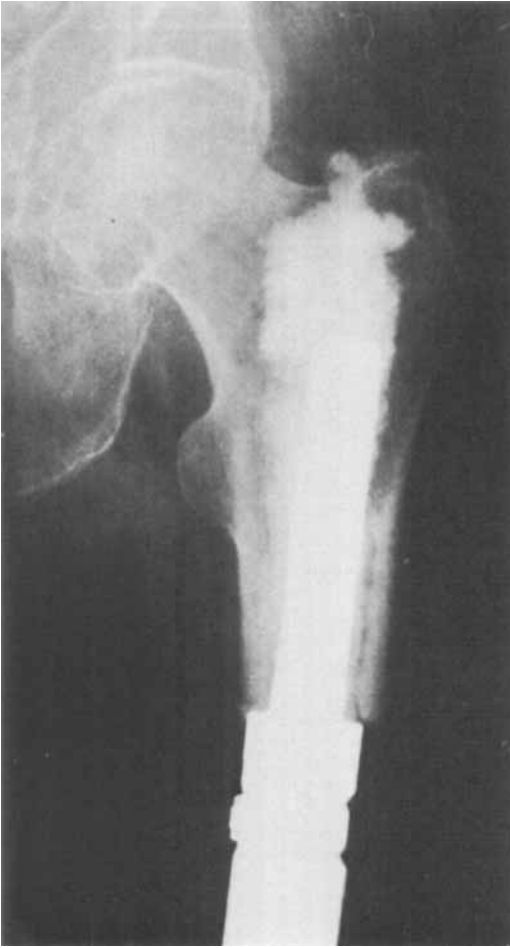
Figure 4. This femur prosthesis was inserted after the first prosthesis in the third case was removed (see text) because of varus bending in the proximal stem. The diameter is larger and the prosthesis is resting on the medial cortex. Note the quite extensive cement mass which was inserted in an attempt to get maximum weight distribution.

A new prosthesis was manufactured with a stem 12 mm in diameter and the collar of the stem was broadened to 24 mm in order to obtain better support for the prosthesis on the cortex of the bone (Figure 4). The patient had no problems with the new prosthesis during a further survival time of 9 months.
