A PHYSICAL EXAMINATION OF ORTHOPAEDIC IMPLANTS AND ADJACENT TISSUE

E. SMETHURST & R. B. WATERHOUSE

Department of Metallurgy and Materials Science,
University of Nottingham, England

This paper reports a metallurgical study of five metal-on-metal total hip replacements removed from patients because of varying degrees of loss of bone substance and/or proven sensitivity to Ni and Cr. Evidence of corrosion of the Co-Cr-Mo-C alloy used to fabricate the prostheses was found. It is suggested that the products of this corrosion may alter the balance of bone formation/resorption to produce a loss of bone substance. An unusual tissue response which included rod-like particles (1-2 μm long \times 0.2 μm in cross section), of possible immunological origin, was seen on examination of the articulating surface of one of the prostheses by scanning electron microscopy.

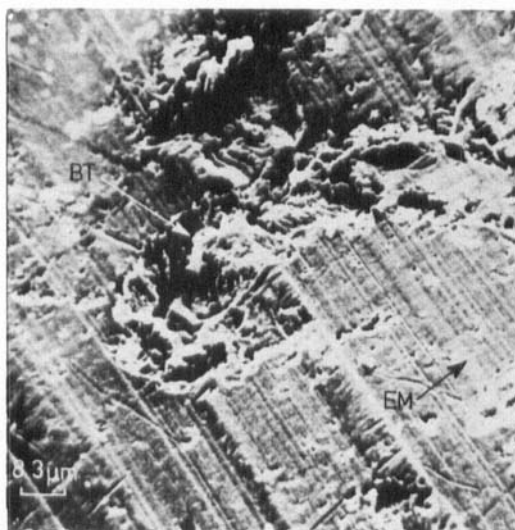
Figure 1. Tissue removed from Patient 1, embedded and examined in the optical mode of the scanning electron microscope. The arrows point to embedding medium (EM) and the bone tissue (BT).

femoral stem of the Co-Cr-Mo-C alloy implant were examined using the analytical and optical modes of the scanning electron microscope. Spicules of bone could readily be discerned and identified in the tissue. Figure 1 shows the tissue as revealed by the scanning electron microscope, in which pieces of hard substance are evident. The analytical mode for the same field of view identifies calcium as shown in Figure 2. Superpositioning of these two figures revealed the specific areas of bone. No trace of cobalt was detected in the tissue using these techniques.

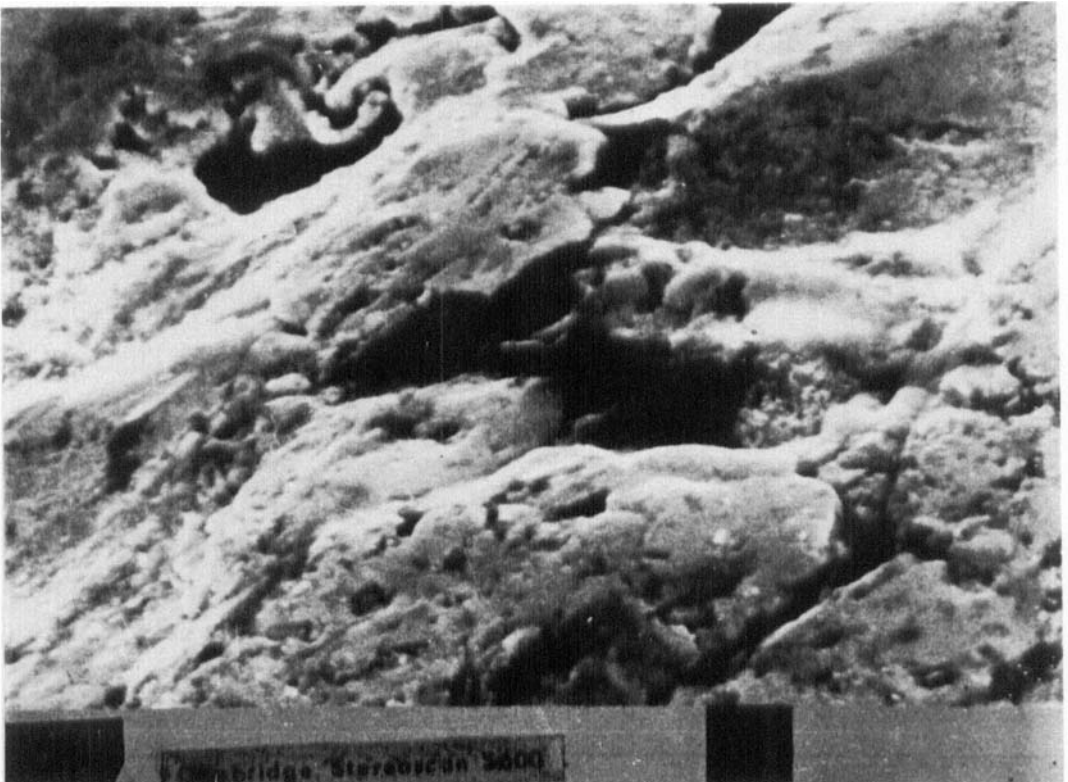
Figure 7. Scanning electron micrograph of the pelvic surface of the acetabular component of the prosthesis removed from Patient 3. Note the irregular surface resulting from corrosion.

component removed from Patient 3 showed the same type of wear behaviour as reported previously (Walker & Gold 1971). This type of wear was also present in the implant from Patient 1. Figure 6 shows the articulating surface present in Patient 2. It is seen that the scratches are broad and pitted, which is indicative of the presence of some form of corrosion. The articulating surface present after manufacture of a McKee-Farrar cup was also examined by scanning electron microscopy. The surface examined exhibited the normal type of finish that would be expected from polishing the metal. In Patient 3, the outer unpolished surface of both components of the prosthesis appeared to have been attacked (Figure 7).

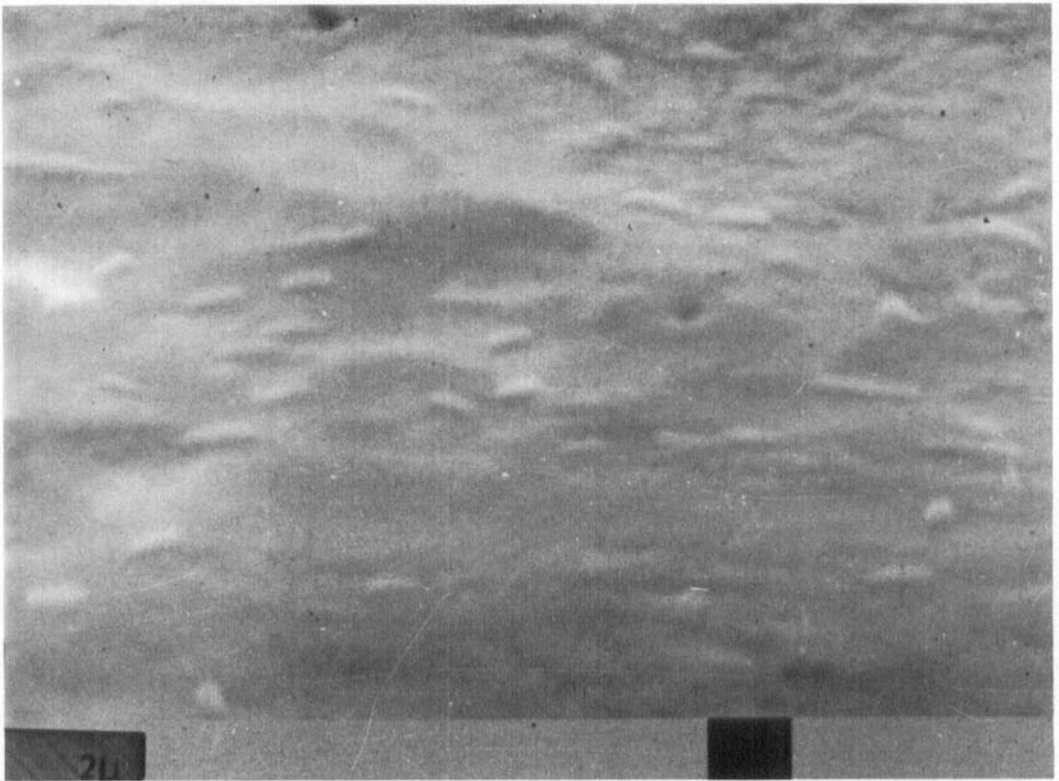
Figure 8. Scanning electron micrograph of collagenous tissue and rod-like particles. Note the size of particle, 1–2 μm long \times 0.2 μm in cross section.

SEM examination. Scanning electron microscopy of the articulating surface of the acetabular component revealed the presence of rod-like particles embedded in the collagenous tissue that surrounded the prosthesis (Figure 8). The particles were 1–2 μm long \times 0.2 μm in cross section. Table 5 shows the results obtained with the EDXA attachment. There is enrichment of Cr within the particles. These particles have been observed from time to time in the last few years in our laboratory both on bone plates and on prostheses removed from patients. They are usually

associated with implant corrosion. Other workers (Vernon-Roberts 1976, personal communication), have observed similar particles and they are only found on implants from patients of proven sensitivity to one of the constituent elements of the Co-Cr-Mo-C alloy used to fabricate the prostheses.
