PENETRATION OF A LONG STEM PROSTHESIS INTO THE KNEE JOINT: A COMPLICATION OF TOTAL HIP REPLACEMENT

The unusual occurrence of penetration of the stem of a femoral prosthesis into the knee joint during total hip replacement and the method used to deal with this complication successfully, without replacing the prosthesis, is described.

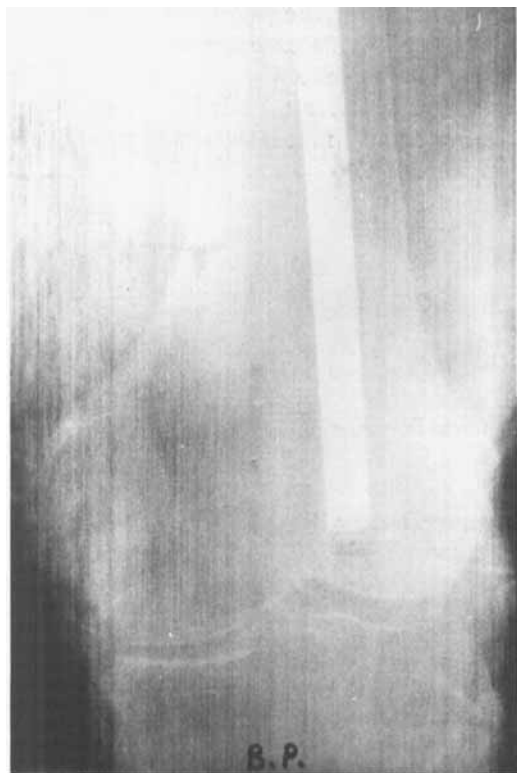
Figure 1. Anteroposterior radiograph of the left knee at operation. There is no evidence of penetration of the knee joint in this view.

A 68-year-old woman with a markedly symptomatic left hip resulting from gross loosening of a Thompson femoral prosthesis was admitted for total hip replacement on June 6, 1976. Because of severe osteoporosis of the femoral shaft, a femoral component 28 cm long, reaching the supracondylar region, was used. An antero-posterior radiograph of the knee region performed during operation, before injection of the cement, was considered satisfactory (Figure 1).

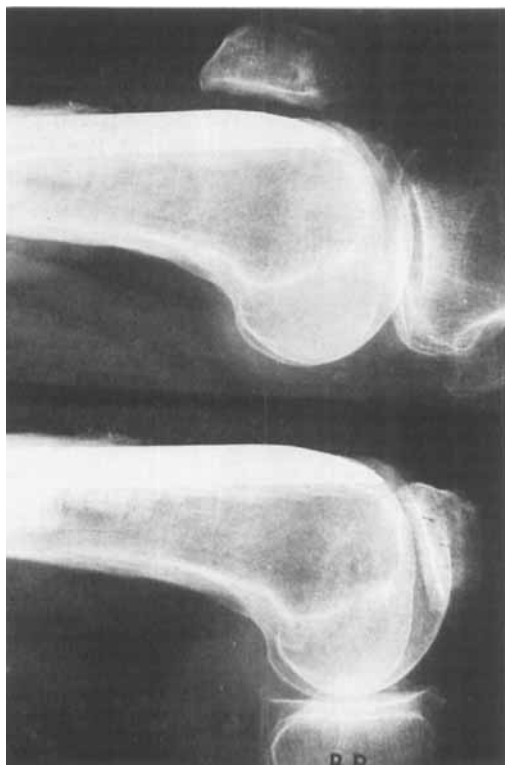
Figure 3. Lateral radiograph of the knee, 4 months after operation, showing the final shape of the tip of the stem and the complete absence of contact between it and the articular surface of the patella.

Arthrotomy of the knee, under tourniquet, was performed 3 weeks after the joint replacement. A small irregular erosion of the articular surface of the patella was noted. The excess methylmethacrylate was removed and the cement lying on either side of the projecting metallic stem was undermined to about one millimetre below the level of the anterior cortex. The joint space was isolated, the articular surfaces protected with wet sponges and a high-speed saw-blade mounted on a hand-saw, cutting tangentially, was used to cut off the distal end of the prosthesis flush with the anterior cortex. A small grinding stone (7 mm wide) mounted on an air drill and fine metal files were then used to polish the cut surface, making sure that there was absolutely no contact between it and the patella (Figure 3). The wound was very thoroughly irrigated before closure. The postoperative
