ACTA ORTHOPAEDICA SCANDINAVICA  
SUPPLEMENTUM no. XLIVb

EXPERIMENTAL INVESTIGATION OF CORROSION  
OF STAINLESS STEELS USED  
IN BONE SURGERY

HANS EMNÉUS

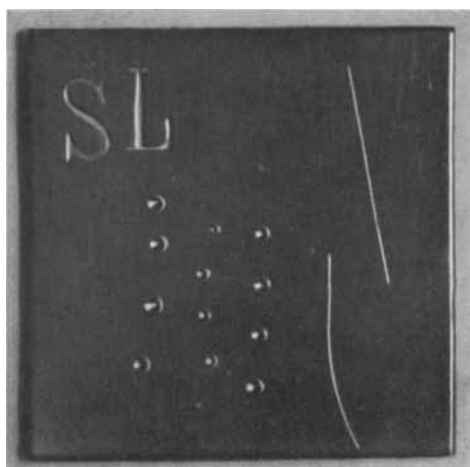
Fig. 6 d. 832 SL without corrosion in any cavity.

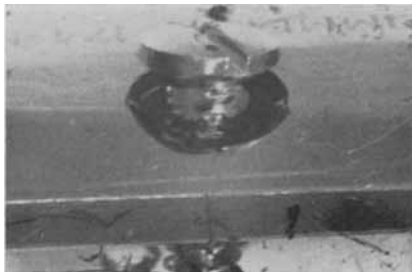
Fig. 33 b. This screw head ( $\times 5$ ) was deformed by the screw driver but shows hardly any corrosion. The screw hole, however, shows corrosion. The colours seen to ooze from underneath the plate around the screw come from the screw hole. This may be an example of crevice corrosion. In one of the larger areas damaged on the edge of the plate some corrosion is seen. No corrosion is seen in the stamped letters and figures.

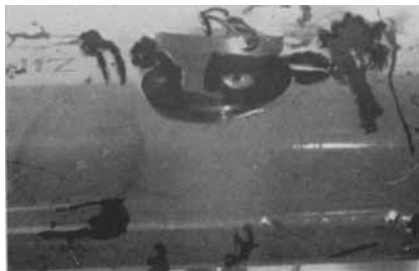
Fig. 33 c. Detail of middle screw ( $\times 5$ ). Edges of plates severely damaged and corroded. Screw head shows hardly any corrosion. Abundant corrosion in screw hole.
