# Faulty design increases the risk of neck fracture in a hip prosthesis

**ABSTRACT** – From October 1993 to May 1994, we performed 35 total hip arthroplasties (20 women) using a Charnley type modular 28 head manufactured by Medical Tec Brazil. 9 fractures through the neck of the stem prostheses occurred, all but 1 in men, after mean 4 (0.3–6) years. All fractures were due to an inadequate confluent radius causing abnormal transmission forces through the neck. The higher the load (men, heavy body weight), the greater the risk of fracture. The metallographic, chemical and microhardness analyses showed no abnormalities. We ascribe these fractures to faulty design of the stem prosthesis.

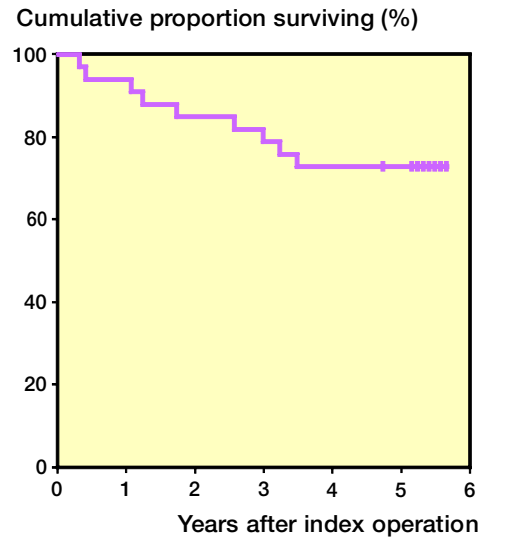
The overall survival of the prosthesis at 4 years—e.g., the risk of not sustaining a fracture of the neck—was as high as 72% and as low as 50% (Figures 3 and 4) in men.

Figure 3. Risk of fracture.

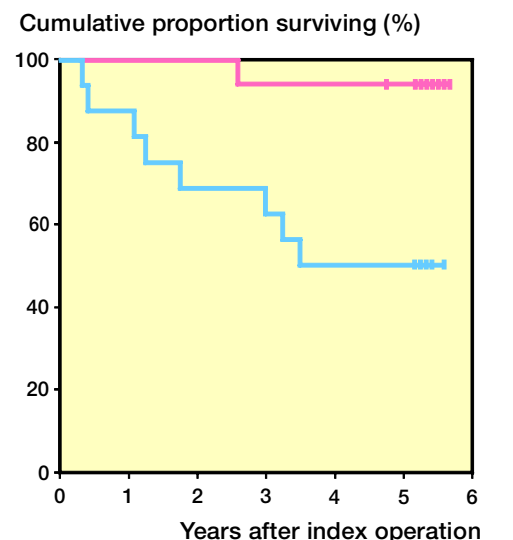
Figure 4. Risk of fracture according to gender.
