## FACTORS IN THE MECHANICAL FAILURE OF THE FEMORAL COMPONENT IN TOTAL HIP PROSTHESIS

*Report of Six Fatigue Fractures of the Femoral Stem and Results  
of Experimental Loading Tests*

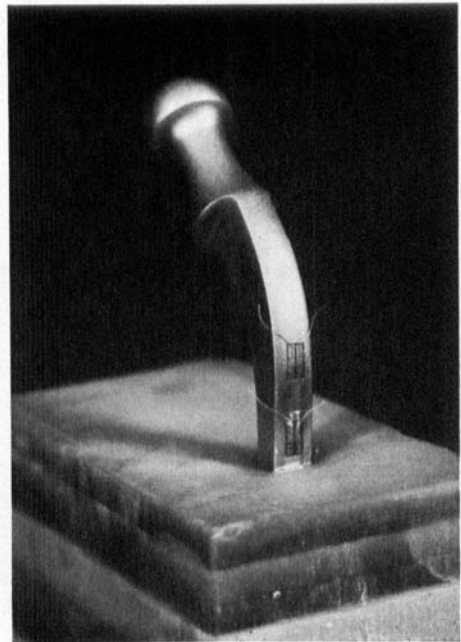
The femoral component of a Charnley Muller Protasul and a stainless steel Charnley prosthesis were imbedded at their stem in an epoxy (Technovit) (Figure 11). The level of imbedding was 57 per cent of their stem length and the stem was mounted vertically so that the applied load on the femoral head at 0° was parallel to the axis of the femoral stem (Figure 12).

*Figure 11. Shows the mounting of the femoral component in the epoxy (Technovit). The level is 57 per cent of the height of the femoral stem and two strain gauges are sealed on the outer base at an identical relative height for both prostheses.*

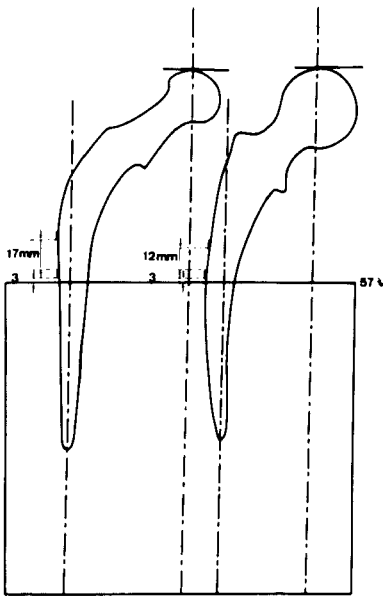
Figure 12. Shows the level of imbedding at 57 per cent of the stem height and the location of the strain gauges. It also demonstrates the  $\pm 20$  per cent difference in bending moment arm at the stem being the perpendicular distance between the application line of the experimental loading force and the axis of the stem.

This does not necessarily represent the moment arm of the resultant joint reaction force in vivo where the direction of the resultant force at the femoral head will be influenced by the possible action of the abductor muscles.

The moment arm of the bending moment at the femoral stem produced by the loading force at the femoral head was about 25 per cent smaller for the Charnley Muller prosthesis in comparison with the Charnley prosthesis (Figure 12). However, this effect was cancelled to some extent because of the smaller cross-sectional area of the

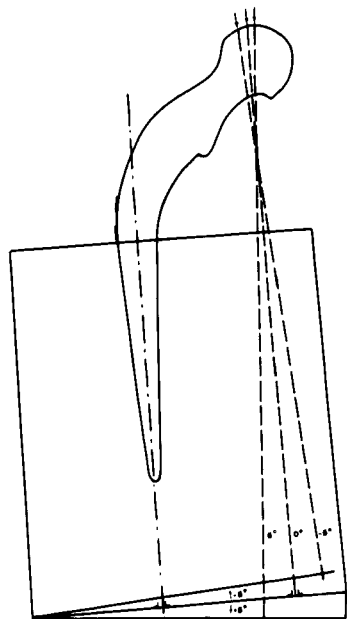
Figure 13. Shows the different experimental loading directions in order to evaluate the influence of the inclination of the stem axis with regard to the axis of the femoral shaft.

Two strain gauges were sealed on the lateral surface at an identical relative position on the stem (Figure 12). The loading at the femoral head was applied in three different directions; parallel to the axis of the stem ( $0^\circ$ ) and with a valgus ( $-5^\circ$ ) and varus ( $5^\circ$ ) position of the stem towards the loading application line (Figure 13). This variation in loading direction towards the femoral stem was applied in order to evaluate the effect of inclination of the femoral stem with regard to the femoral shaft axis. The degree of possible deviation of the stem from the axis of the femur in the frontal plane is dependent upon the width of the medullary canal but measurements demonstrate that a possible tilting over  $\pm 5^\circ$  is a realistic average figure. The modulus of elasticity and the yielding point were

It would seem to be technically important to insert the stem in the varus position with respect to the femoral shaft axis and to insure that it is well covered by acrylic. The cracking of the acrylic is a potential danger leading to an unfavourable loading condition of the femoral stem. Stainless steel is a more resistant material with regard to fatigue phenomena in comparison with the protasul alloy because of the significantly higher yielding point and its better metallographic structure.

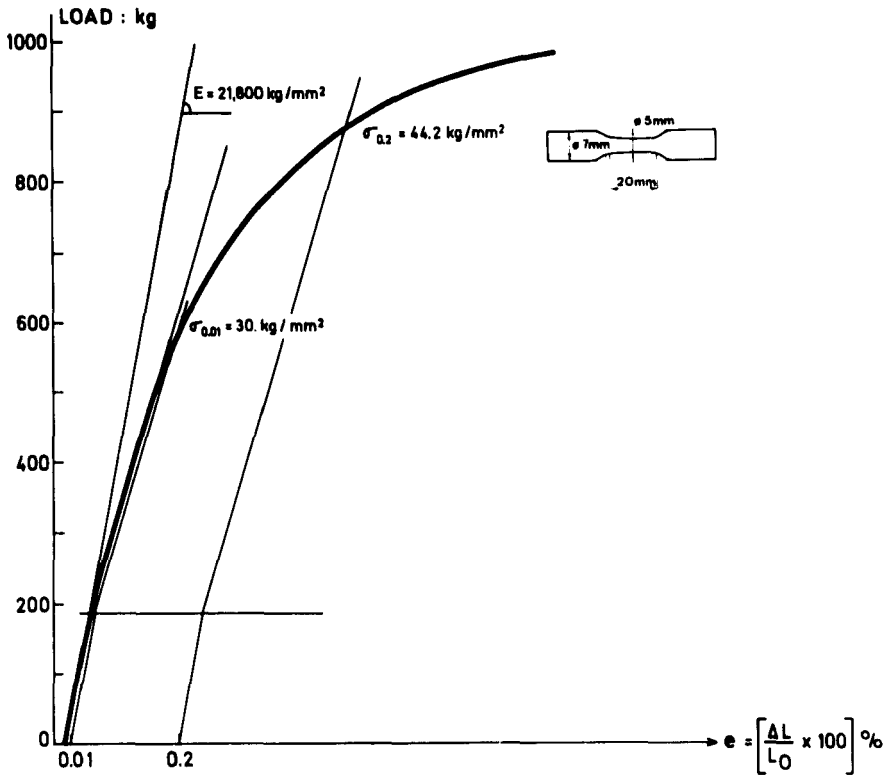
Figure 14 A. A material specimen taken from a Charnley Muller Prosthesis was tested in tension in order to determine:

- the modulus of elasticity ( $E = 21,800 \text{ kg/mm}^2$ ),
  - the 0.01 yielding point ( $\sigma_{0.01} = 30 \text{ kg/mm}^2$ ),
  - the 0.2 yielding point ( $\sigma_{0.2} = 44.2 \text{ kg/mm}^2$ ).
- The ultimate tensile strength is  $72.6 \text{ kg/mm}^2$ .

The 0.01 yield stress is 68 kg/mm<sup>2</sup> for stainless steel and 30 kg/mm<sup>2</sup> for the Protasul alloy (Figure 14). The absolute values of the load at the yield stress increase from the valgus ( $-5^{\circ}$ ) towards the varus ( $+5^{\circ}$ ) position.

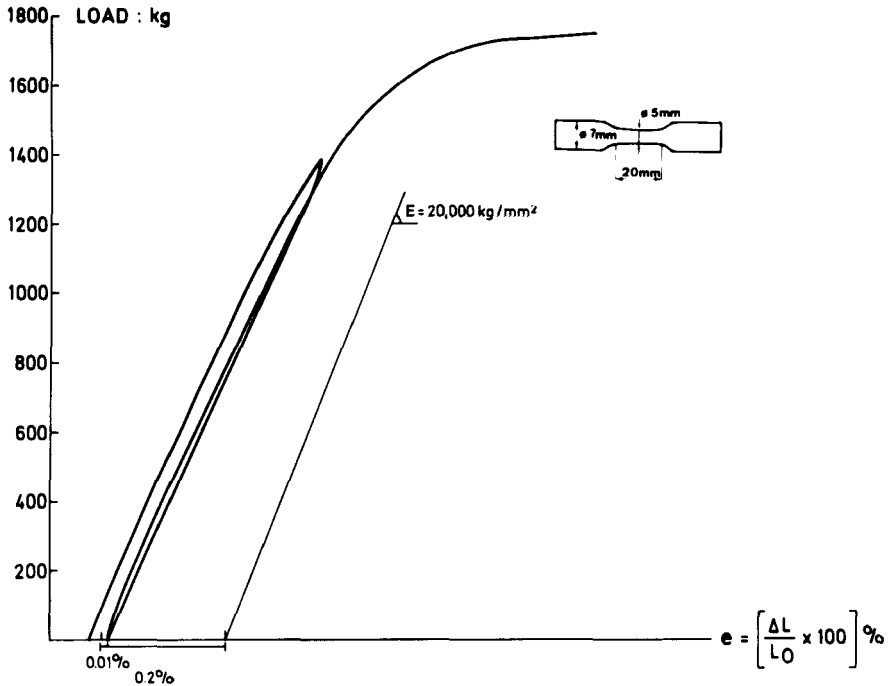
Figure 14 B. A stainless steel specimen taken from a Charnley Prosthesis tested in tension reveals:

- a modulus of elasticity:  $E = 20,000 \text{ kg/mm}^2$ ,
- a  $\sigma_{0.01}$  yield stress:  $\sigma_{0.01} = 68 \text{ kg/mm}^2$ ,
- a  $\sigma_{0.2}$  yield stress:  $\sigma_{0.2} = 87 \text{ kg/mm}^2$ ,
- an ultimate yield stress:  $\sigma_u = 93 \text{ kg/mm}^2$ .

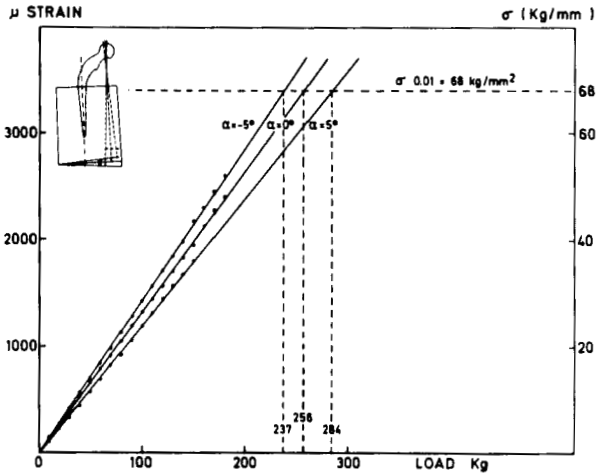
The relationship of the applied load to the measured strain is shown in Figures 15, 16, 17 and 18. In both types of prosthesis the strain recorded at the lower strain gauge was higher than that at the upper. This is explained by the fact that the lower strain gauge is affected by the clamping of the prosthesis in the epoxy and the difference in cross-

Figure 15. Charnley Prosthesis. Readings at the upper strain gauge.

Figures 15, 16, 17, 18 demonstrate that the 0.01 yield stress was reached at a significantly lower load for the Charnley Muller prosthesis than for the Charnley prosthesis. This difference is mainly due to the different 0.01 yield stress of the material.

A  $5^{\circ}$  deviation of the prosthesis stem from the femoral shaft axis alters the loading conditions at the femoral stem significantly (Figures 15, 16, 17, 18). There was a  $\pm 20$  per cent decrease of the loading at the femoral head from a  $+5^{\circ}$  position towards a  $-5^{\circ}$  position to obtain the level of 0.01 yielding stress for the surface covered by the strain gauge.

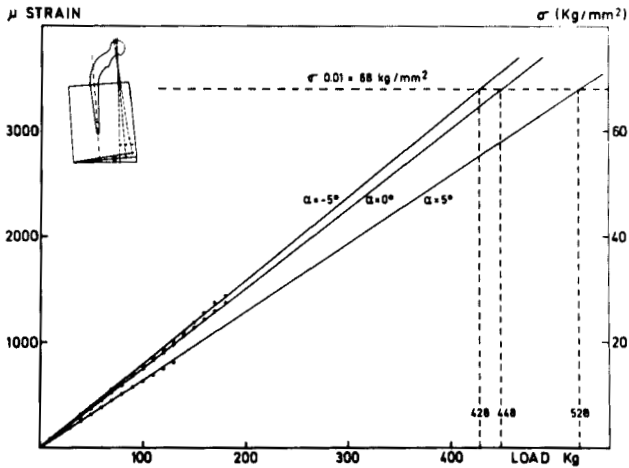
Figure 16. Charnley Prosthesis. Readings at the lower strain gauge.

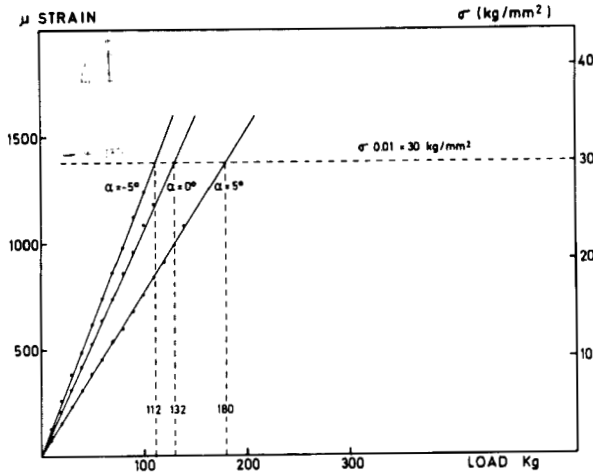
Figure 17. Charnley Muller Prosthesis. Readings at the upper strain gauge.

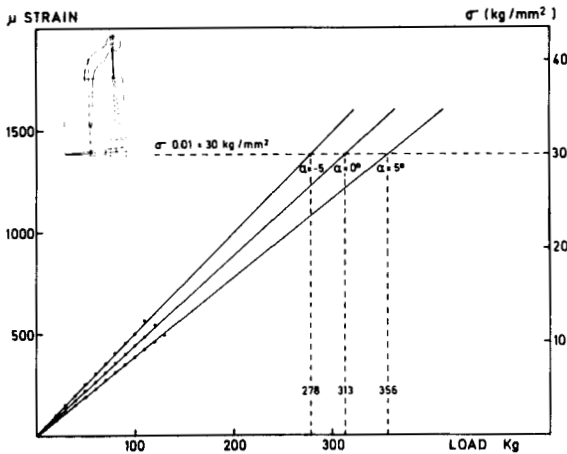
Figure 18. Charnley Muller Prosthesis. Readings at the lower strain gauge.

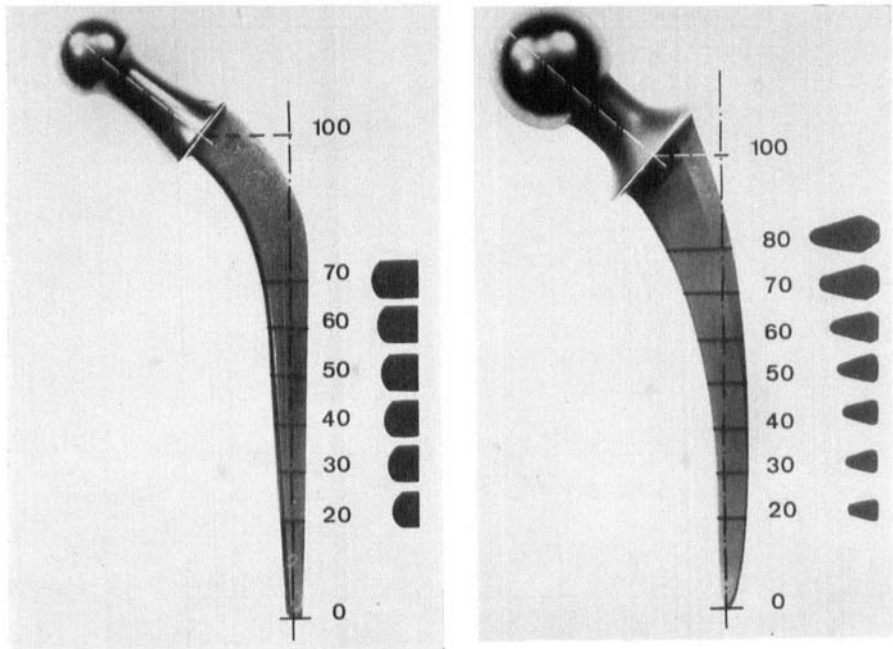
Figure 19. A map of the cross sections of the two types of prosthesis shows the more pronounced tapering of the Charnley Muller type resulting in smaller cross-sectional areas at the levels 60 to 20 per cent stem height.

Charnley Muller femoral stem at the level of the recorded strain. The tapering of the stem is more pronounced in the Charnley Muller prosthesis (Figure 19) resulting in a steeply decreasing cross-sectional area of the stem.
