Supplementary data

Table 2. Chemical composition (wt.%) of STRYDE based on PMI analysis

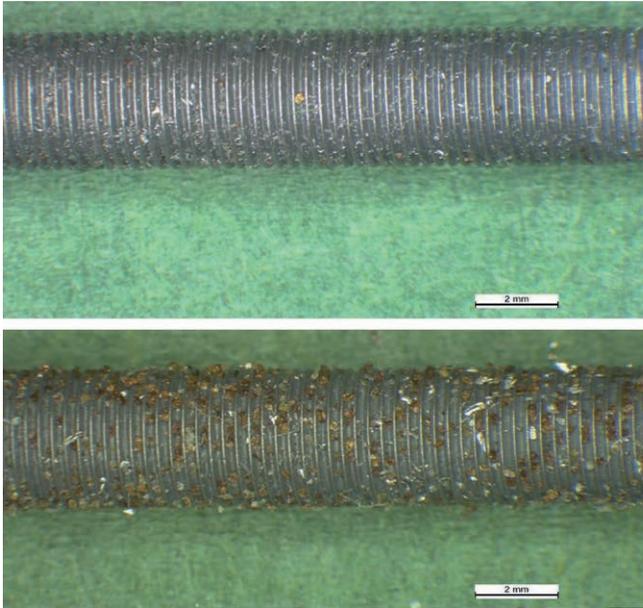
PMI analysis

V%	Cr%	Mn%	Fe%	Cu%	Mo%	W%	Al%	Ti%	Si%	Ni%
Sample 1	4.10	2.05	1.76	2.63	0.47			16.0	72.1	0.79	0.03
Sample 2	4.20	3.27	3.00	5.69	0.16			1.2	81.8	0.62	0.05
