Plain radiographs inadequate for evaluation of the cement-bone interface in the hip prosthesis

A cadaver study of femoral stems

Maarten E. Jacobs, Eric M. J. Koeweiden, Tom J. J. H. Slooff, Rik Huiskes and James R. van Horn

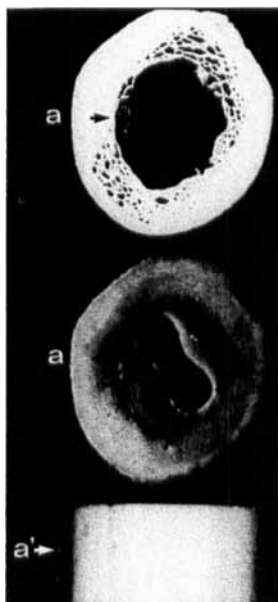
Figure 2. In vivo cementation. Patient succumbed postoperatively. Gross interposition of blood (a), giving a radiolucent line on plain radiograph (a').

Interpretation of Figures 2, 3, 4, and 6. The figure at the bottom represents a part of the plain radiograph. The white line indicates at which level the cross section in the center of this figure is taken. The figure at the top is a contact radiograph of the same cross section. The cross sections at the top and the center are viewed from above.

It was not possible to differentiate from radiographs between good penetration of cement in the intratrabecular spaces and accumulations of broken trabeculi trapped within the cement. Sharply delineated radiolucencies were definitely not just related to interposition of blood, soft tissue, or air between bone and cement; similar radiolucencies were also seen as the result of either a specific arrangement in the proximity of the interface and in the femoral wall, or an irregular configuration of the border between cortex and cement, with macroscopically good alignment (Figures 2 and 3).

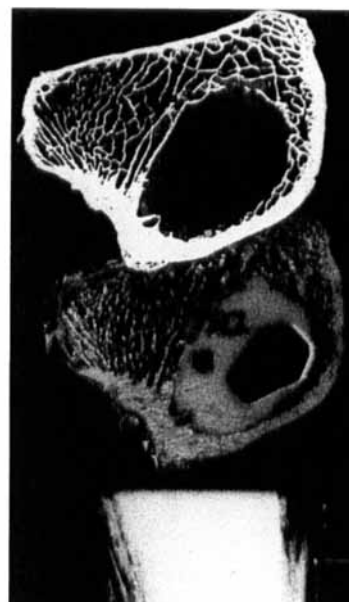
Figure 4. In vitro cementation. Cross section at level of trochanter minor. The non-homogeneous and lamellated appearance of the cement on the slices is not seen on the radiograph. The radiographic projection of the complex bone structure obscures the cement bone interface.

In the trochanteric region, the interpretation of radiolucencies was rendered highly speculative, because various structures in a cross section are superimposed on the plain radiographs (Figure 4).

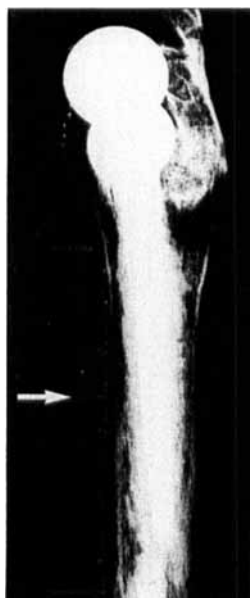
Figure 5. In vivo cementation. Patient died 10 years postoperatively. No hip complaints. Radiograph suggestive of "poor quality cancellous bone."

In the two late postoperative specimens, thin, but solid, sheets of new cortical bone, enveloping the cement and strutted by radially oriented trabeculi, were observed around the cement along the full length of the implant. On the plain radiographs, these sheets blended with the opacity of the cement, and thus were not visible (Figures 5 and 6).
