Correspondence

Failed internal fixation

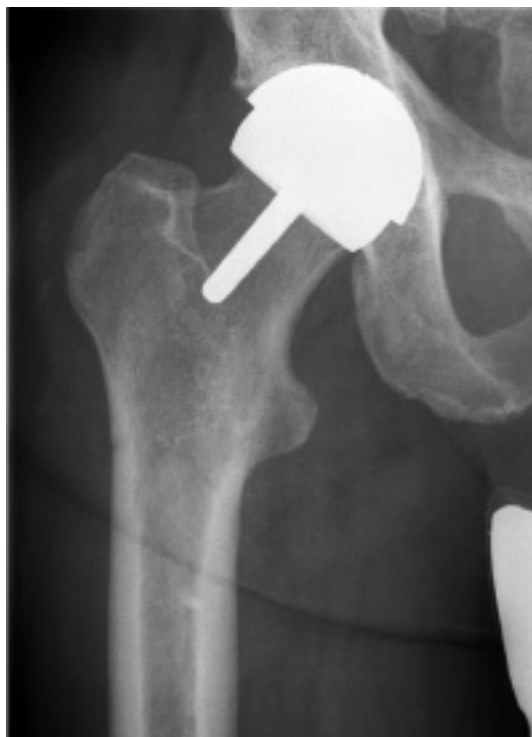
Postoperative radiograph of the presented patient after implantation of the THRA.

In the presented case, we did not recognize any radiographic signs of post-implantation notching (Figure). Also, despite the sufficient time (11 weeks) between the surgical therapy of the periprosthetic fracture and the revision surgery, we did not find any cellular reaction at the bone-metal interface on the surface of the screws. In contrast to this finding, a vital reaction was apparent at the bone-cement interface of the femoral component. Moreover, although the bone tissue proximal to the fracture line was areactive and multifocally fragmented due to the collapse of necrotic bone trabeculae adjacent to the fracture line, mineralized callus formation was apparent distally to the fracture line consistent with a vital reaction to the multifocal fractured and collapsed bone. Therefore I strongly believe that in our case, the femoral remnant was viable after the implantation of the THRA but not following the periprosthetic fracture caused by the motorcycle accident and its surgical therapy.

It would be of some interest to review the pre-injury radiograph with the hip resurfacing in situ to rule out superior notching as this fracture pattern is usually associated with superior notching and trauma in a young patient with good quality of bone.
