Displacement of a cemented polished tapered stem during closed reduction of a dislocated total hip arthroplasty—a case report

Matías Petracchi, Alejandro González Della Valle, Martín Buttaró and Francisco Piccaluga

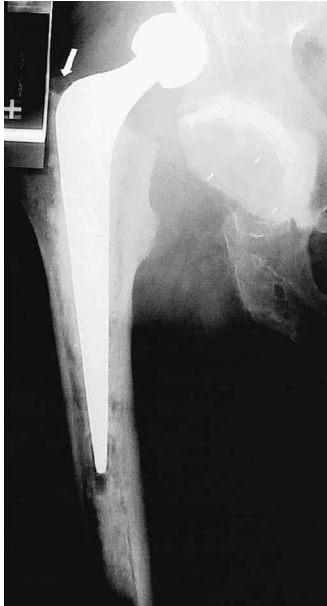
Figure 1. Dislocation of the arthroplasty with an intact metal-cement interface. No cement is present over the shoulder of the stem (white arrow).

In our patient, no cement was placed over the shoulder of the stem. Therefore, we believe that the stem became displaced when the femoral head impinged with the acetabular margin during the attempt of reduction.

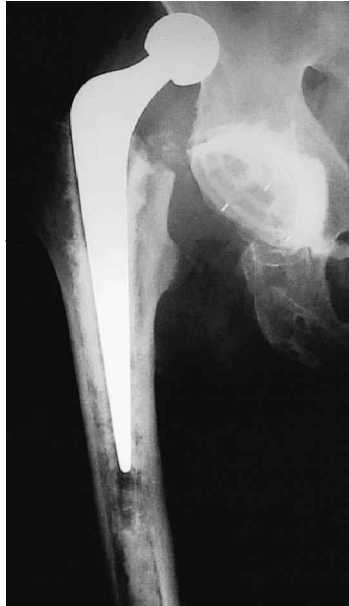
Figure 2. After an attempted reduction, the stem separated from the cement mantle.

and covering the shoulder may be difficult. If a dislocation occurs, radiographs should be examined for the presence of cement over the shoulder. If cement is present, closed reduction without fluoroscopy may be attempted. If cement is absent, we recommend closed reduction with sedation and under fluoroscopic control, to monitor possible impingement of the femoral head and displacement of the stem.

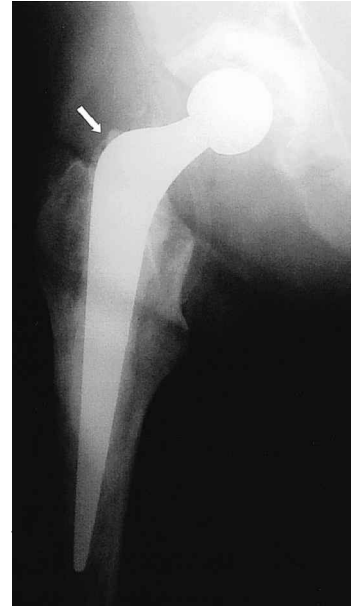
Figure 3. Postoperative radiograph after open reduction shows an intact cement-metal interface. Cement was placed over the stem's shoulder to prevent a new separation (white arrow).

tissue. Before the cement had hardened, we placed more cement over the stem's shoulder to prevent a new separation, as suggested by Staal et al. (2000) (Figure 3). The arthroplasty was reduced and found to be stable with an adequate soft tissue tension and arch of motion. The postoperative course was uneventful. 12 months after surgery, she had had no further dislocations and radiographs show an intact cement-stem interface.

Surgeons should be aware of this infrequent complication associated with the use of stems having a polished surface finish. Placing cement over the shoulder of the stem may avoid this complication (Staal et al. 2000). Ideally, there should be a continuous cement mantle covering the shoulder of the stem in continuity with the cement mantle in the lateral femur. Interdigitation of the cement in the cancellous bone of the greater trochanter may increase its mechanical strength and prevent displacement of the stem. In revision surgery, insufficient bone stock in the greater trochanter is frequently encountered; therefore, achievement of a continuous cement mantle extending proximally
