Dislodgement of the femoral component of a cemented hip

A case report

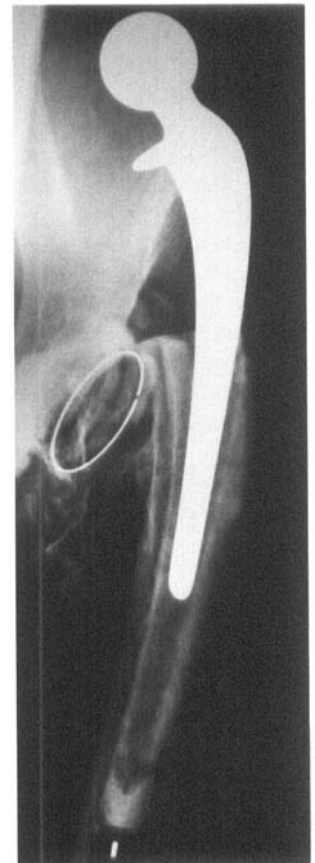
After another 3 weeks the hip redislocated, again without excessive movements. Under general anesthesia several attempts to reduce the hip were unsuccessful, and fluoroscopy then revealed that the femoral component was dislodged (Figure 1). At the revision arthroplasty the remaining femoral neck was noticed to have a defect in the posterior part and was also judged to be somewhat too long. After shortening of the femoral neck, a short-necked femoral component was cemented, and the acetabular component was fitted with a posterior rim. The patient has had no further dislocation.

Figure 1. An 88-year-old woman with a dislodged femoral component after attempts to reduce her redislocated hip.

Dislodged cement-free arthroplasty components have been described, the femoral component by Friedman (1989) and the acetabulum by Laughlin et al. (1992). Our case shows that dislodgement of a cemented femoral component is possible. We suggest that reduction of a dislocated hip prosthesis should be performed under fluoroscopic control, unless it can be achieved easily under mild sedation.
